DAILY REPORT #47 – DORIS NORTH INFRASTRUCTURE/ NORTH DAM

Prepared by:	Murray McGregor Iozsef Miskolczi	Date:	2012.02.21
Reviewed by:		Project #:	1CH008.058.0320
Role	Company	Personnel – Position	On Site
Client	Hope Bay Mining Limited (HBML)	Angela Holzapfel – ESR Compliance Manager David Vokey – ESR Coordinator Don Ethelston – HSLP Advisor Dean Wold - Safety Jill Turk – ESR Coordinator Katsky Venter – ESR Manger Michelle Tanquay – ESR Site Manager Stirling Kelly – HSLP Advisor	No No No No Yes No Yes No
	JDS	Lloyd Jackson – Mechanical Superintendent Doug Fielding – Construction Manager Ishan Fechter – Construction Coordinator Jerry Graham – Construction Manager Kevin Whieldon – Project Coordinator Mark Valeriote – Construction Manager	Yes Yes Yes No No Yes
Engineering Design Consultants	SRK Consulting (Canada) Inc.	John Kurylo – Site Engineer Megan Miller – Site Engineer Lawrence Borowski – Site Engineer Murray McGregor – Site Engineer Iozsef Miskolczi – Site Engineer	No No No Yes Yes

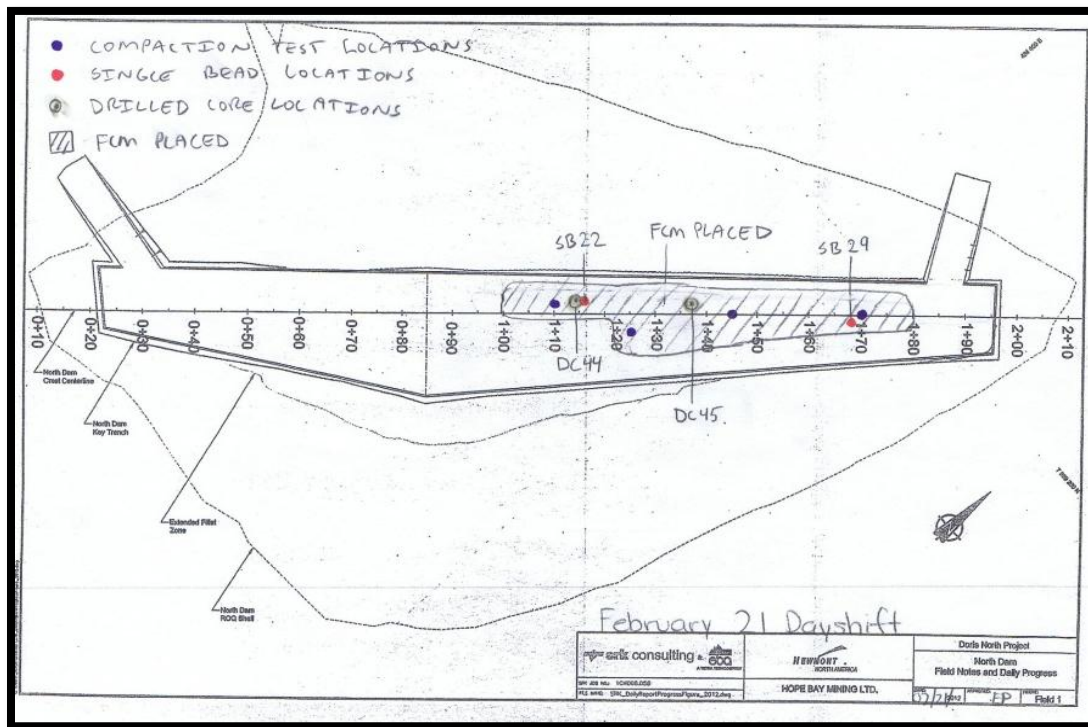
FIGURES:**Figure 1 – North Dam Progress – Dayshift**

- An area from 1+25 to 0+60 was cleaned for placement; the area had an odd shape dictated by last day's placement.
- Some additional spot cleaning was required near ledges before approval for placement was given.
- Material placed was drier than yesterday, but still had a noticeable sheen in most areas.
- Diligent compaction was observed resulting in smoother finished surfaces.
- All Troxler measurements indicated acceptable saturation and compaction.

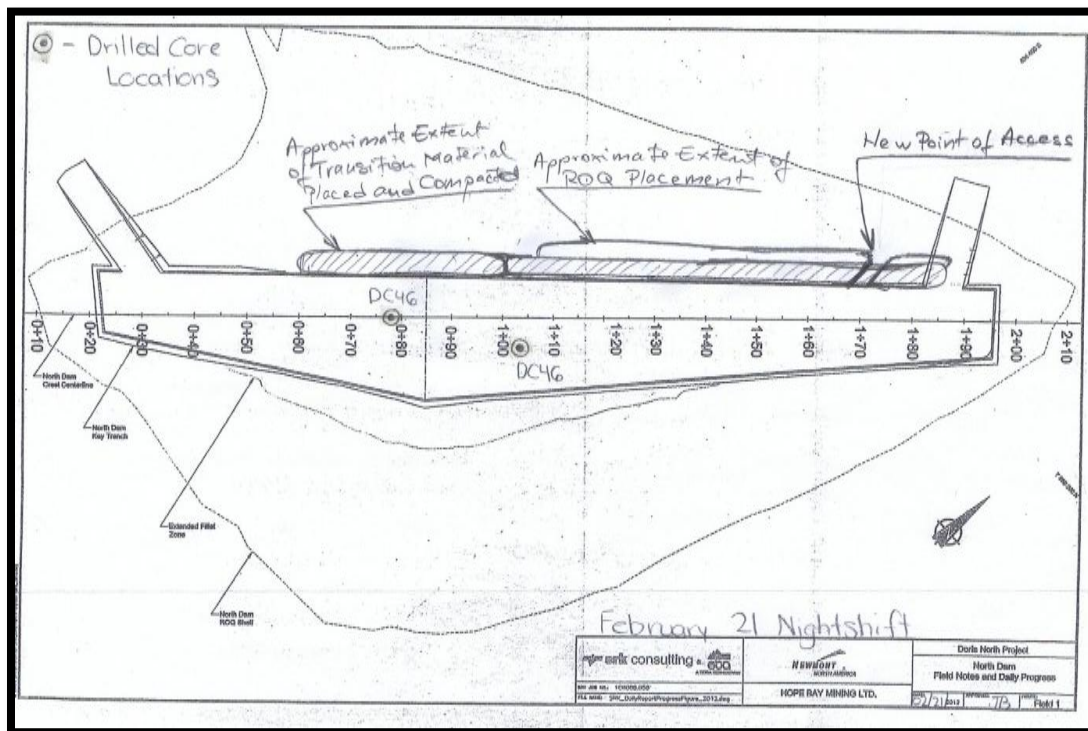
**Figure 2 – North Dam Progress – Nightshift**

- The overbuilt section at Sta. 1+35 resulted in the encasement on the thermistor cables in the frozen core. The nightshift foreman was notified; workers used a jackhammer to break up the frozen core to get the cables loose.
