**Re: August 2018 – Monthly Monitoring Report for Water Licence 2AM-DOH1323**

This report is comprised of monitoring requirements as set out in Part J and Schedule J of water licence 2AM-DOH1323 Amendment 1, and additional requirements from CIRNAC.

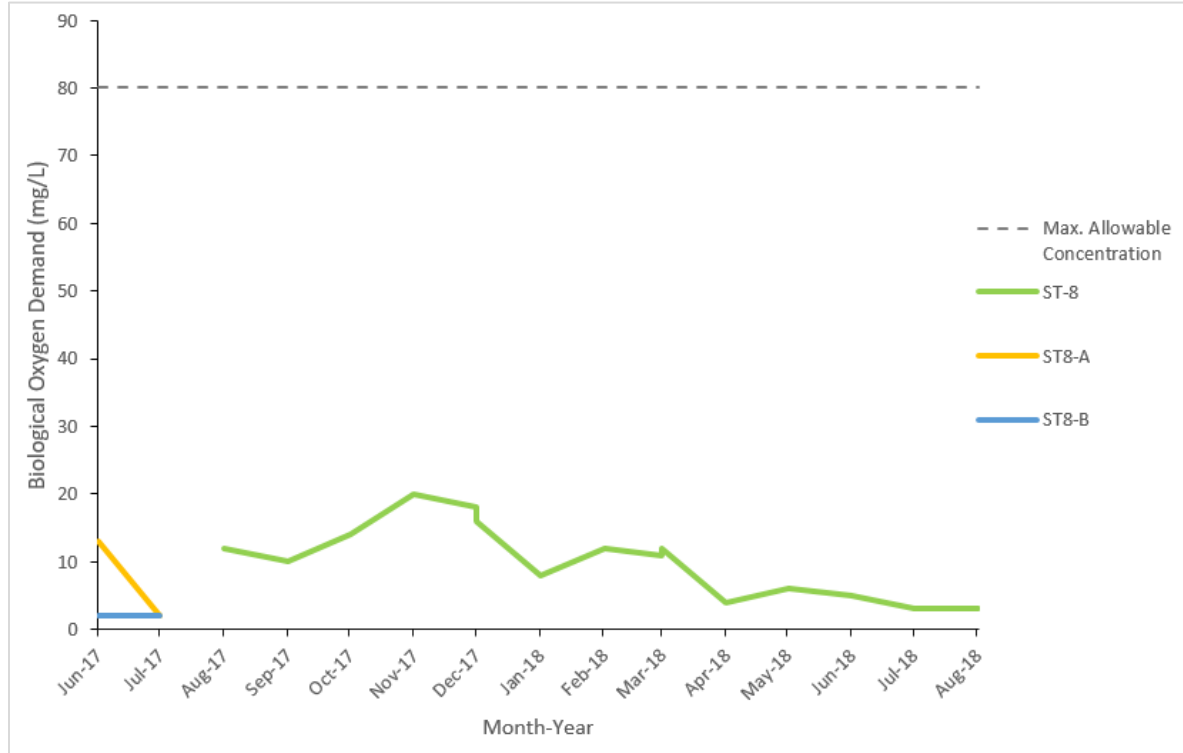
**Figure 1. Biological Oxygen Demand Results Consistently Below Discharge Criteria for Wastewater Treatment Plant (ST8, ST8A, ST8B)**

Note: Maximum Average Concentration as per Part G Item 4(b).

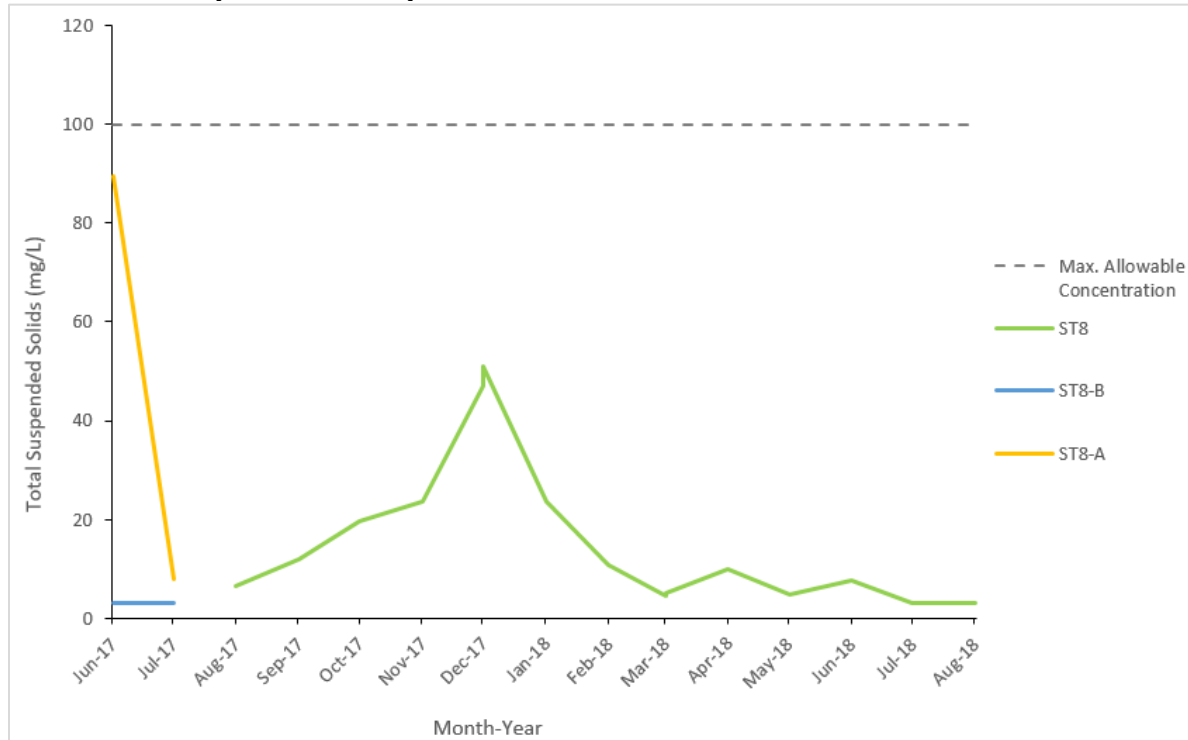
**Figure 2. Total Suspended Solids Results Consistently Below Discharge Criteria for Wastewater Treatment Plant (ST8, ST8A, ST8B)**

Note: Maximum Average Concentration as per Part G Item 4(b).
