Re: December 2018 – Monthly Monitoring Report for Water Licence 2AM-DOH1323

This report is comprised of monitoring requirements as set out in Part J and Schedule J of water licence 2AM-DOH1323 Amendment 1, and additional requirements from CIRNAC.

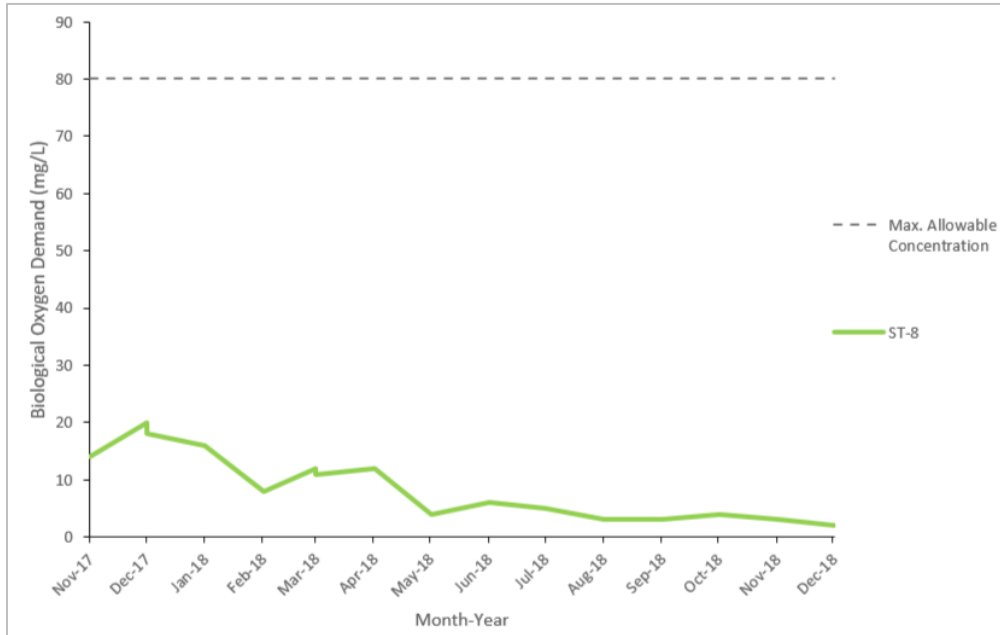
Figure 1. Biological Oxygen Demand Results Consistently Below Discharge Criteria for Wastewater Treatment Plant (ST8)

Note: Maximum Average Concentration as per Part G Item 4(b).

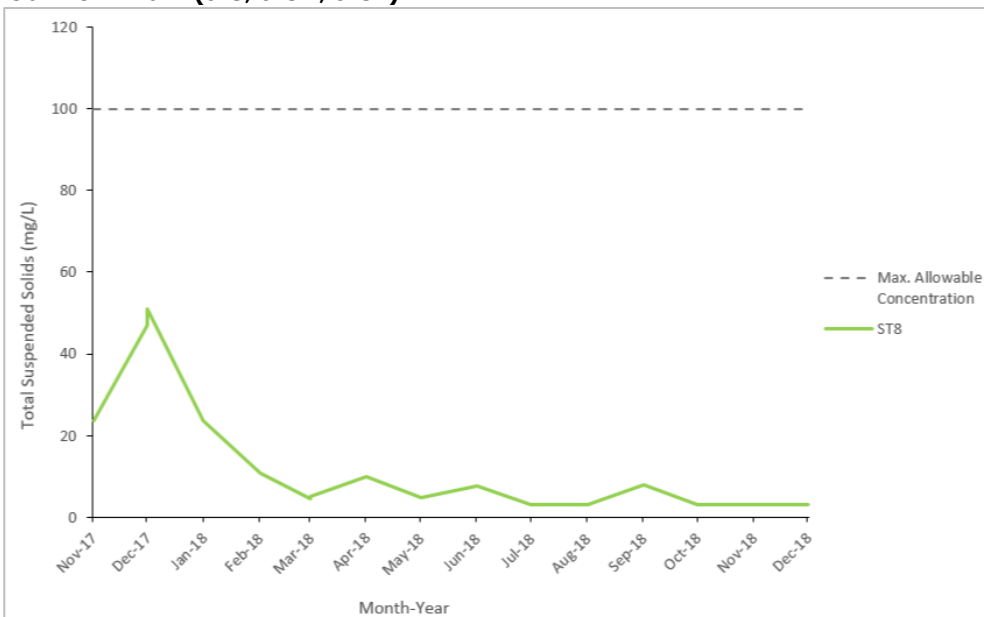
Figure 2. Total Suspended Solids Results Consistently Below Discharge Criteria for Wastewater Treatment Plant (ST8, ST8A, ST8B)

Note: Maximum Average Concentration as per Part G Item 4(b).
