**Re: June 2019 – Monthly Monitoring Report for Water Licence 2AM-DOH1335**

This report is comprised of the monitoring requirements set out in Part I and Schedule I of water licence 2AM-DOH1335 Amendment 2, and additional requirements from CIRNAC.

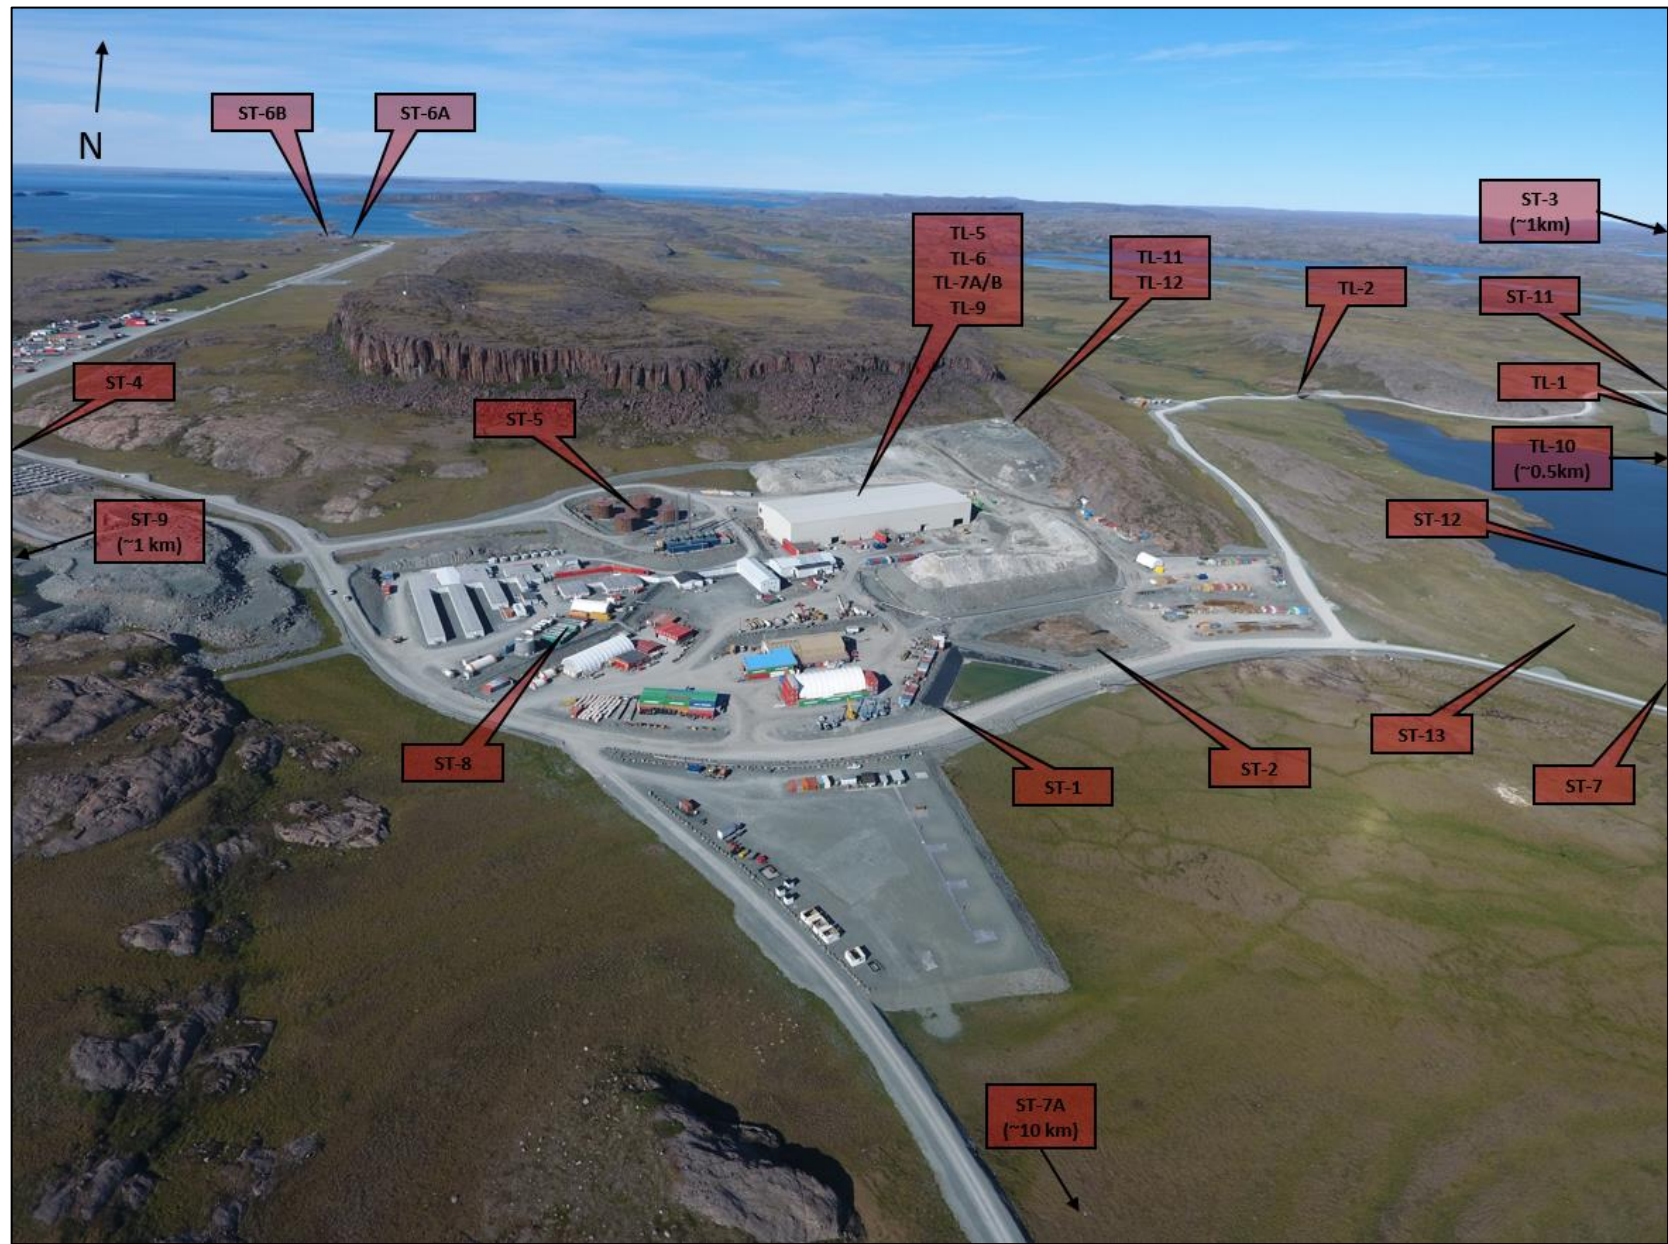
Figure 9. 2AM-DOH1335 SNP Monitoring Locations

Sampling locations monitored under this licence (seasonally or when facilities are operational) are provided in Figure 9 at the end of this report.
