**Re: July 2019 – Monthly Monitoring Report for Water Licence 2AM-DOH1335**

This report is comprised of the monitoring requirements set out in Part I and Schedule I of water licence 2AM-DOH1335 Amendment 2, and additional requirements from CIRNAC.

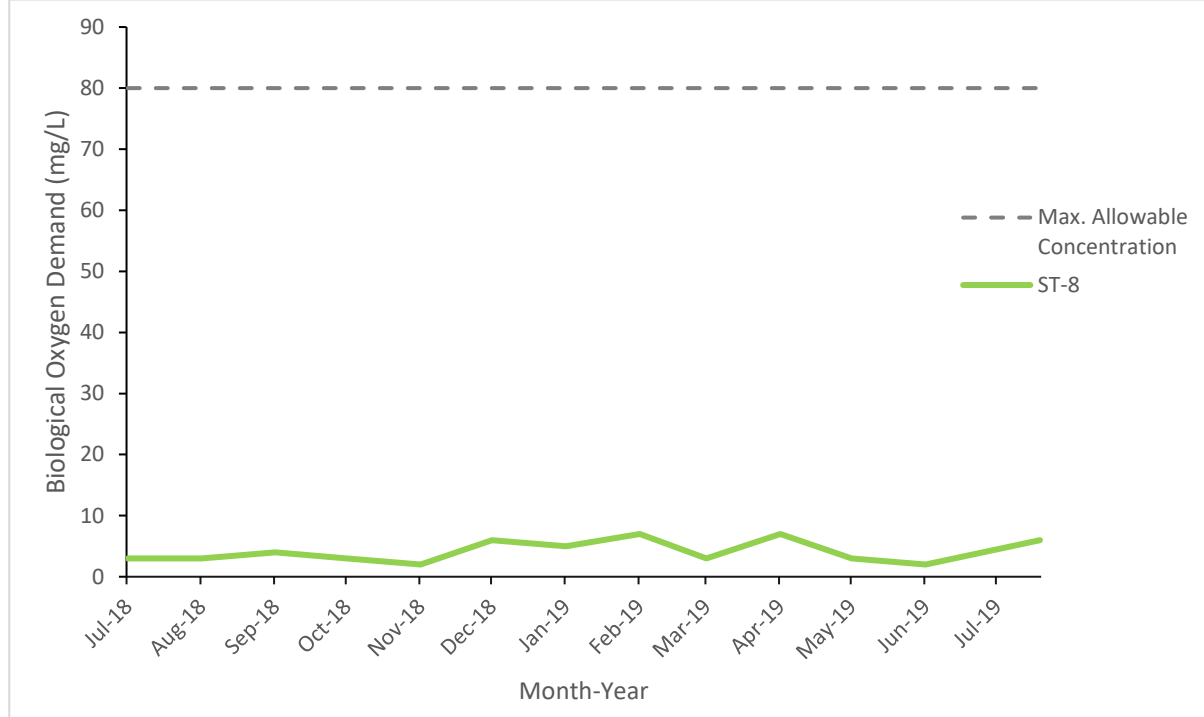
**Figure 3. Biological Oxygen Demand Results Consistently Below Discharge Criteria for Wastewater Treatment Plant (ST8)**

Note: Maximum Average Concentration as per Part F Item 4(b).

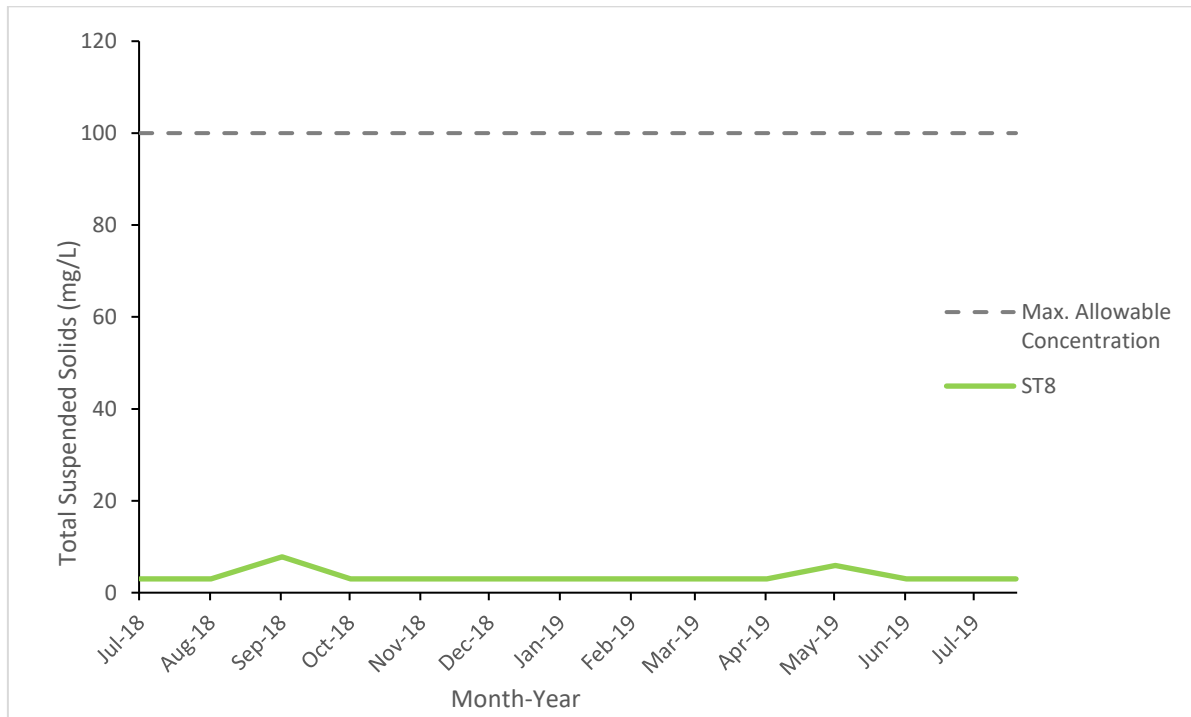
**Figure 4. Total Suspended Solids Results Consistently Below Discharge Criteria for Wastewater Treatment Plant (ST8)**

Note: Maximum Average Concentration as per Part F Item 4(b).
