**DORIS TIA**

| 2018 Annual Geotechnical Inspection | | |
| Station 0+60<br>Horizontal Ground Temperature<br>Cable Temperature Vs. Time | | |

2018 Annual Geotechnical Inspection

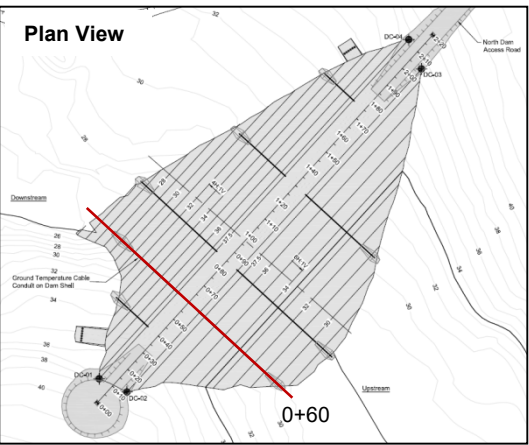
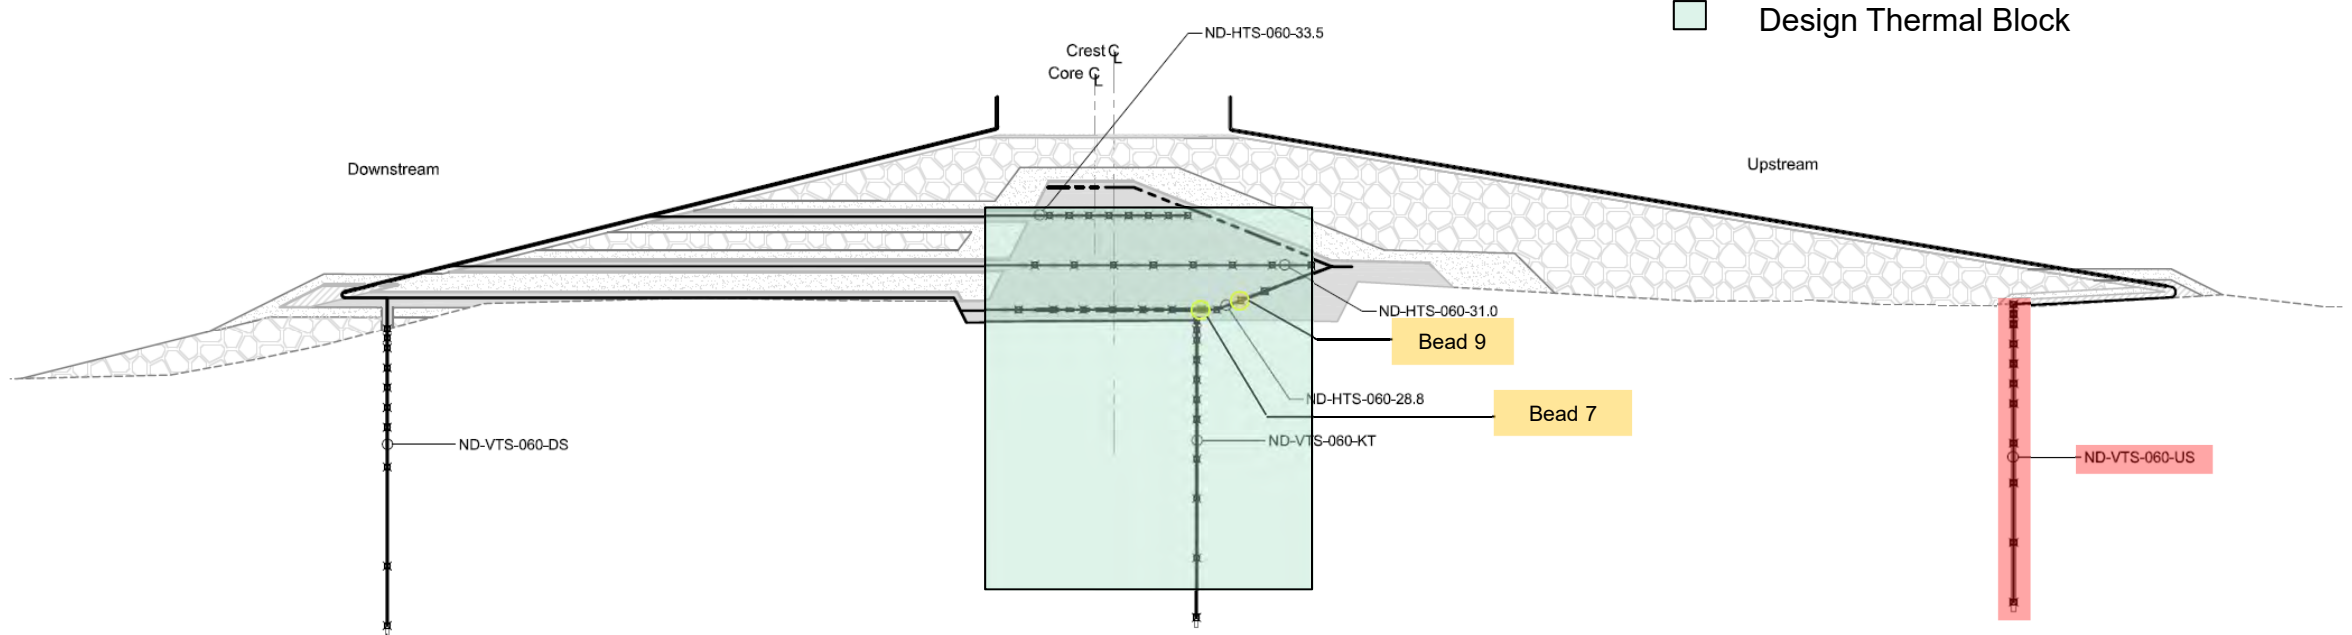
| Date:<br>Jan. 2019 | Approved:<br>PL | Figure:<br><b>B.3</b> |

- Notes:**
- Bead numbers increase from downstream to upstream (horizontal) and top to bottom (vertical)
  - **(A)** Variation in Ground Temperature Cable readings during winter months due to close proximity of Ground Temperature Cable beads to thermosyphon pipes.
  - **(B)** Data logger was disconnected from January 1, 2018 to March 3, 2018 for recalibration
  - **(C)** No readings from Bead 7

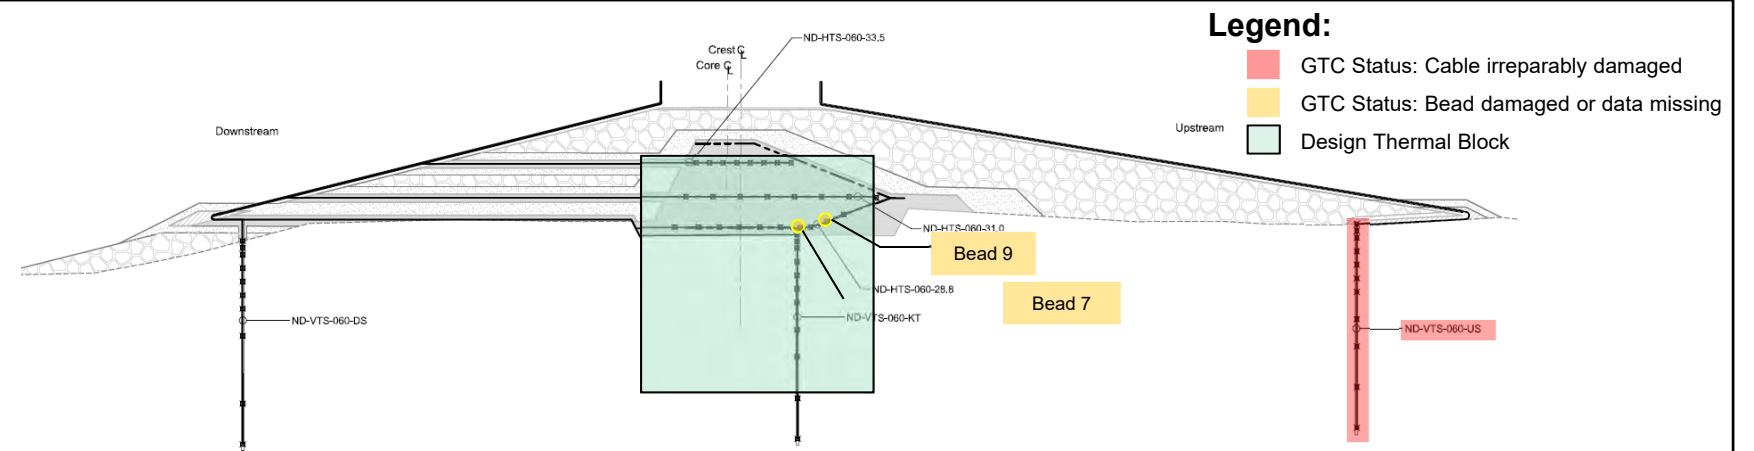
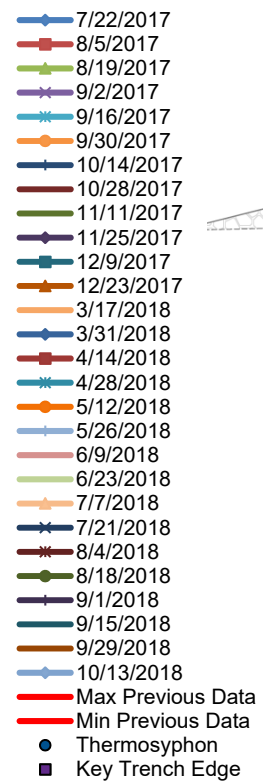
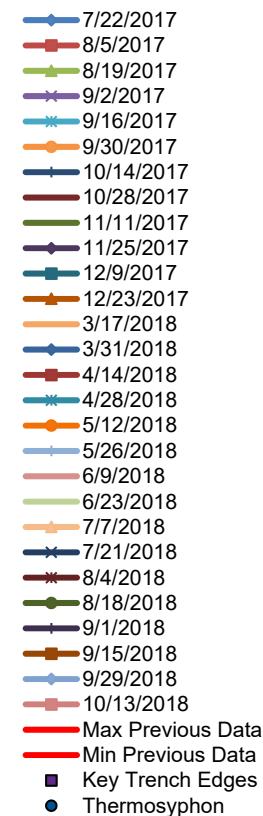
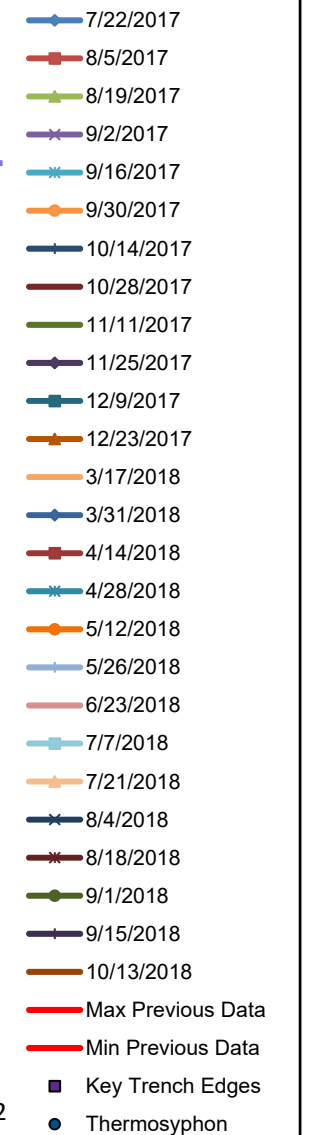
Date: Jan. 2019  
Approved: PL  
Figure: B.4

- Previous Data was recorded between August 2012 and July 2017
- Data logger was disconnected from January 1, 2018 to March 3, 2018 for recalibration
