2018 Annual Geotechnical Inspection

**DORIS TIA**

## Appendix G – Walk Over Surveys

# North Dam Weekly Walkover Survey Report

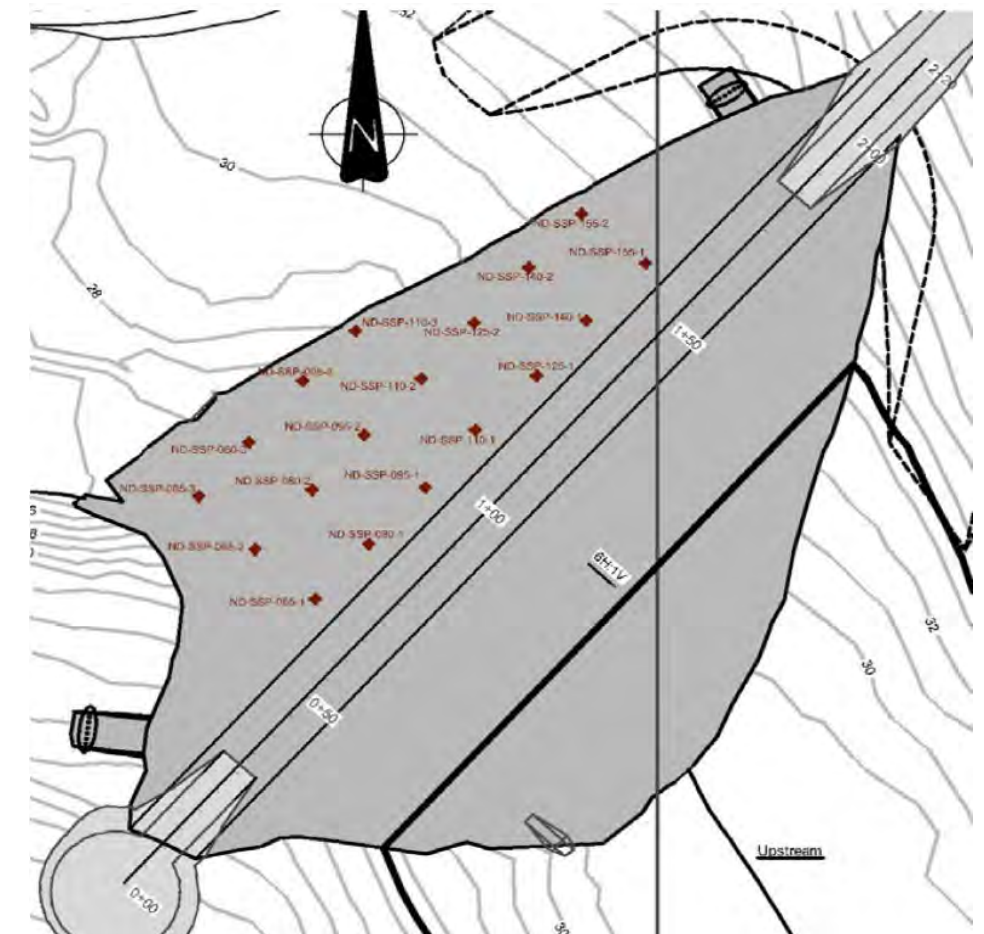
1. The anomolous horizontal displacement observed are Settlement point ND-SSP-110-3 and ND-SSP-155-2 near the downstream toe of the dam.

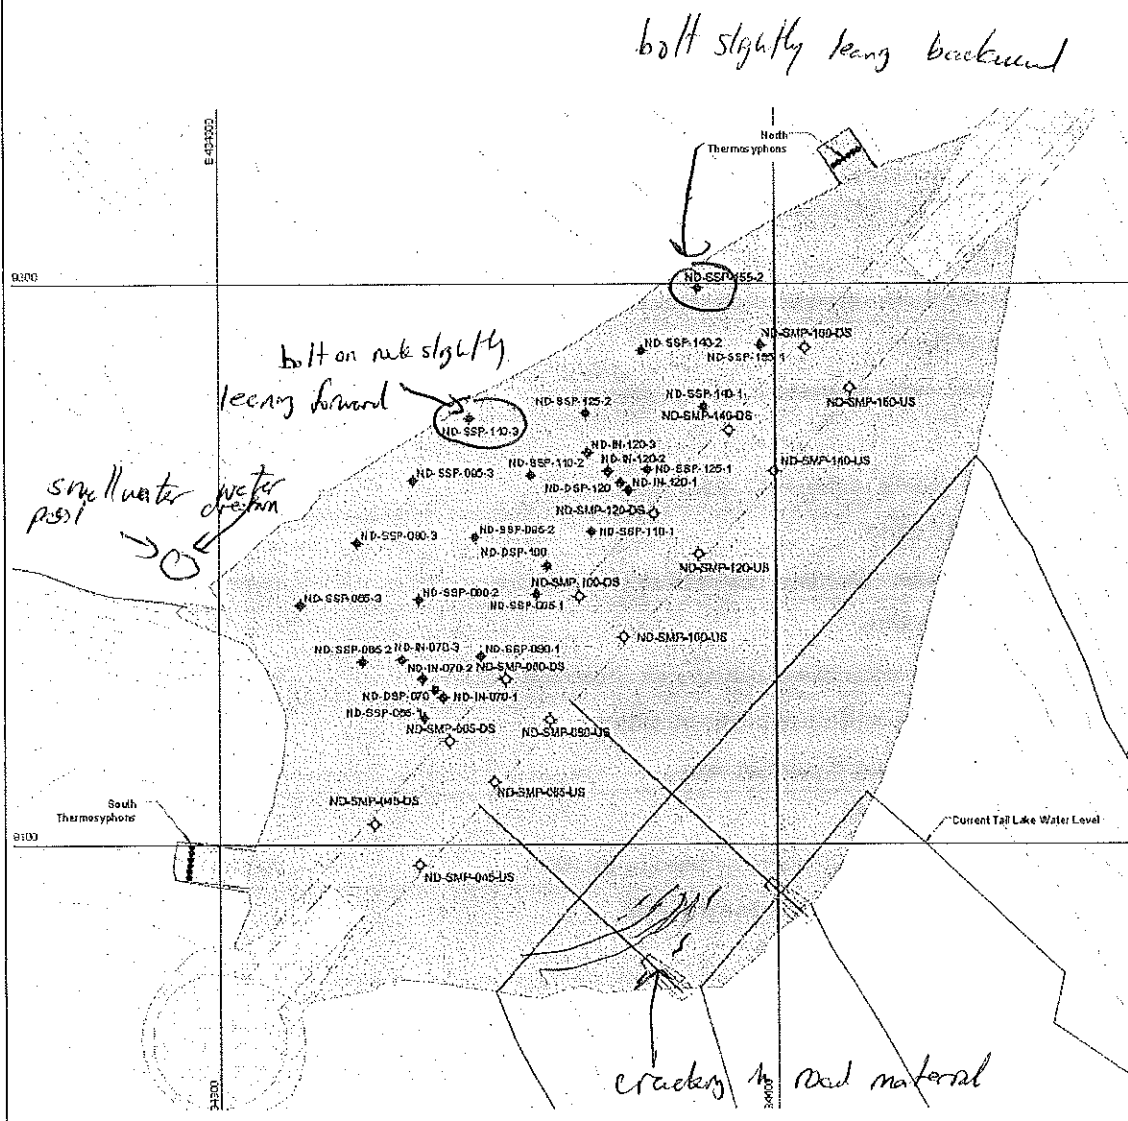
cracks @ upstream part near road  
 pictures of ND-SSP-110-3 & ND-SSP-155-2
