# North Dam Weekly Walkover Survey Report

2018 Annual Geotechnical Inspection

## Memo

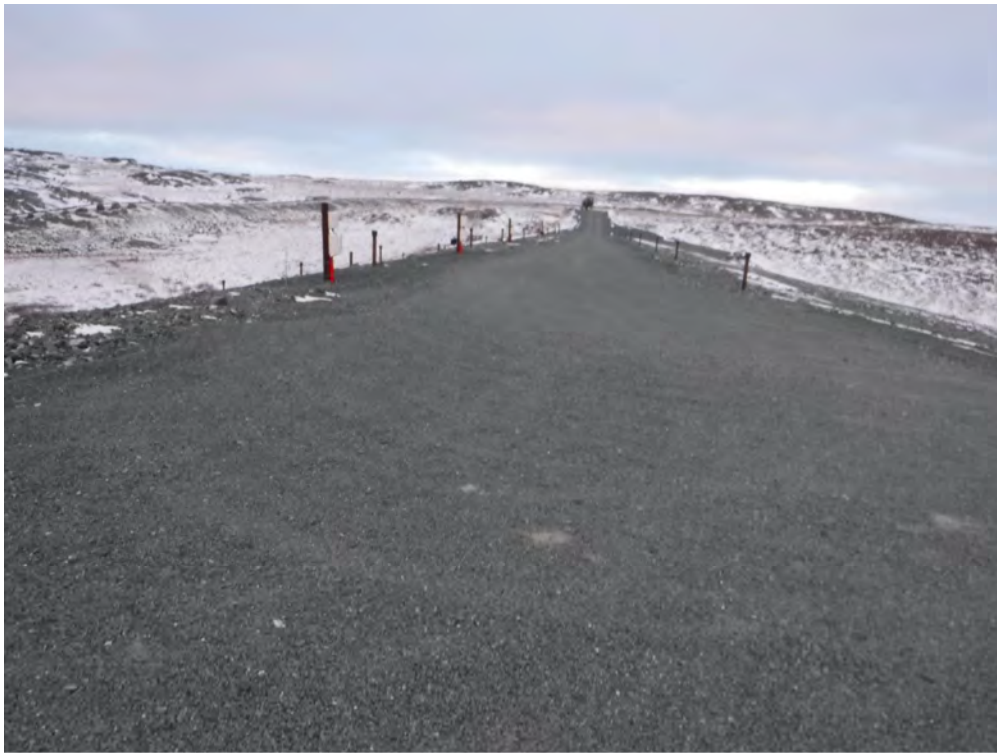
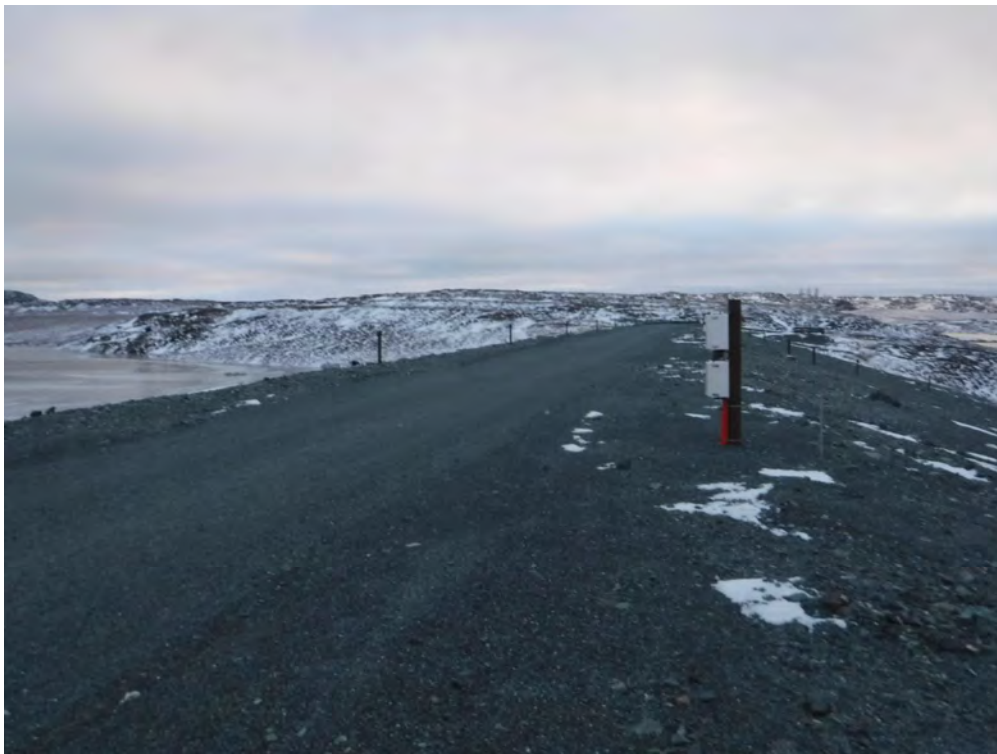
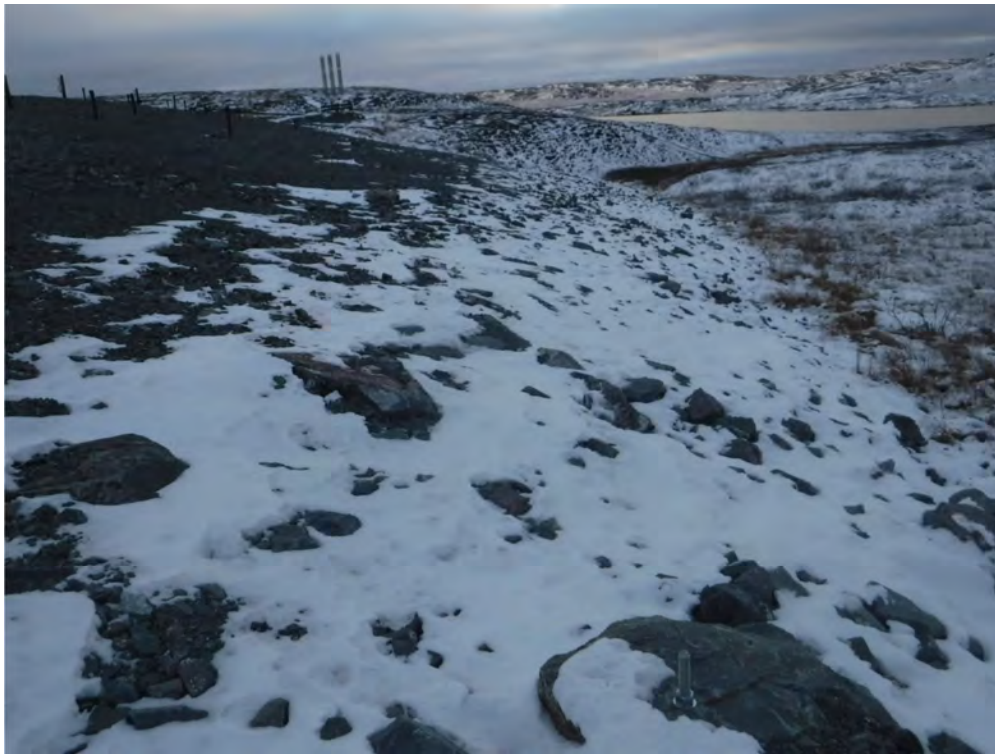
Photo of snow on downstream side

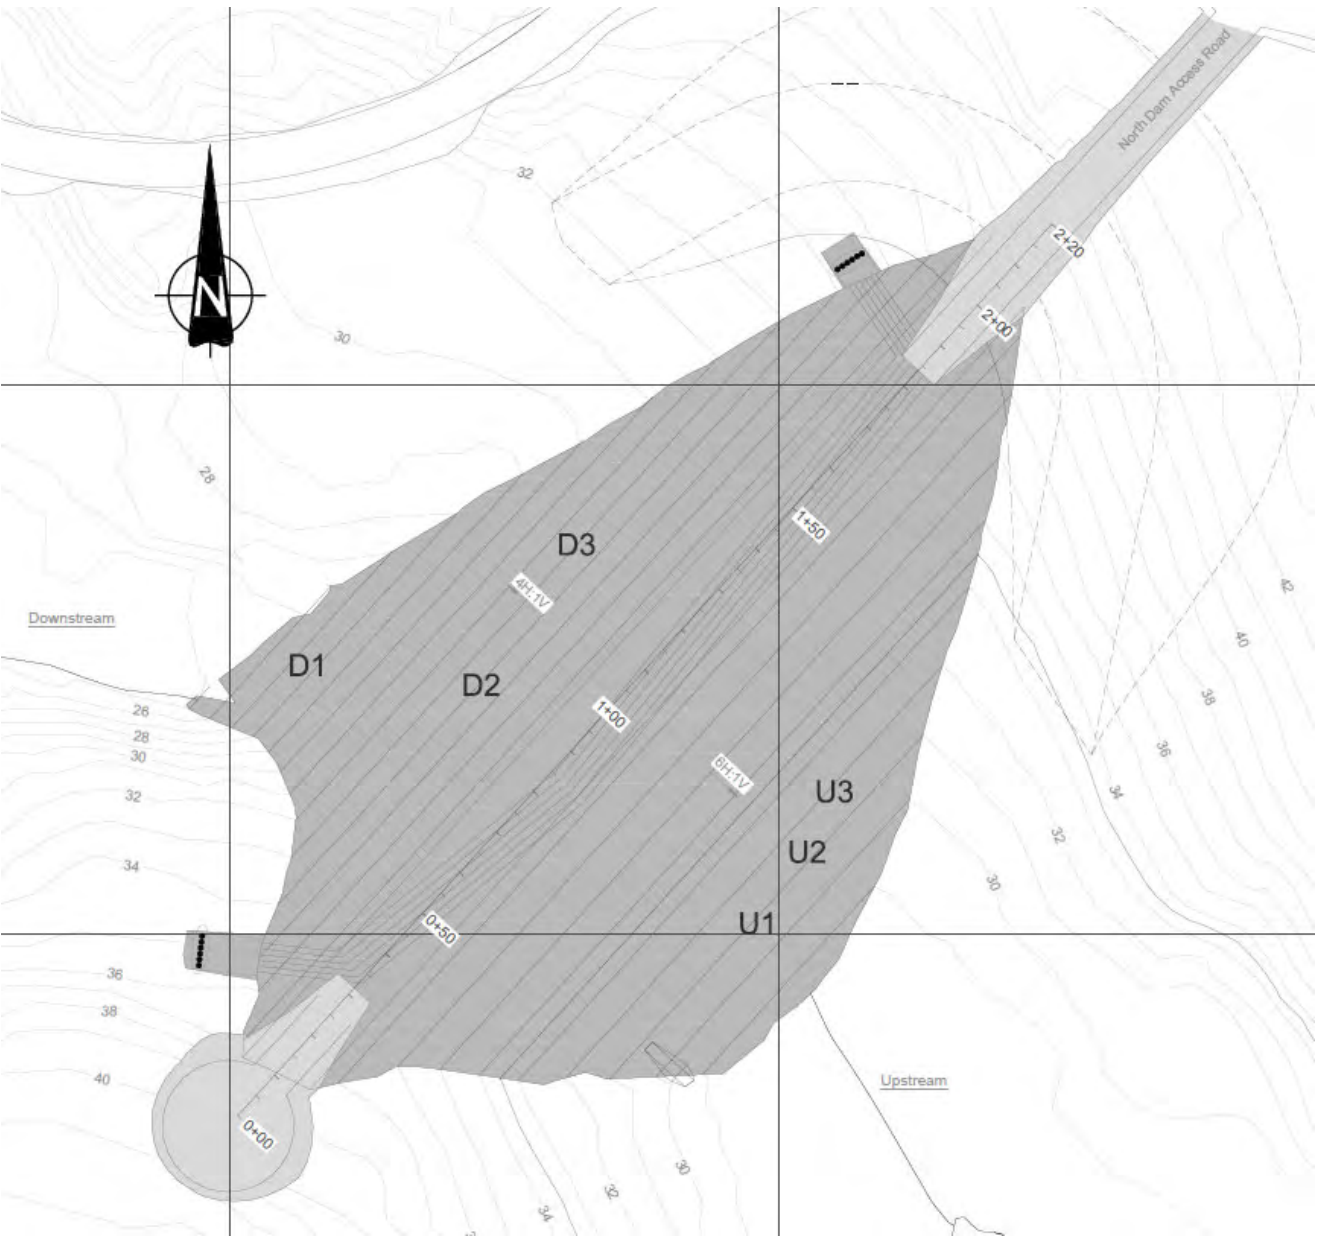
DEPRESSION TRACKING

ID	Location	Comments	Northing	Easting
U1	Upstream	First noted June 2014	7559104	434393
		Boundaries spray painted and ID given July 2014		
		No substantial changes from previous inspection		
U2	Upstream	First noted June 2014	7559117	434402
		Boundaries spray painted and ID given July 2014		
		No substantial changes from previous inspection		
U3	Upstream	First noted June 2014	7559128	434407
		Boundaries spray painted and ID given July 2014		
		July 4, 2015 - Expanding toward U2		
		No substantial changes from previous inspection		
D1	Downstream	Identified during 2014 annual geotechnical inspection, spray painted and given ID.	7559151	434311
		September 1, 2014 - expanded towards the south		
		September 20, 2014 - TMAC ESR noted the depression looks to have expanded, paint mark updated.		
		July 4, 2015 - Slight expansion toward the crest was noted in the daily report		
		No substantial changes from previous inspection
