Appendix L – 2018 AGI Inspection Feedback Presentation

Hope Bay Project 2018 Annual Geotechnical Inspection: On Site Feedback

Maritz Rykaart, PhD, PEng, Doris Camp, Nunavut, August 2-7, 2018

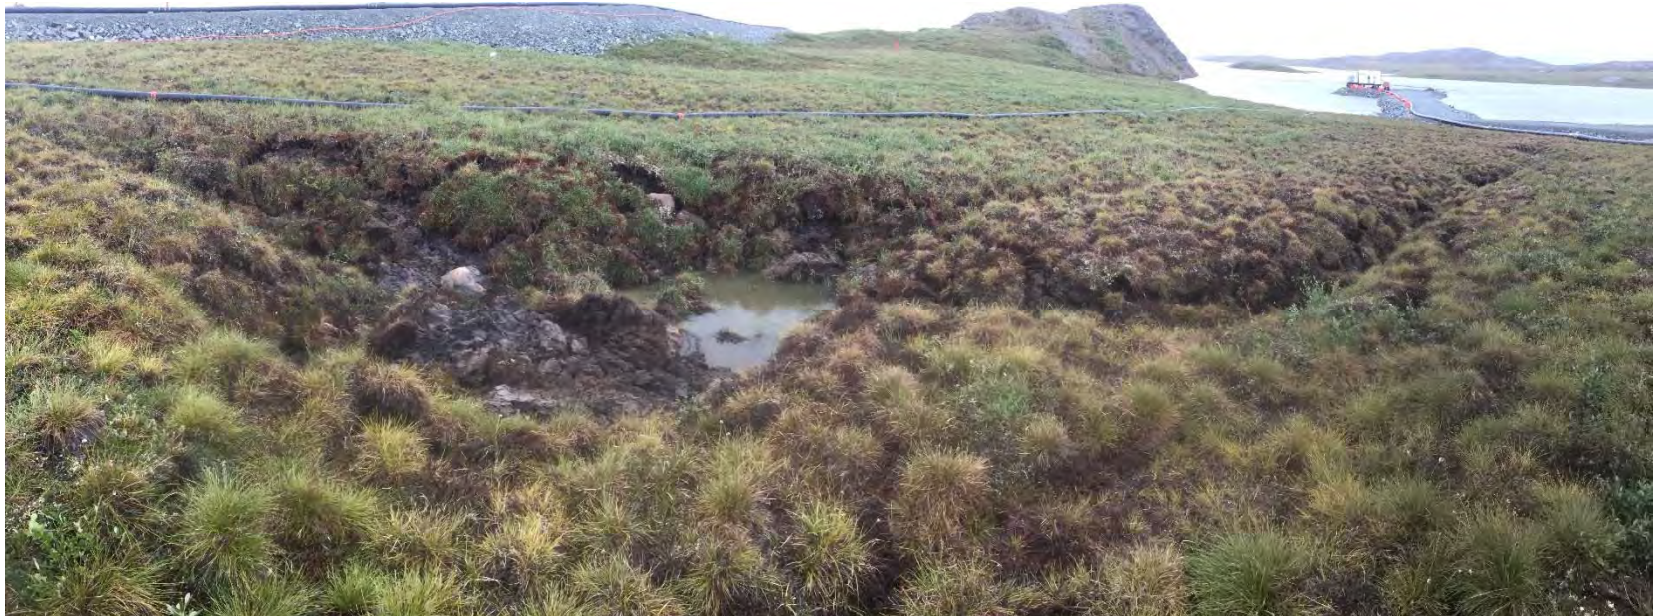
Reminder: Don't Disturb Permafrost

- Damage occurs fast, progresses rapidly and is very hard to fix!

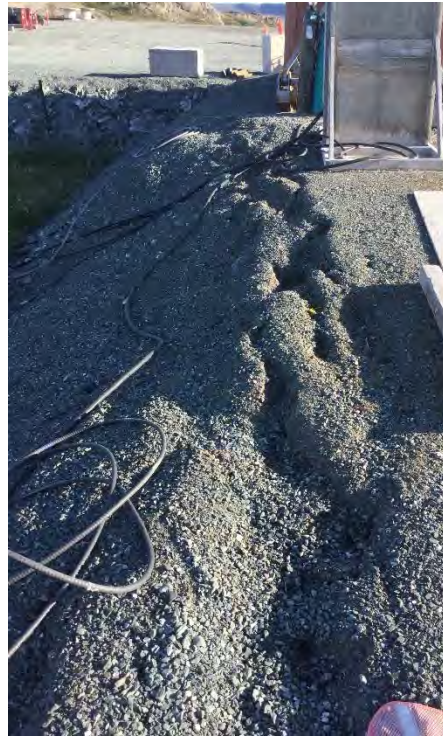
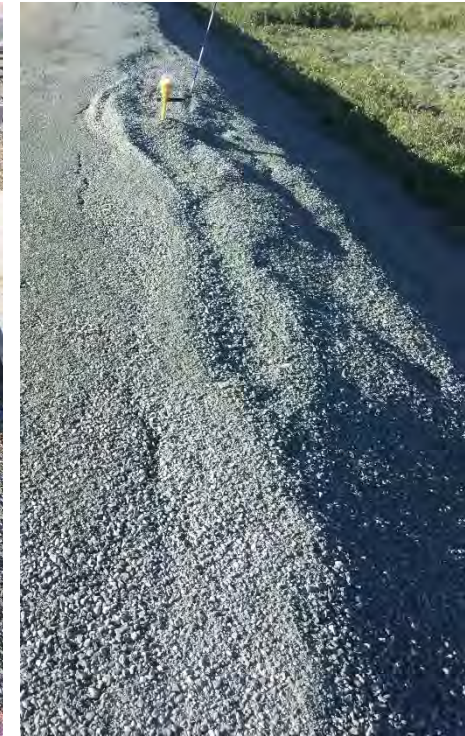
Reminder: Road/Pad Shoulders at Highest Risk in August

- Active layer thickness at its peak in August
- Road/pad toes do not have adequate thermal protection so there is inevitable local deepening of active layer; made worse if there is local ponding
- Causes instability of shoulder which is often masked by grading
- Keep equipment off shoulders

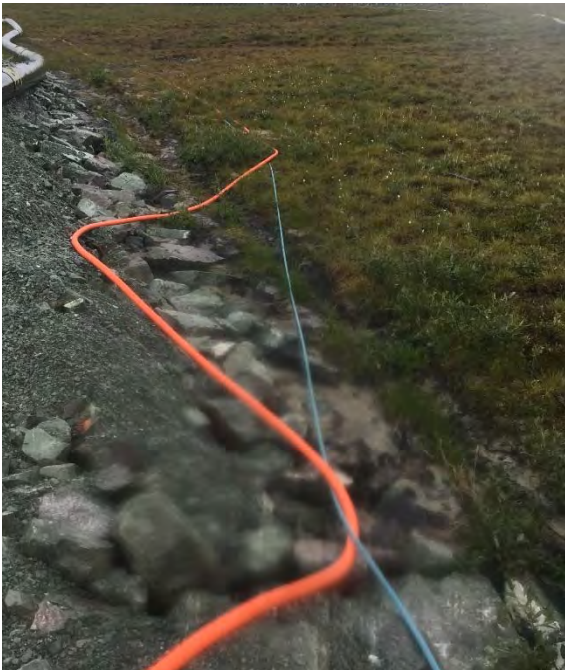
Potential Issue: Pipeline Permafrost Damage

- Uninsulated warm pipelines should not be on tundra
- Preferential flow corridors are created which can onset permafrost damage

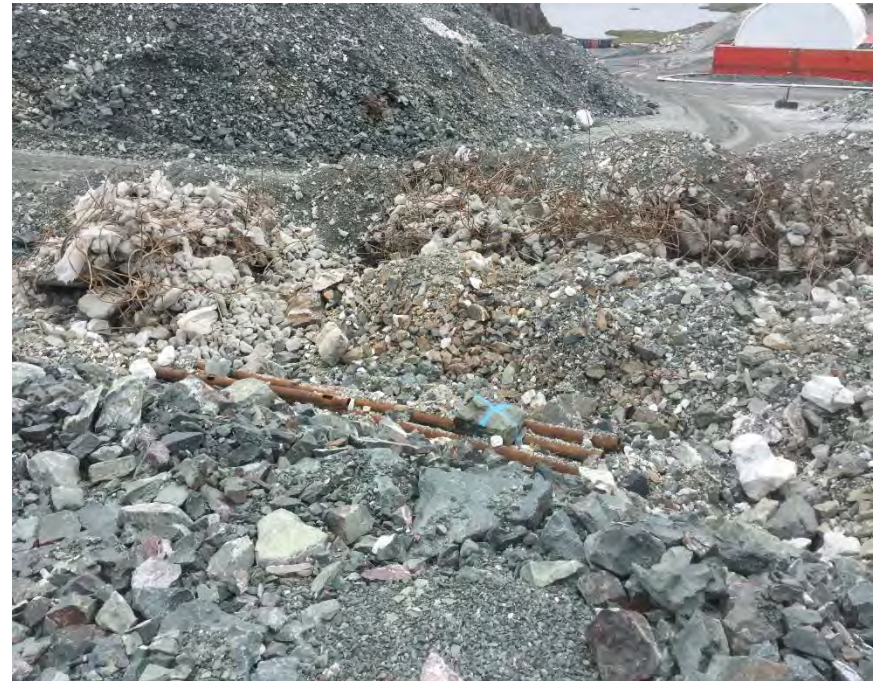
Suggestion: Prioritize Landfill

- Significantly more general construction debris around site
- Probably time to get non-hazardous Landfill going as KIA and INAC may use the general debris status to demand higher closure bond
- Would need License “modification” or “amendment” to get Landfill moved to Quarry 2
