Pad I – Waste Rock & Ore Stockpiles

Roberts Bay Observations

TIA Observations

Closing

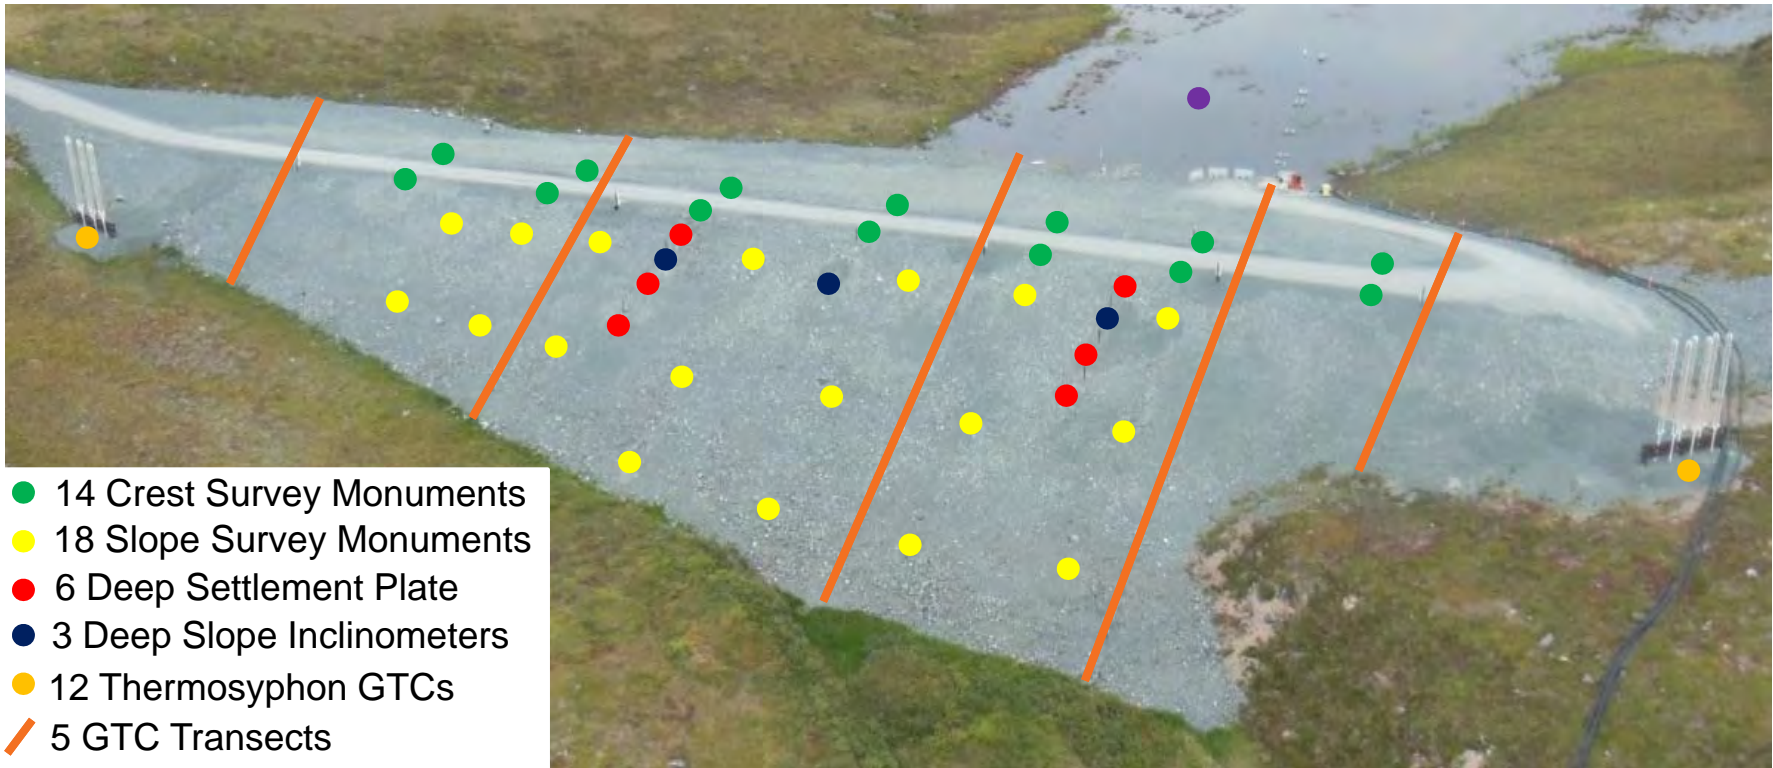
North Dam Instrumentation

- Watch tension cracks on upstream slope near shoreline
- Backfill with crush around inclinometer housing of Station 0+130 m
- Replace bottom weatherproof housing for node D

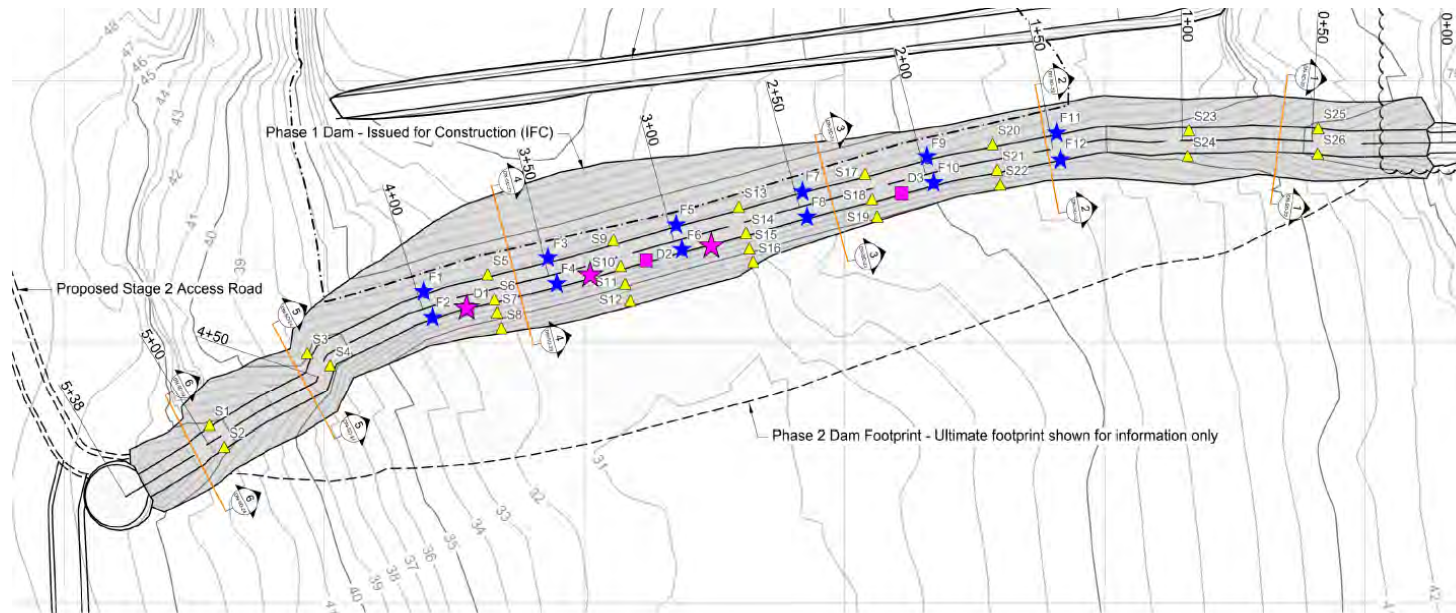
South Dam Instrumentation

- Small construction completion tasks to final signoff
- Some instrumentation to be completed
- Monitoring SOP to be updated
- Watch for ponding at back of dam
- Start beach development immediately

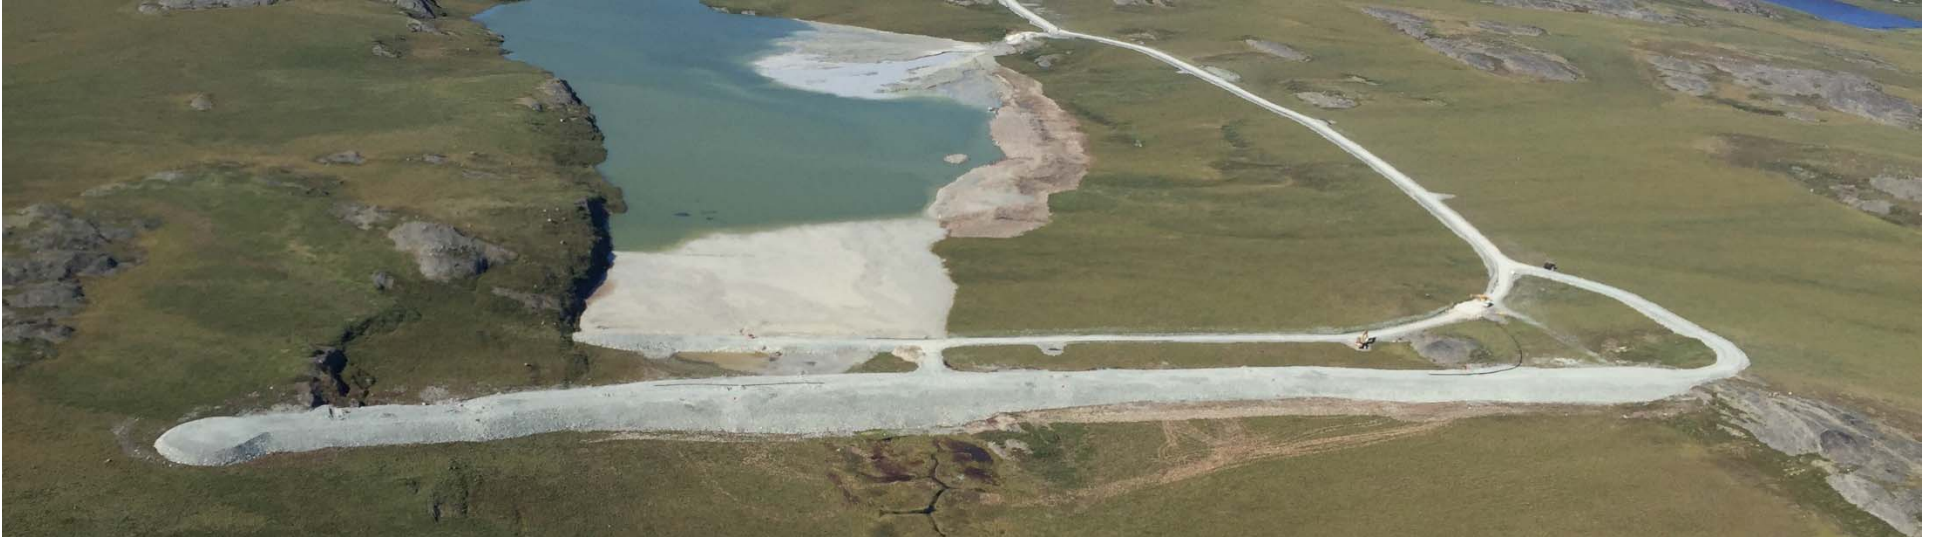
★ Tailings Deposition

- Refer to Phase 1 Design Report, or simply ask SRK
- Detailed Plan will be in the updated OMS, but current plan remain valid
