2018 Annual Geotechnical Inspection		
		TIA Shoreline and Tailings Deposition (South End)		
Job No: 1CT022.028	Doris TIA	Date: January 2019	Approved: PL	Photolog: 6
Filename: 2018NDGeotechInsp_Rev1_sw.pptx

2018 Annual Geotechnical Inspection		
		Emergency Dump Catch Basins		
Job No: 1CT022.028 Filename: 2018NDGeotechInsp_Rev1_sw.pptx	Doris TIA	Date: January 2019	Approved: PL	Photolog: 7

2018 Annual Geotechnical Inspection		
		Tailings Discharge and Reclaim Pipeline (Near TIA)		
Job No: 1CT022.028	Doris TIA	Date: January 2019	Approved: PL	Photolog: 8
Filename: 2018NDGeotechInsp_Rev1_sw.pptx

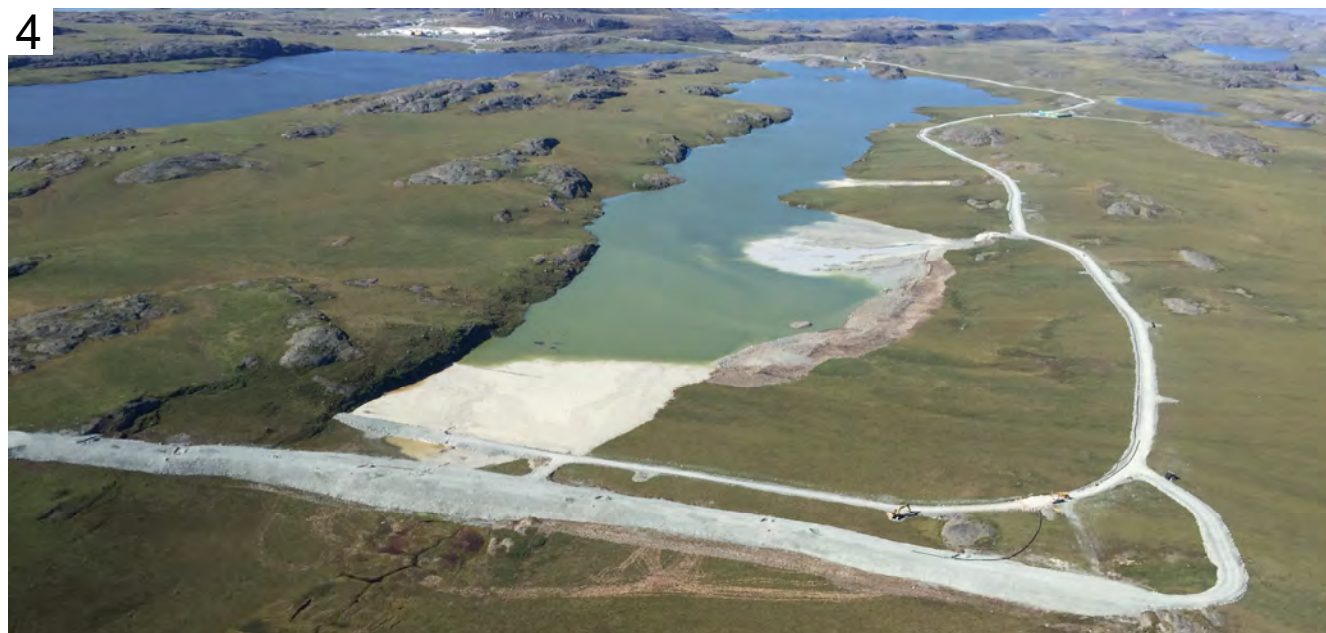
- Photo 1: Photo of the TIA with the primary spigot points and the overburden dump
- Photo 2: East shoreline of the TIA in 2017, prior to the construction of the South Dam
- Photo 3: Northern spigot point on the east side of the TIA
- Photo 4: View of the South Dam and southern shoreline looking north
