Appendix A – Arctic Foundations of Canada Inspection Report

Doris North Dam

Inspection of Thermosyphon System

April 10-11, 2018

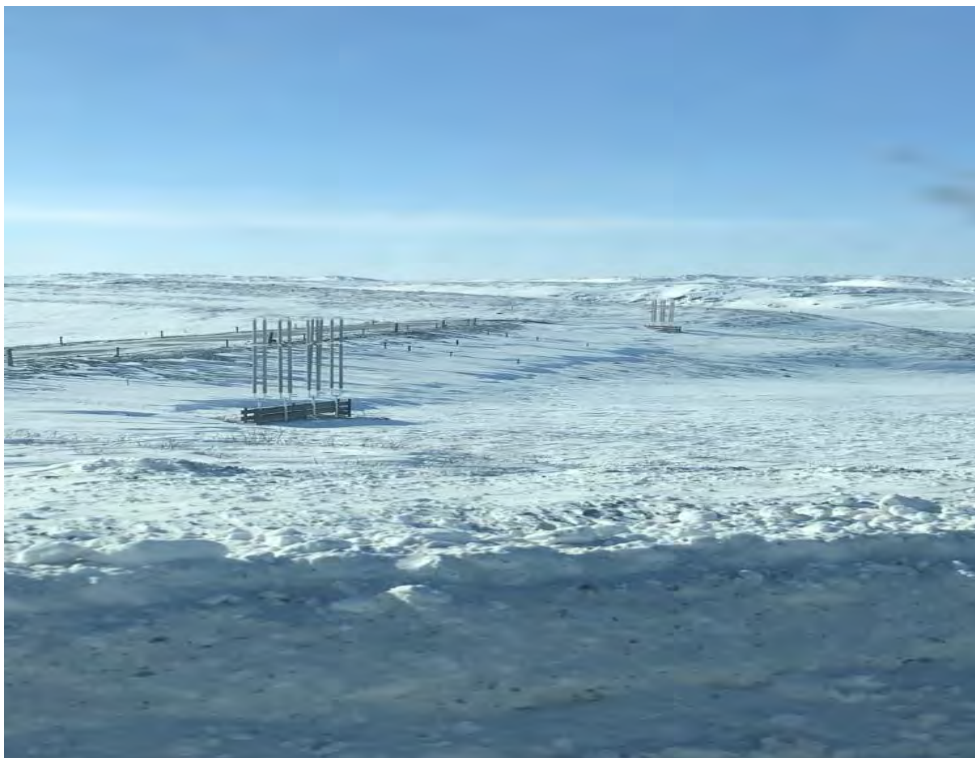
During the inspection, thermal imaging was used as an initial indicator to see if there were obvious signs of a non-functioning unit. Both the north and south banks were inspected and found to show consistent temperature gradients relative to ambient temperature.
