2019 Annual Geotechnical Inspection		
		North Dam Instrumentation and Thermosyphons		
Job No: 1CT022.038	Doris TIA	Date: March 2020	Approved: PL / JK	Photolog: 3
Filename: 2019NDGeotechInsp_Rev1_sw.pptx

## Appendix A – Arctic Foundations of Canada Inspection Report

## Doris North Dam – North Thermosyphon #2

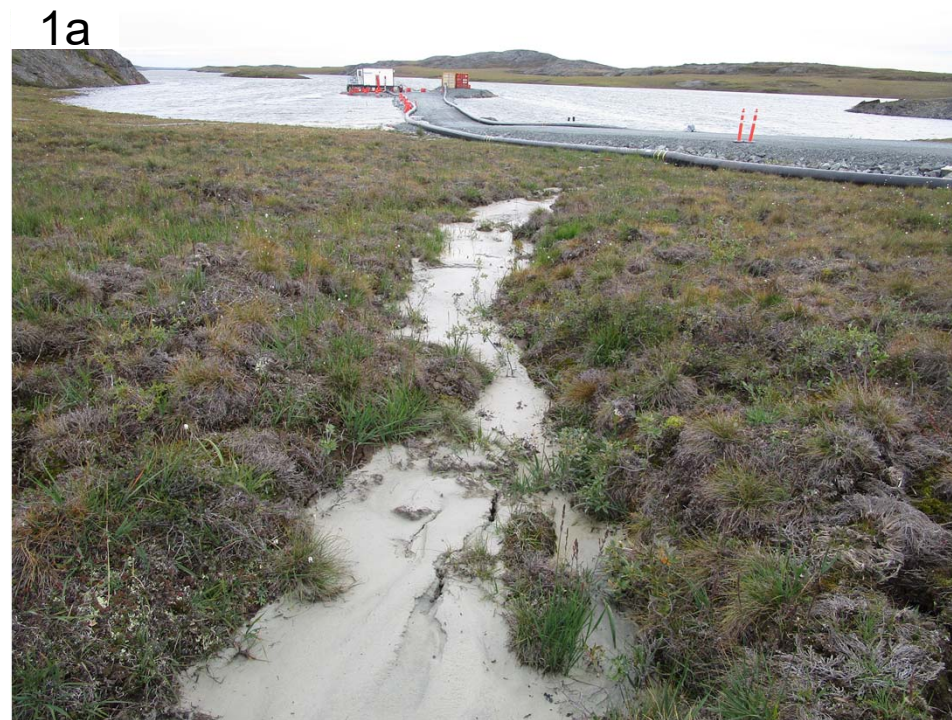
Photo 1a: Permafrost degradation near the reclaim pond access road (partially backfilled with tailings).

Location noted in past / earlier year inspections.

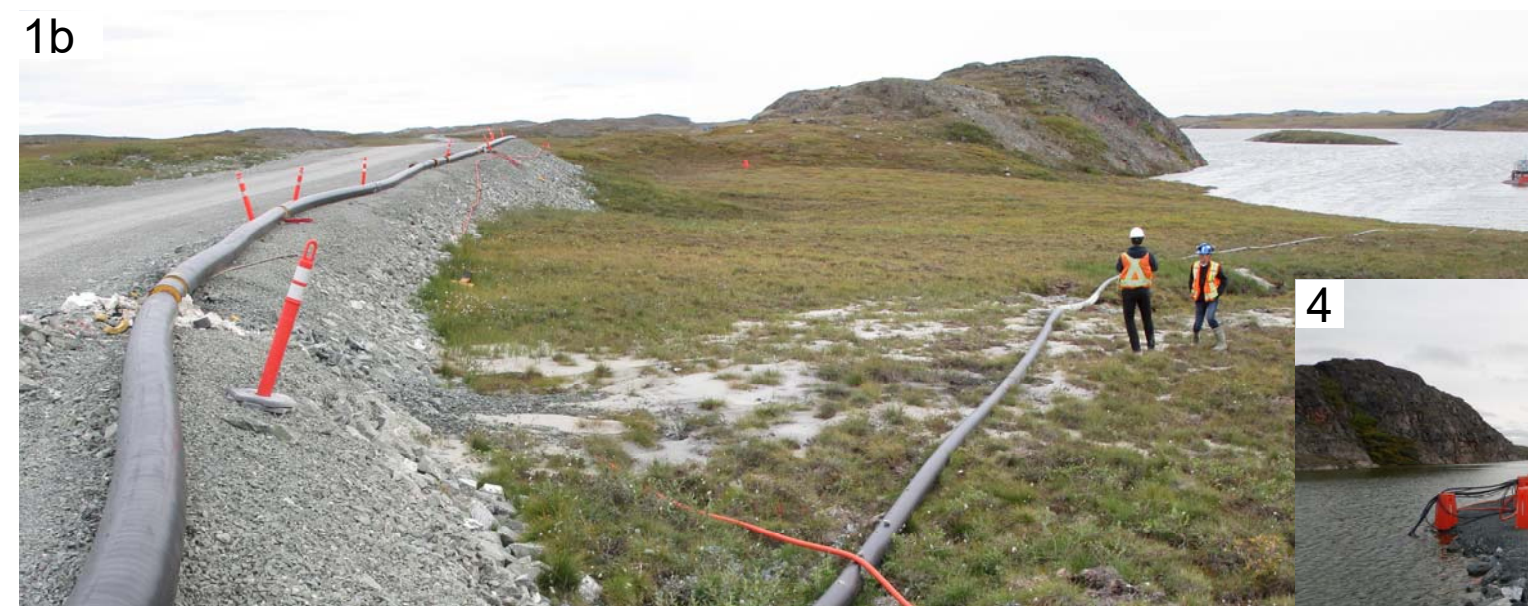
Photo 1b: Second view of the permafrost degradation near the reclaim pond access road

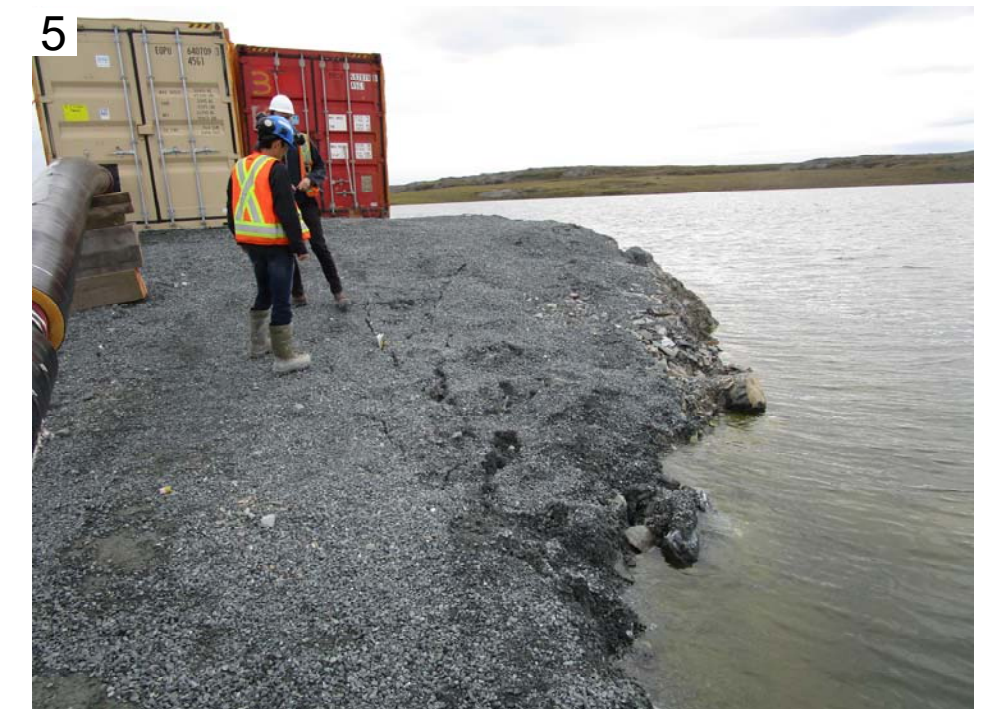
Photo 5: Tension cracking on reclaim pad on the north side of the 710 pumphouse.

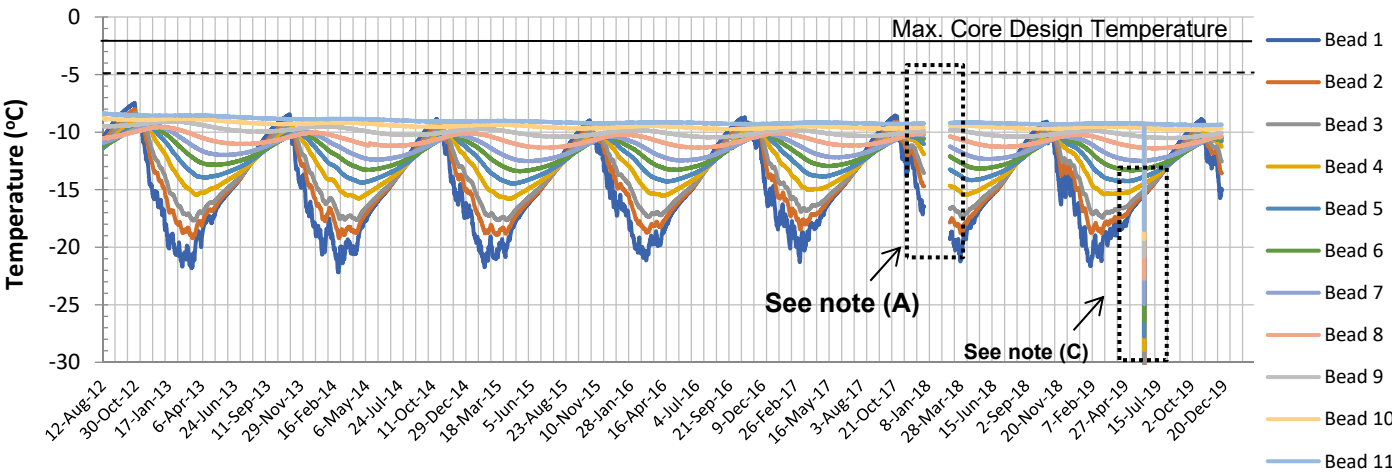
**ND-VTS-040-KT**

- Notes:**
- Bead numbers increase from downstream to upstream (horizontal) and top to bottom (vertical)
  - (A) Data logger was disconnected from January 1, 2018 to March 3, 2018 for recalibration
  - (B) GTC was disconnected from datalogger
  - (C) A low temperature spike for all beads was observed for a single reading on June 12, 2019 and is attributed to an instrumentation error.

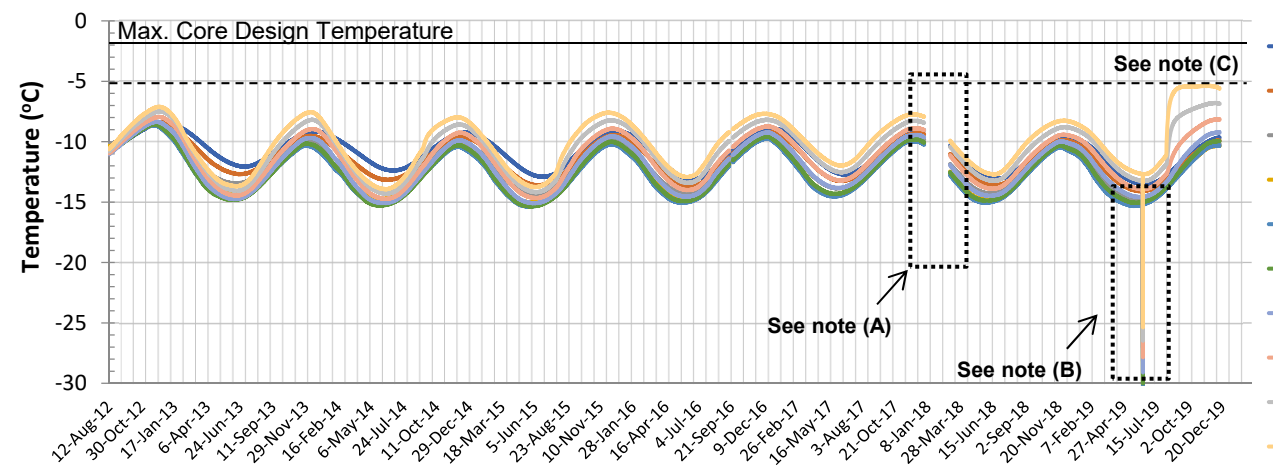
**ND-HTS-085-29.4**

- Notes:**
- Bead numbers increase from downstream to upstream (horizontal) and top to bottom (vertical)
  - **(A)** Data logger was disconnected from January 1, 2018 to March 3, 2018 for recalibration
  - **(B)** A low temperature spike for all beads was observed for a single reading on June 12, 2019 and is attributed to an instrumentation error
  - **(C)** Temperature rise is expected to be a result of the rise in the reclaim pond water level.
