2019 AGI - South Dam		
		South Dam Station 3+65 Ground Temperature Cable Readings by Location		
Job No: 1CT022.038 Filename: AppB_1CT022.038_SD_GTC	Doris TIA	Date: Mar. 2020	Approved: PL	Figure: B.29

2019 AGI - South Dam		
		Station 3+65 Vertical Ground Temperature Cable Temperature Vs. Time		
Job No: 1CT022.038 Filename: AppB_1CT022.038_SD_GTC	DORIS TIA	Date: Mar. 2020	Approved: AB	Figure: B.30

2019 AGI - North Dam	
	Inclinometer 070-1A Velocity Time Series	
Job No: 1CT022.038 Filename: AppE_1CT022.038_Inclinometers.pptx	  DORIS TIA	Date: Feb. 2020 Approved: AB Figure: E.5

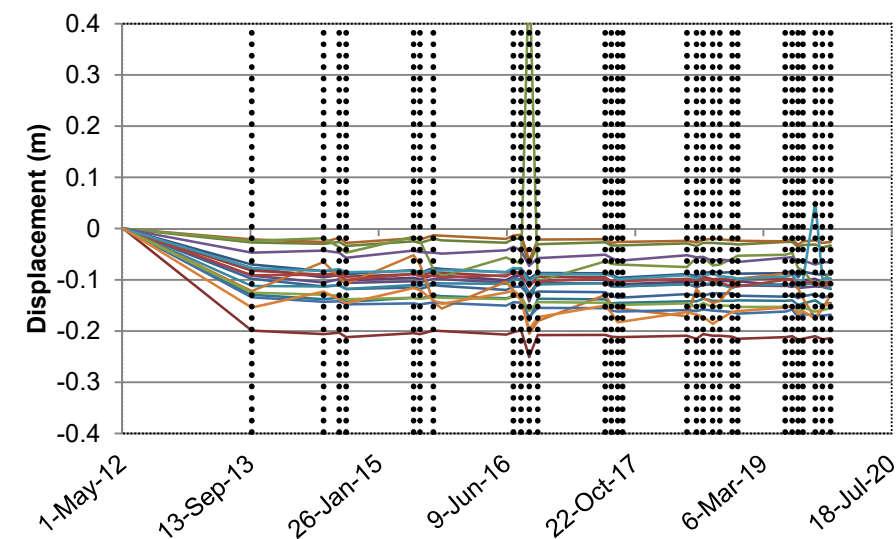
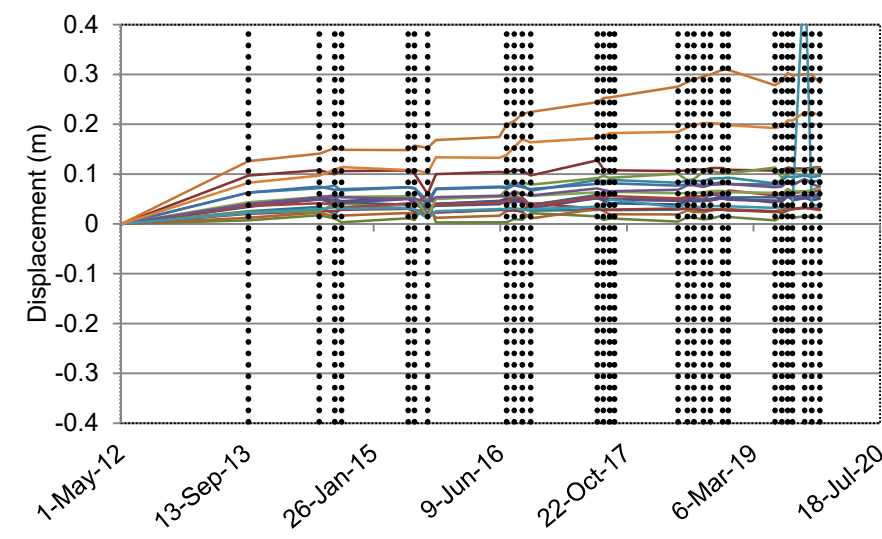
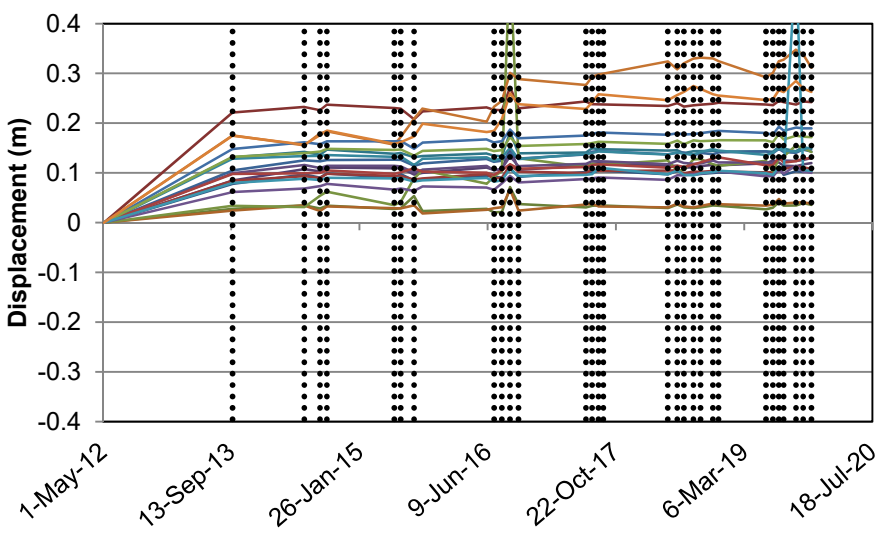
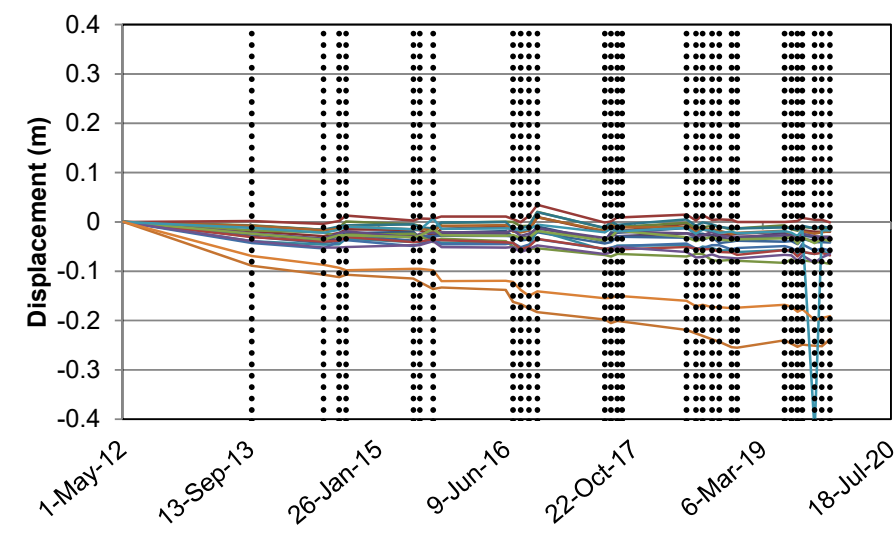
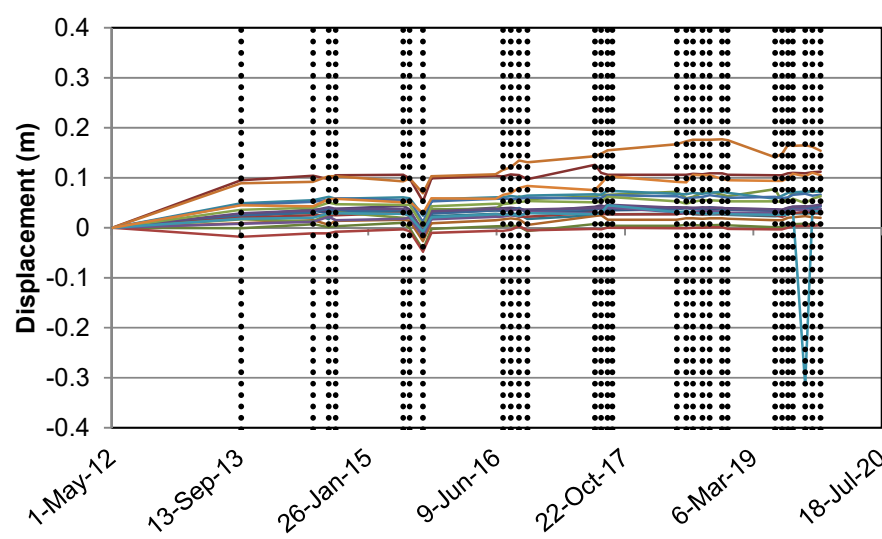
1. The anomalous horizontal displacement observed are Settlement point ND-SSP-110-3 and ND-SSP-155-1 near the downstream toe of the dam and ND-SSP-155-2 near the crest of the dam

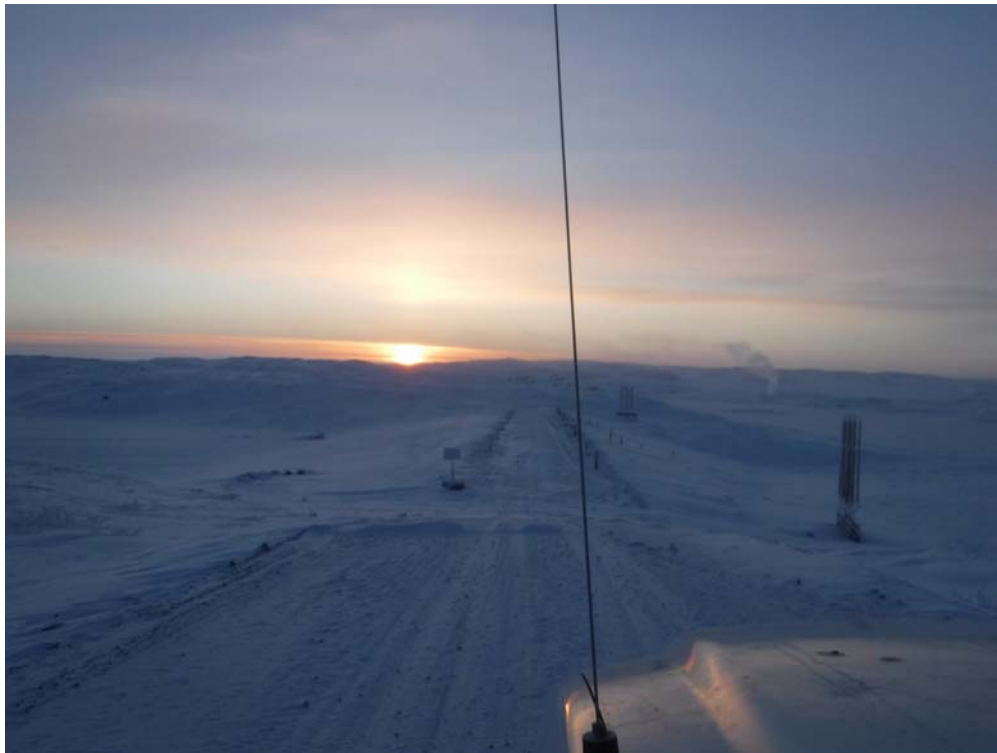
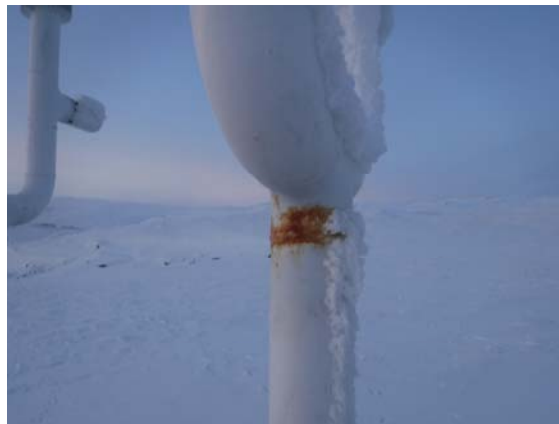
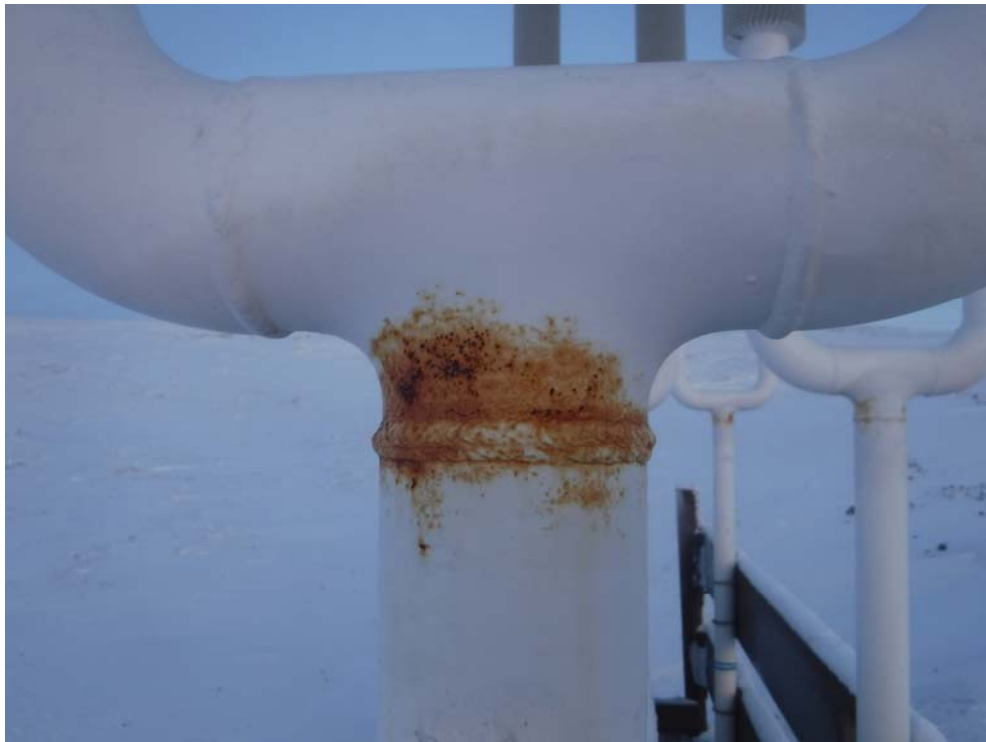
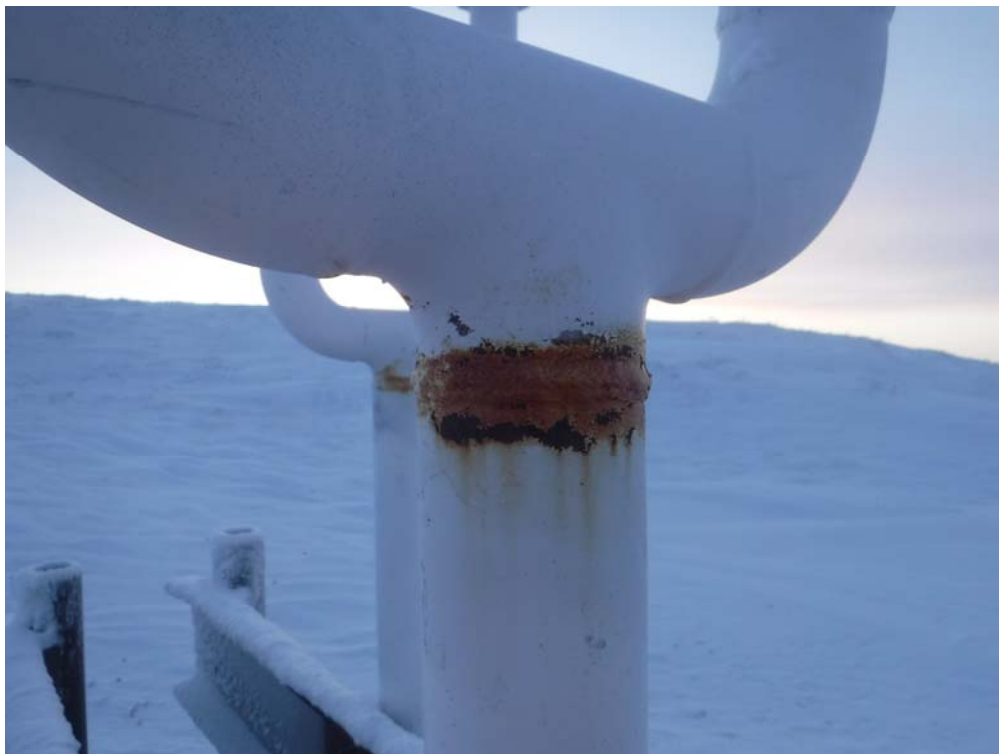
Upstream Side of Dam		
Any visible concerns? (cracks, depressions, erosion, etc.)	Yes	No
Downstream Side of Dam		
Any visible concerns? (cracks, depressions, erosion, seepage, etc.)	Yes	No
Crest of Dam		
Any visible concerns? (cracks, depressions, erosion, etc.)	Yes	No
Thermosyphons North Side Minor Rust		
Any visible concerns? (cracks, punctures, peeling paint, birds nests, etc.)	Yes	No
Thermosyphons South Side Minor rust		
Any visible concerns? (cracks, punctures, peeling paint, birds nests, etc.)	Yes	No
Instrumentation (on crest and downstream side)		
Any visible concerns? (bent, rusted, cracked, etc.)	Yes	No
Thermistors and Dataloggers		
Any visible concerns? (frayed or cut cables, damaged boxes, etc.)	Yes	No
Suspended Sediment in TIA (When not frozen)		
Any suspended sediment in Tail Lake?	Yes	No
Water at the Toe of the Downstream Side of the Dam (If yes refer to Doris North - North Dam and Tail Lake Outflow Seepage Monitoring Work Plan 2015)
