North Dam Weekly Walkover Survey Report

Date:	April 14. 2019
Inspected By:	Mike Tarosa
Conditions:	(ie. snow on ground, clear) Snow

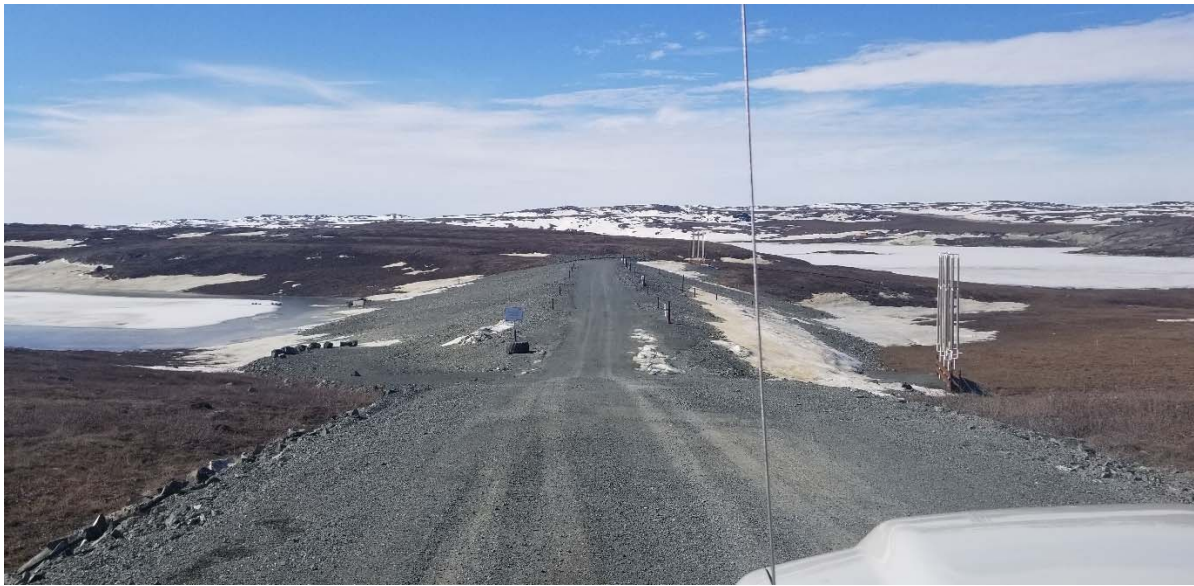
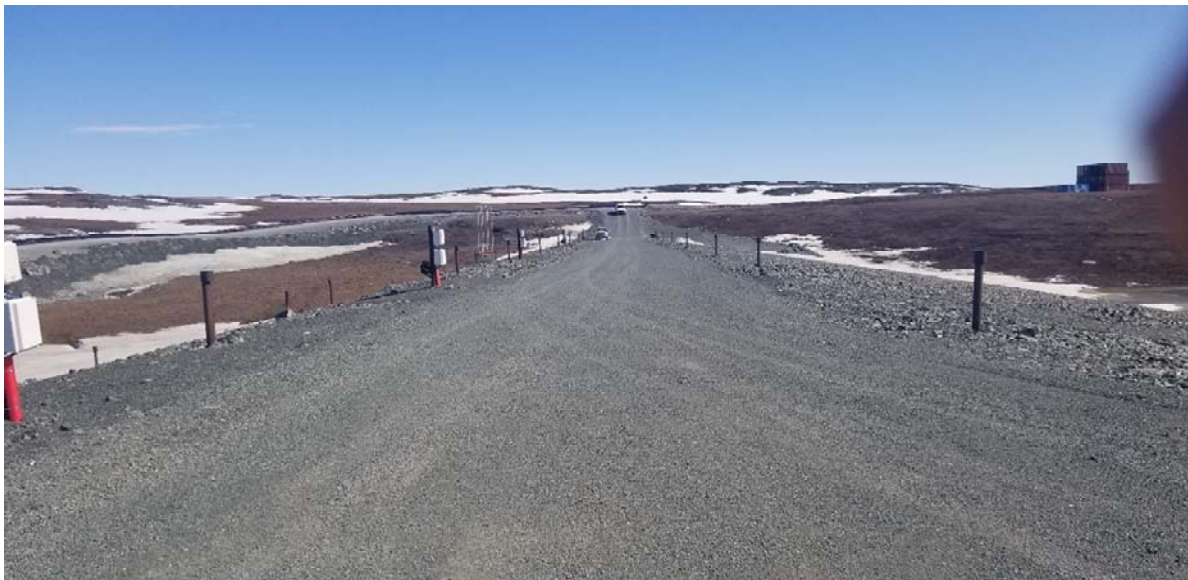
Upstream Side of Dam <i>Minor surface cracking</i>		
Any visible concerns? (cracks, depressions, erosion, etc.)	Yes	<input checked="" type="radio"/> No
Downstream Side of Dam		
Any visible concerns? (cracks, depressions, erosion, seepage, etc.) <i>Snow cover</i>	Yes	<input checked="" type="radio"/> No
Crest of Dam		
Any visible concerns? (cracks, depressions, erosion, etc.)	Yes	<input checked="" type="radio"/> No
Thermosyphons North Side <i>Minor rust</i>		
Any visible concerns? (cracks, punctures, peeling paint, birds nests, etc.)	Yes	<input checked="" type="radio"/> No
Thermosyphons South Side		
Any visible concerns? (cracks, punctures, peeling paint, birds nests, etc.)	Yes	<input checked="" type="radio"/> No
Instrumentation (on crest and downstream side)		
Any visible concerns? (bent, rusted, cracked, etc.)	Yes	<input checked="" type="radio"/> No
Thermistors and Dataloggers		
Any visible concerns? (frayed or cut cables, damaged boxes, etc.)	Yes	<input checked="" type="radio"/> No

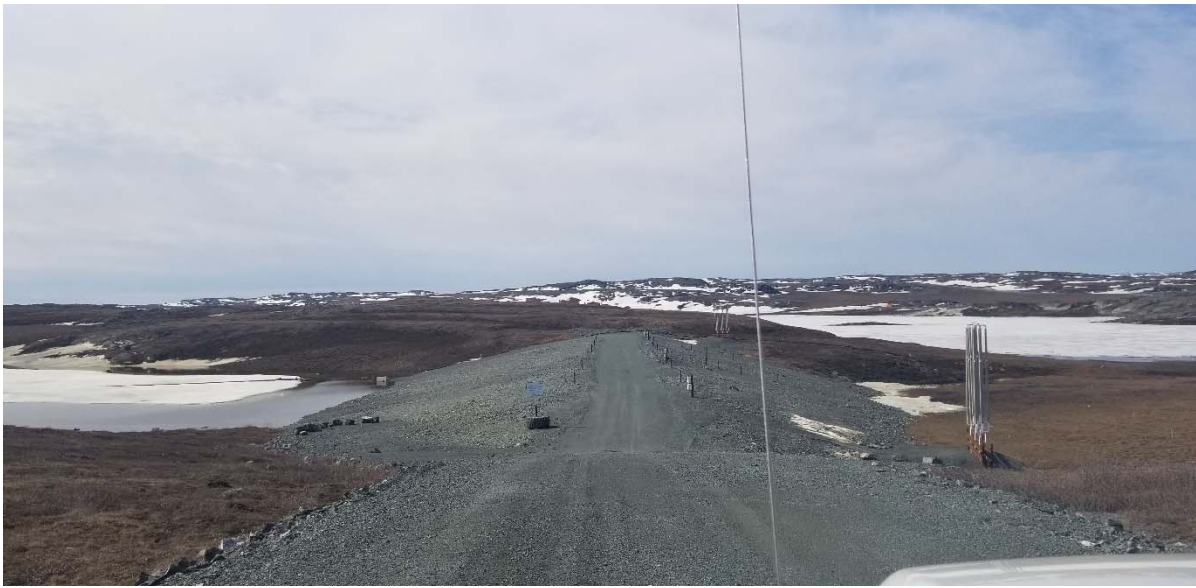
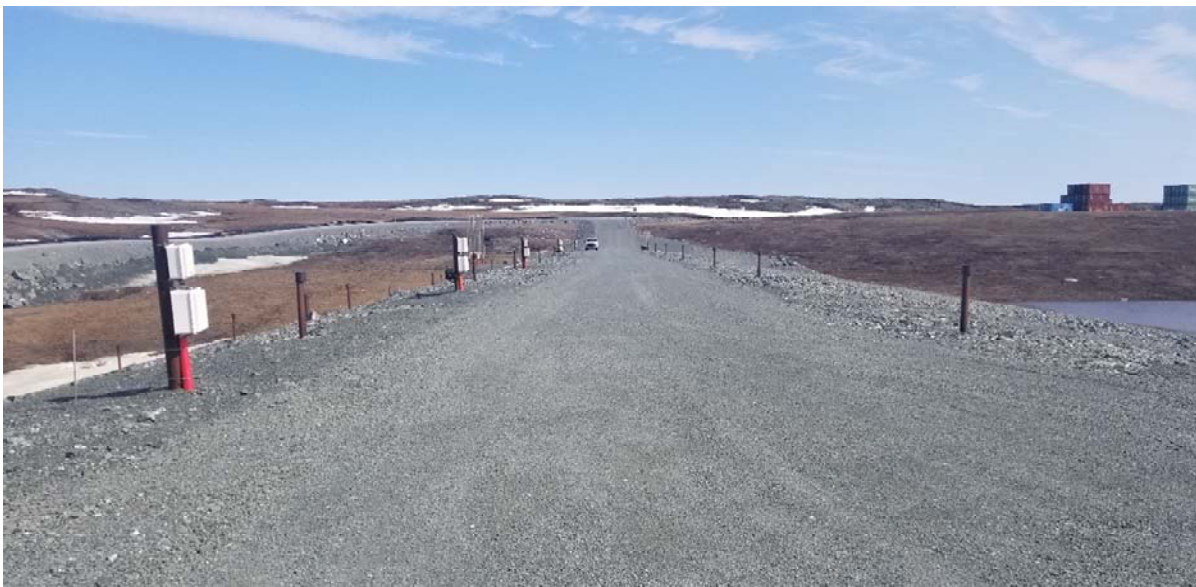
Upstream Side of Dam	<i>Surface cracks near discharge</i>	
Any visible concerns? (cracks, depressions, erosion, etc.)	Yes	<input checked="" type="radio"/> No
Downstream Side of Dam		
Any visible concerns? (cracks, depressions, erosion, seepage, etc.)	Yes	<input checked="" type="radio"/> No
Crest of Dam		
Any visible concerns? (cracks, depressions, erosion, etc.)	Yes	<input checked="" type="radio"/> No
Thermosyphons North Side		
Any visible concerns? (cracks, punctures, peeling paint, birds nests, etc.)	Yes	<input checked="" type="radio"/> No
Thermosyphons South Side		
Any visible concerns? (cracks, punctures, peeling paint, birds nests, etc.)	Yes	<input checked="" type="radio"/> No
Instrumentation (on crest and downstream side)		
Any visible concerns? (bent, rusted, cracked, etc.)	Yes	<input checked="" type="radio"/> No
Thermistors and Dataloggers		
Any visible concerns? (frayed or cut cables, damaged boxes, etc.)	Yes	<input checked="" type="radio"/> No

Up stream cracking.

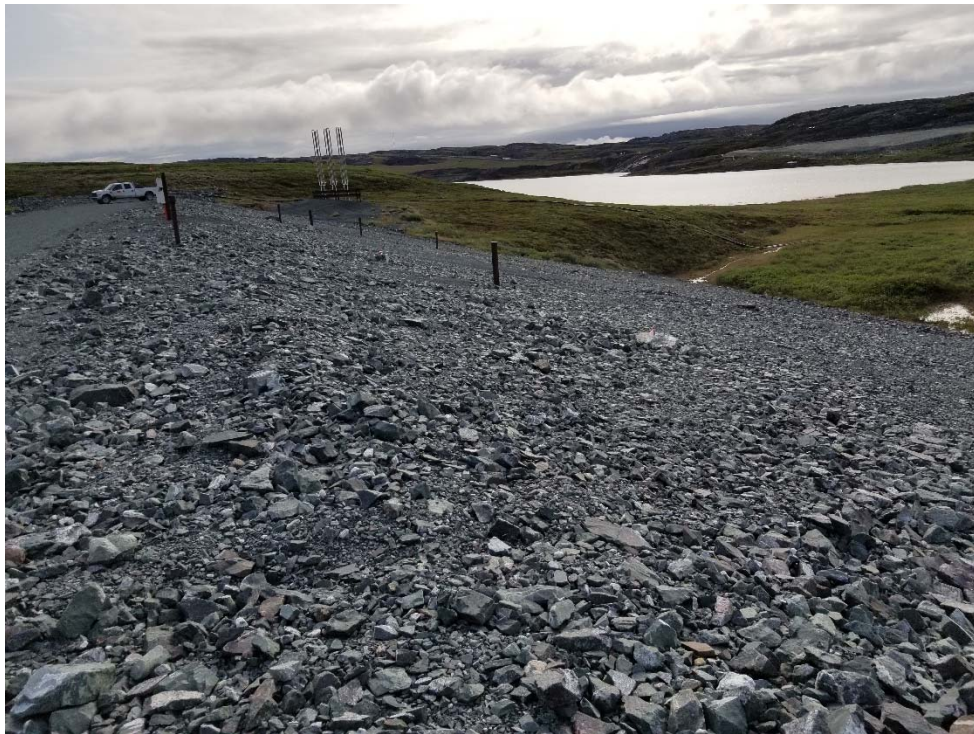
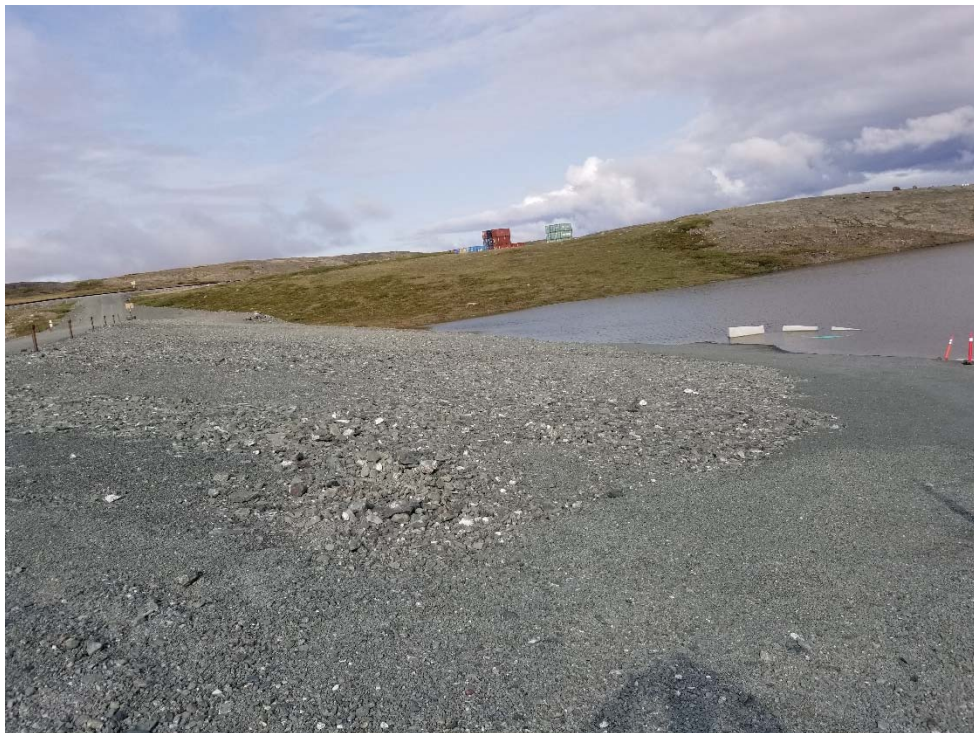
Yes	No
If you answered yes to any of the questions above please provide details and photos. Observations can be sketched on the figure provided on the next page. If seepage has been noted please estimate the flow.		
Minor depression on southern side near the water level

Minor depression near water contact on south side.
