## Memo

Subject: Doris North Project: 2014 Annual Roberts Bay Jetty Inspection

2014 Annual Geotechnical Inspection

2014 As-Built Survey for the Roberts Bay Jetty

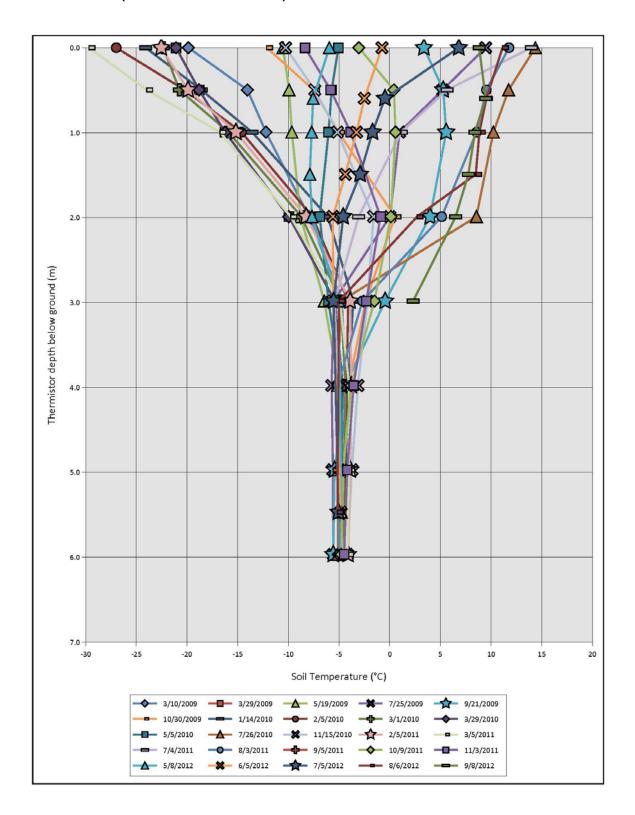
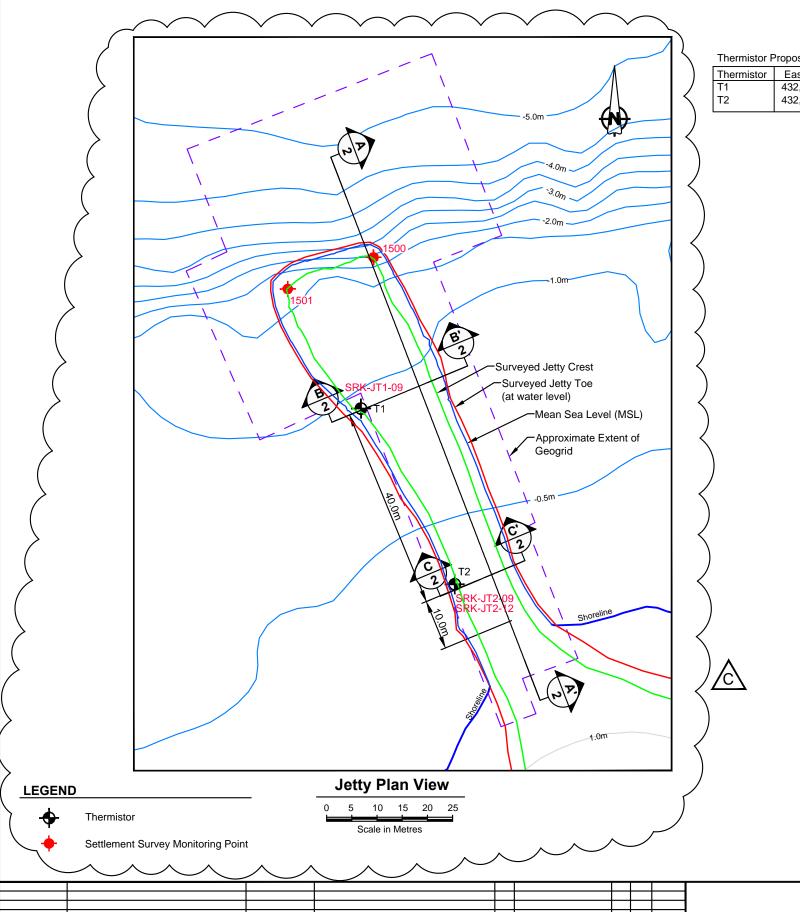
#### Thermistor Data (SRK-JT2-09/ SRK-JT2-12)

- Thermal monitoring from the remaining thermistor string, installed through the jetty into the underlying submarine permafrost, suggests that there has been no degradation of permafrost resulting from the construction of the jetty; and
- In SRK's opinion there is no need to repair or replace thermistor string SRK-JT2-12; however, approval for this has to be sought from the Nunavut Impact Review Board as it was a Project Certificate requirement to have this thermistor string installed.

- 1. Continue to collect monthly thermistor string data as a minimum (July to August).
- 2. Follow the recommendations for settlement monitoring provided in Section 7.0 of PND (2013).
- 3. Remind operational staff annually about the operational limitations of the jetty as proved in Section 4.0 of PND (2013).
