## Appendix A: Ground Temperature Cable Data

| | | 2014 Geotechnical Inspection | | |
| Job No: 1CT022.001 | HOPE BAY MINING LTD. | Date: Oct. 2014 | Approved: MMM | Figure: <b>A.1</b> |

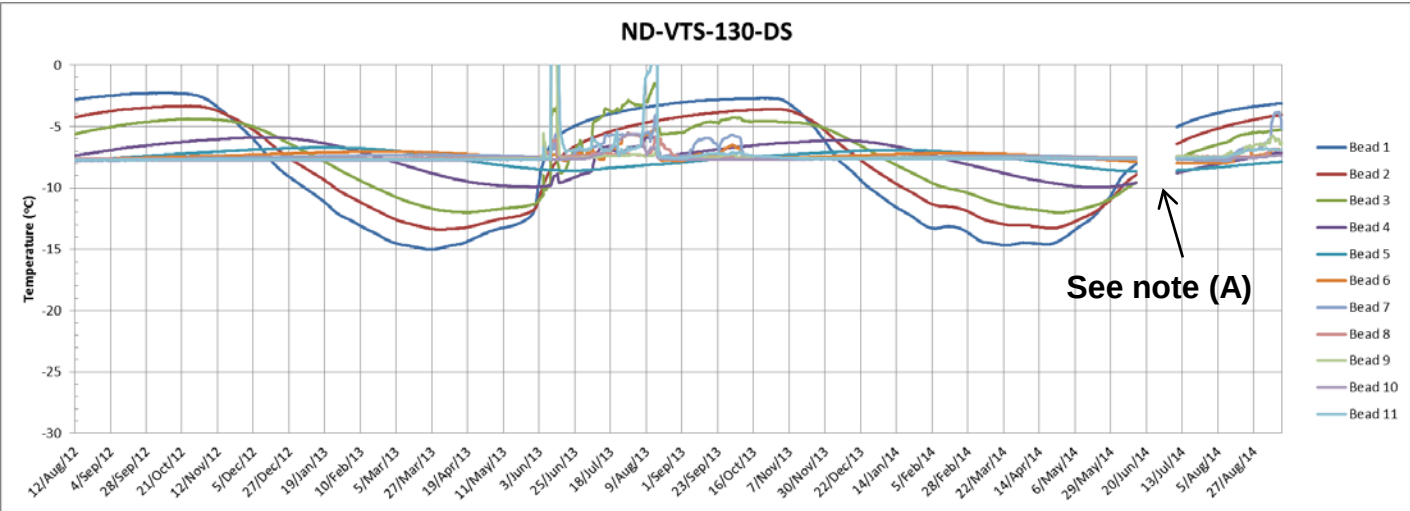
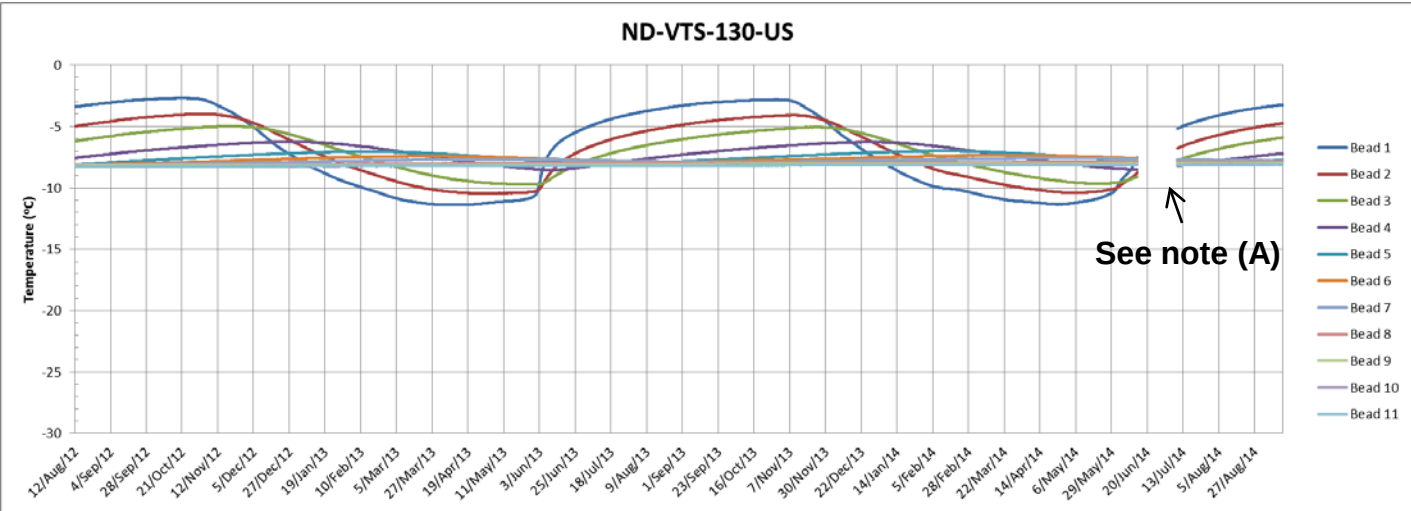
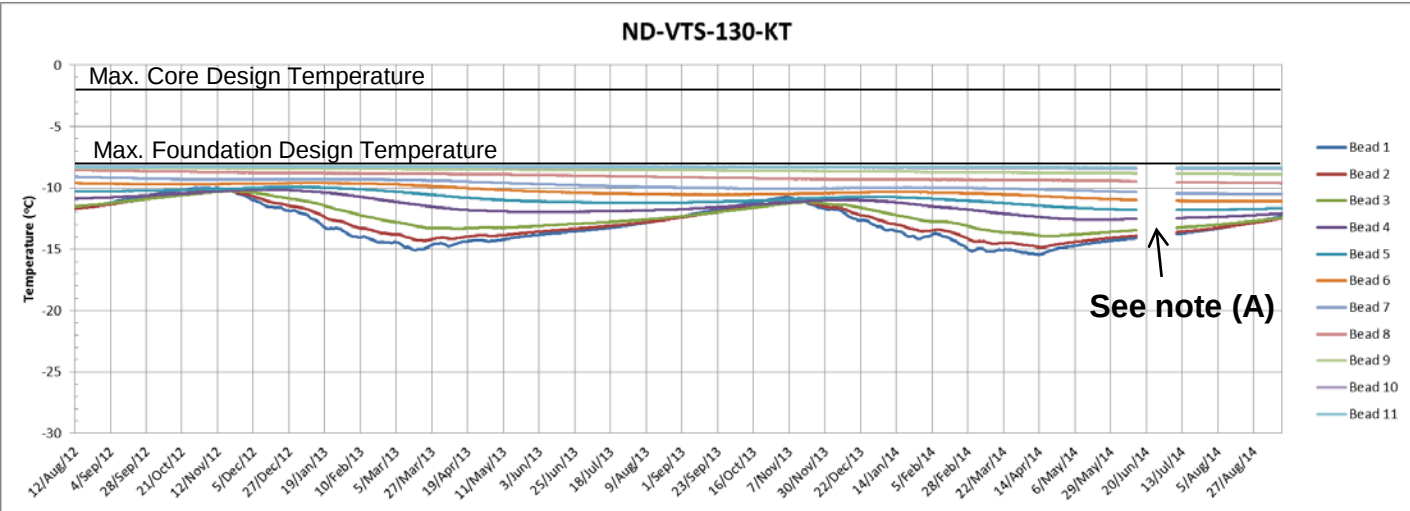
Date: Oct 2014  
Approved: MMM  
Figure: **A.13**

- Cable irreparably damaged
- Bead damaged or data missing

- Notes:**
- Bead numbers increase from downstream to upstream (horizontal) and top to bottom (vertical)
  - (A) Card download error: data needs to be extracted from datalogger.

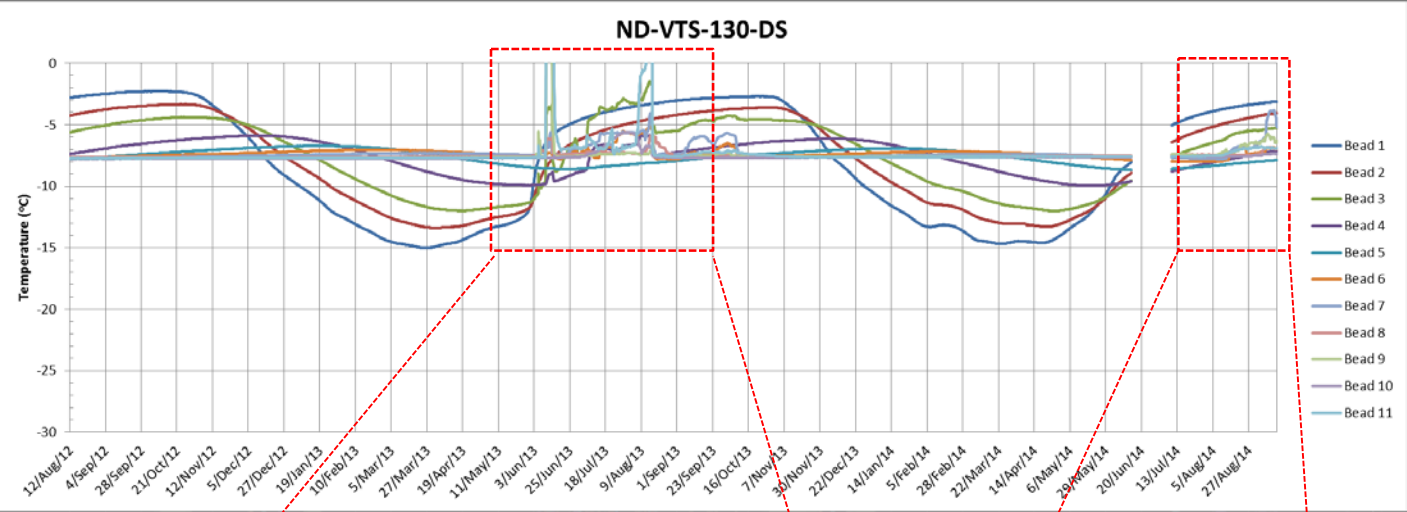
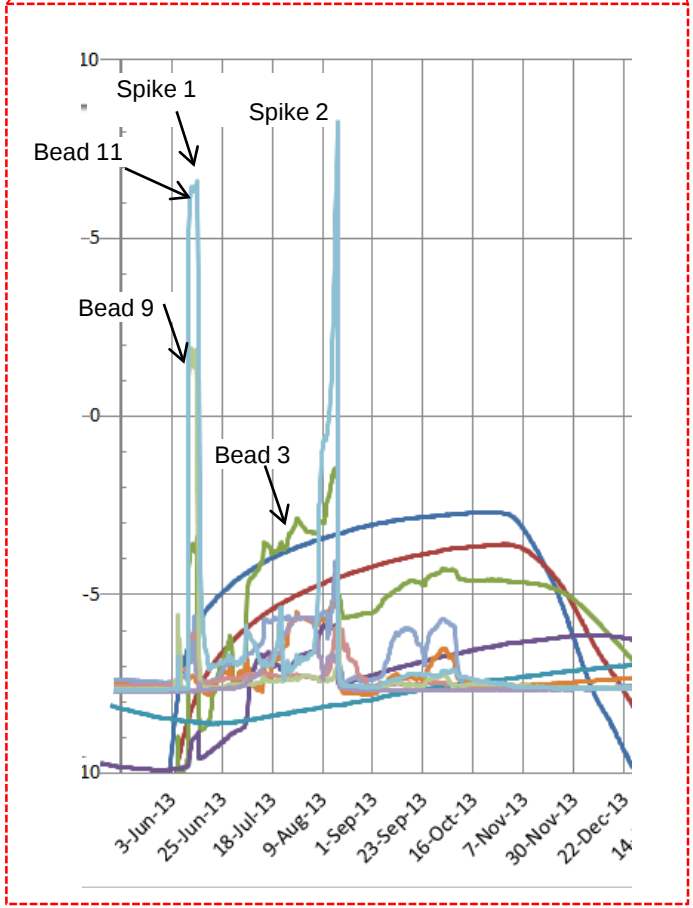
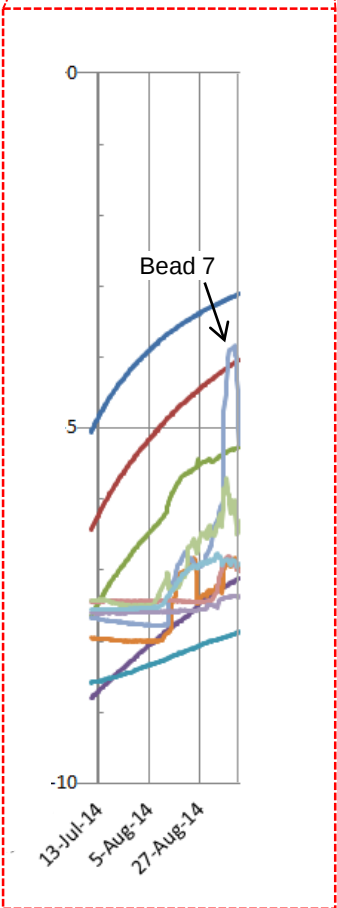
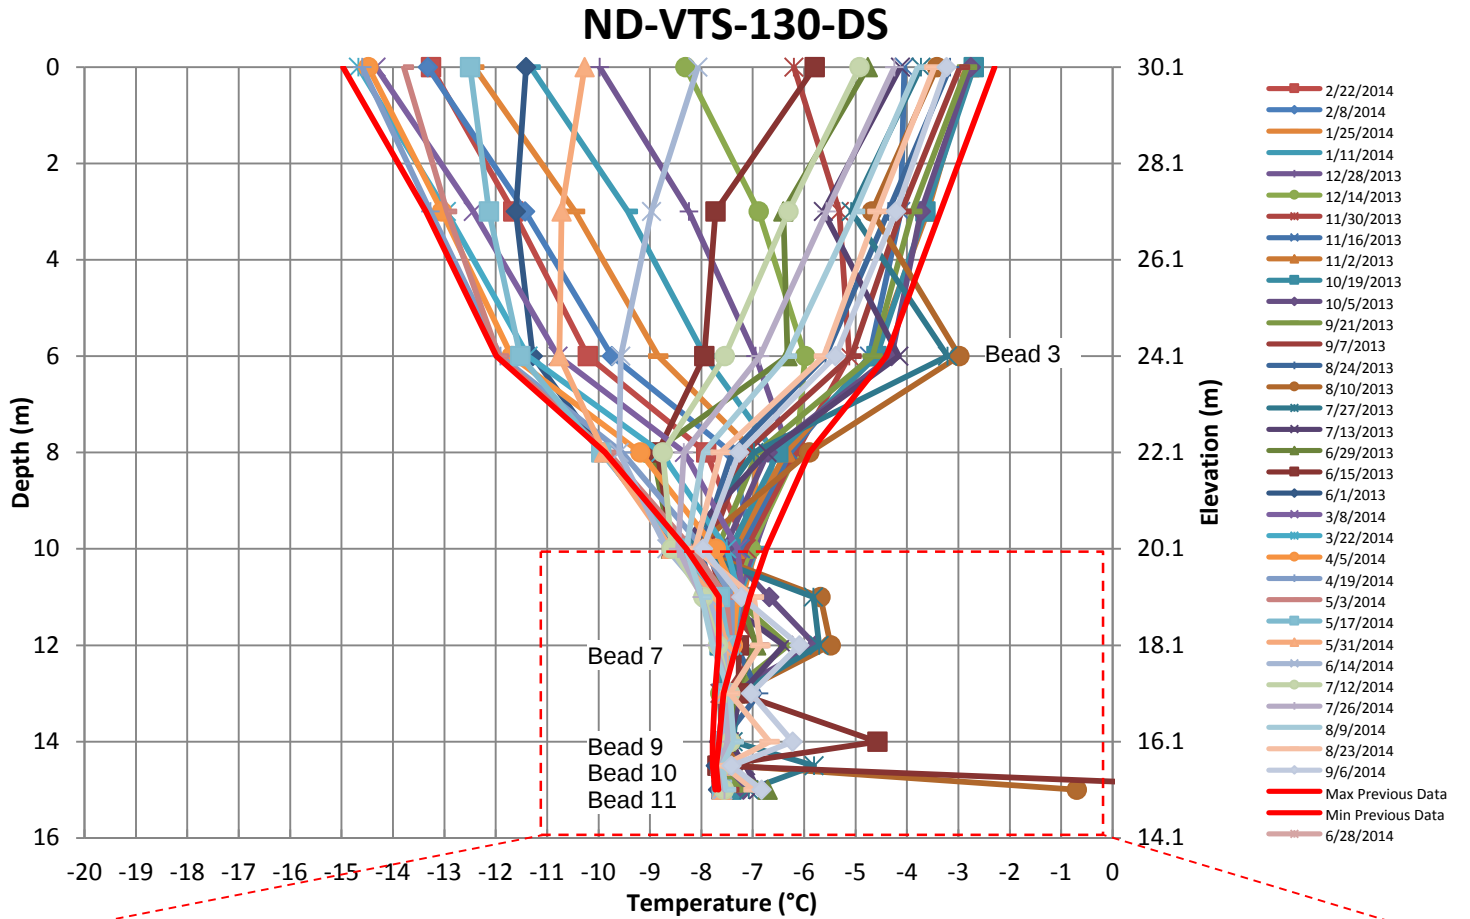
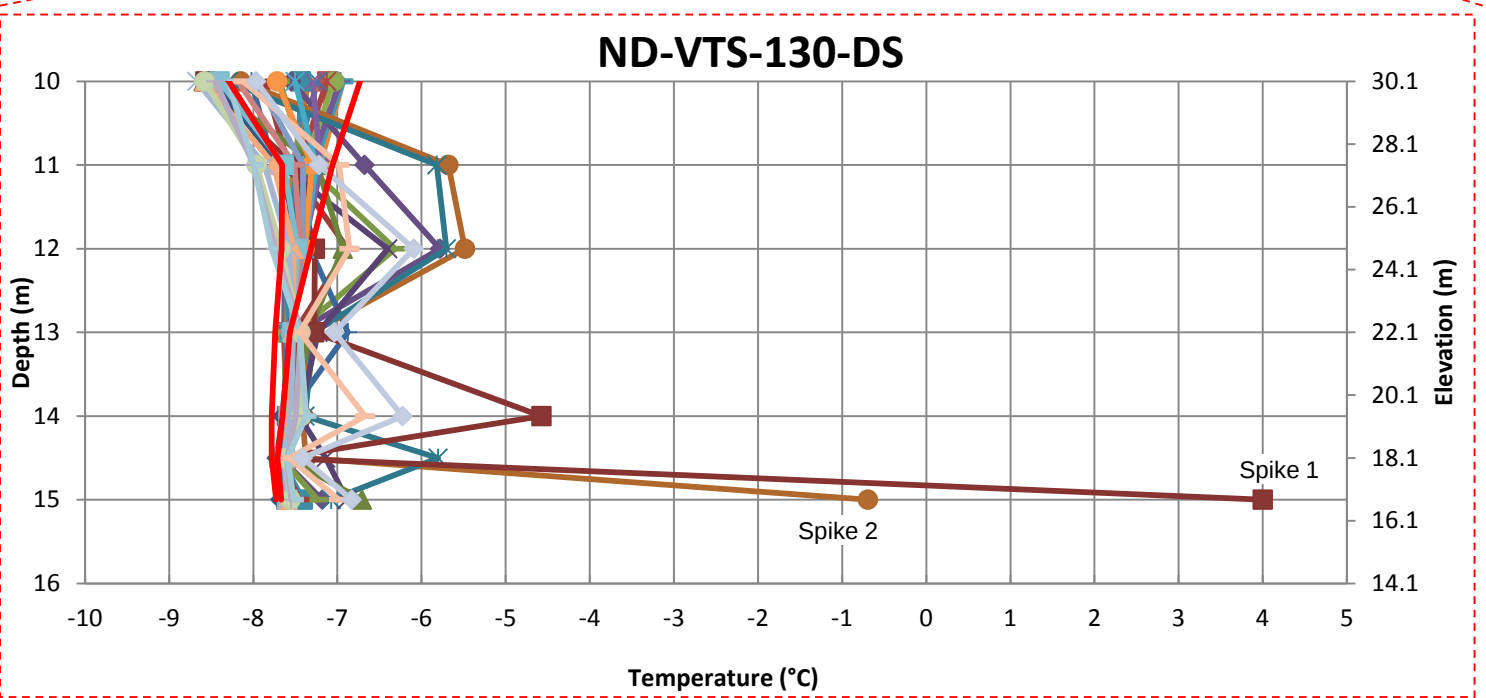
Date: Oct. 2014  
Approved: MMM  
Figure: **A.15**

- Previous Data was recorded between August 2012 and May 2013

**ND-VTS-130-DS**  
**Closer Look at Odd Readings**

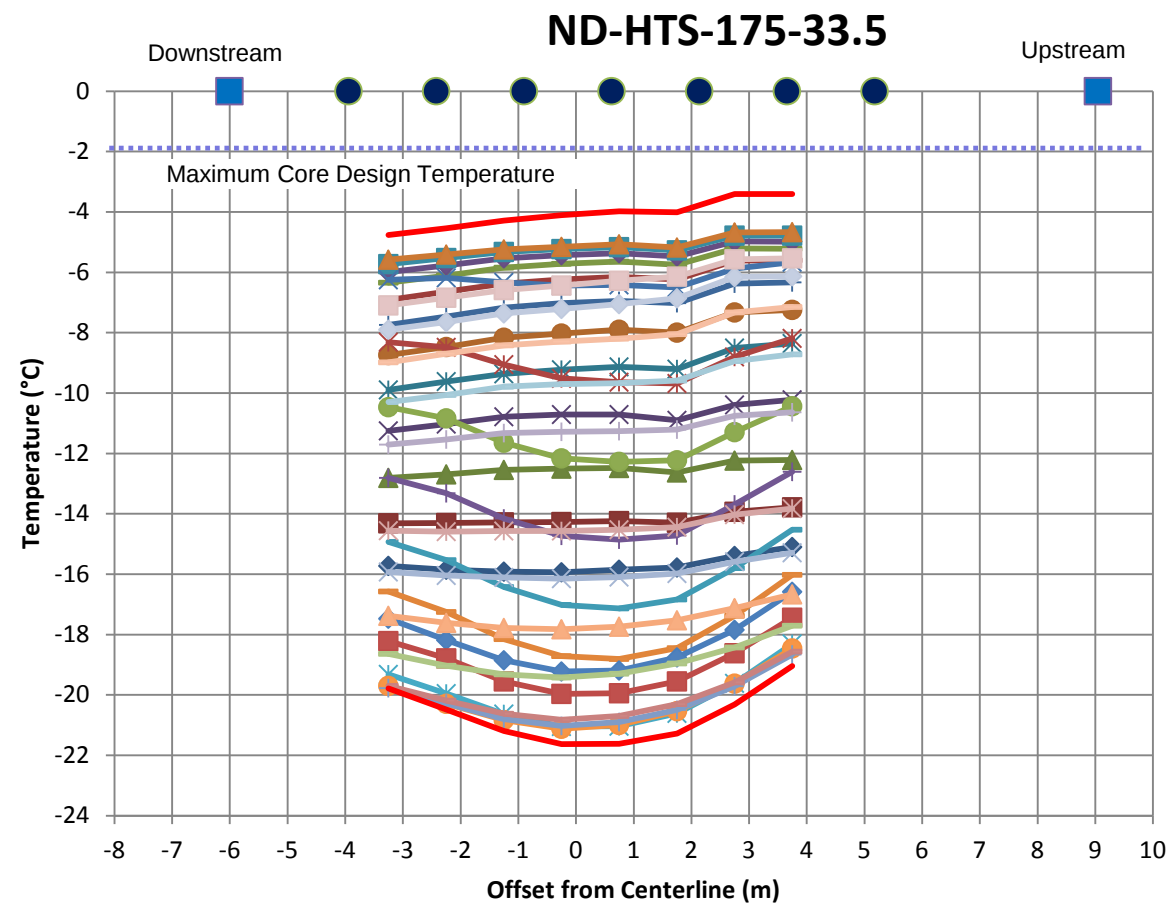
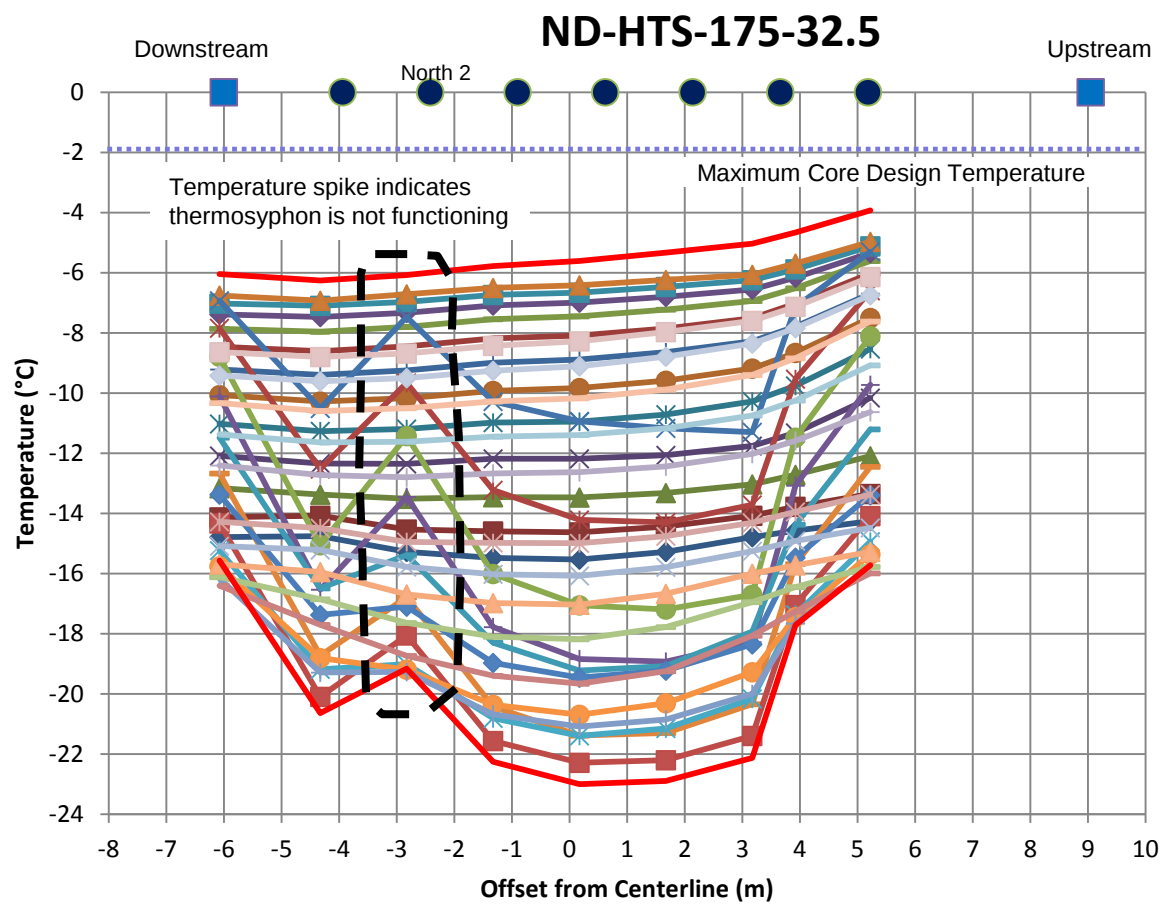
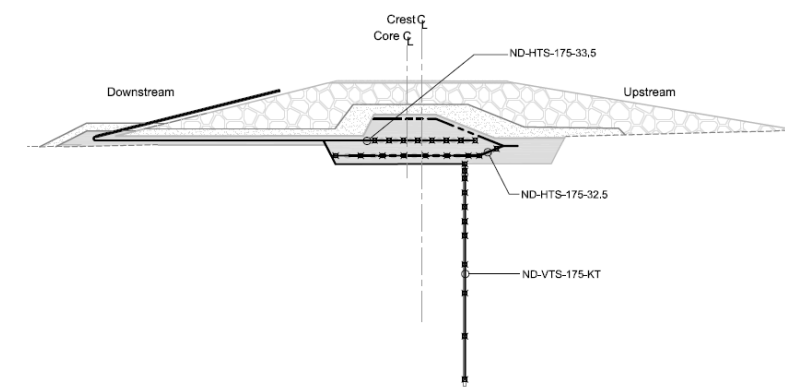
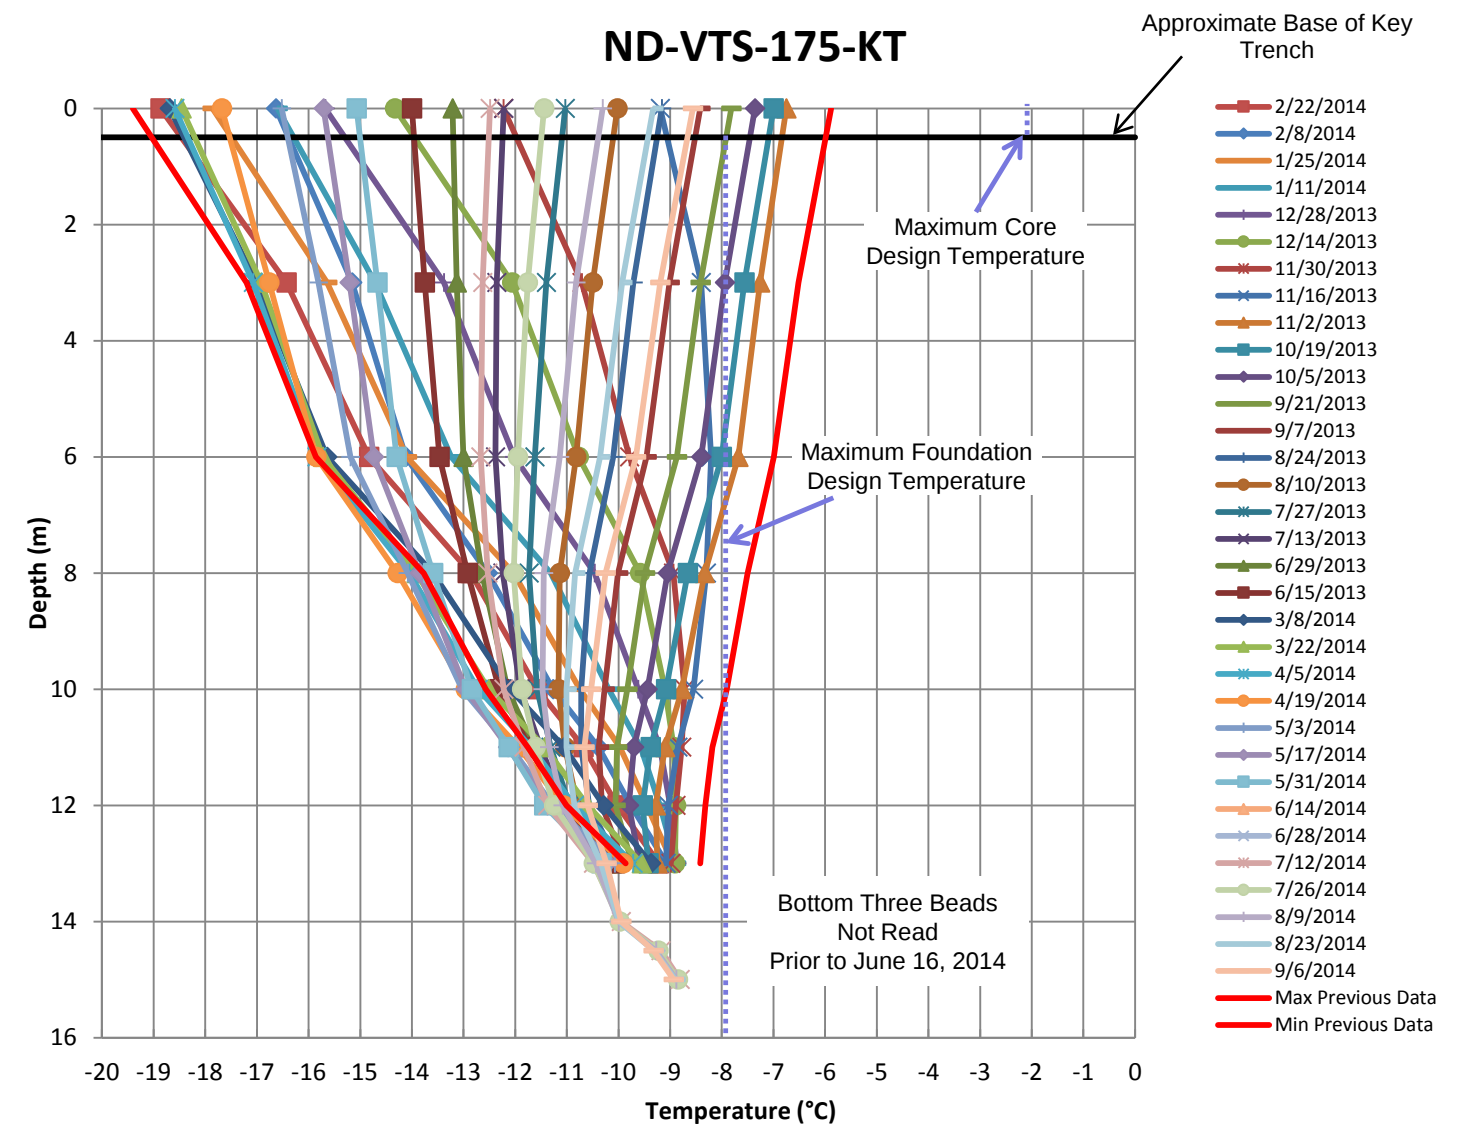
- Previous Data was recorded between August 2012 and May 2013
