North Dam Weekly Walkover Survey Report

Date:	June 28/2014
Inspected By:	Brenden Greenley
Conditions:	(ie. snow on ground, clear) Clear/Rain

Date:	July 6/14
Inspected By:	Jill and Sarah
Conditions:	(ie. snow on ground, clear) no snow, all ground clear, cold and windy

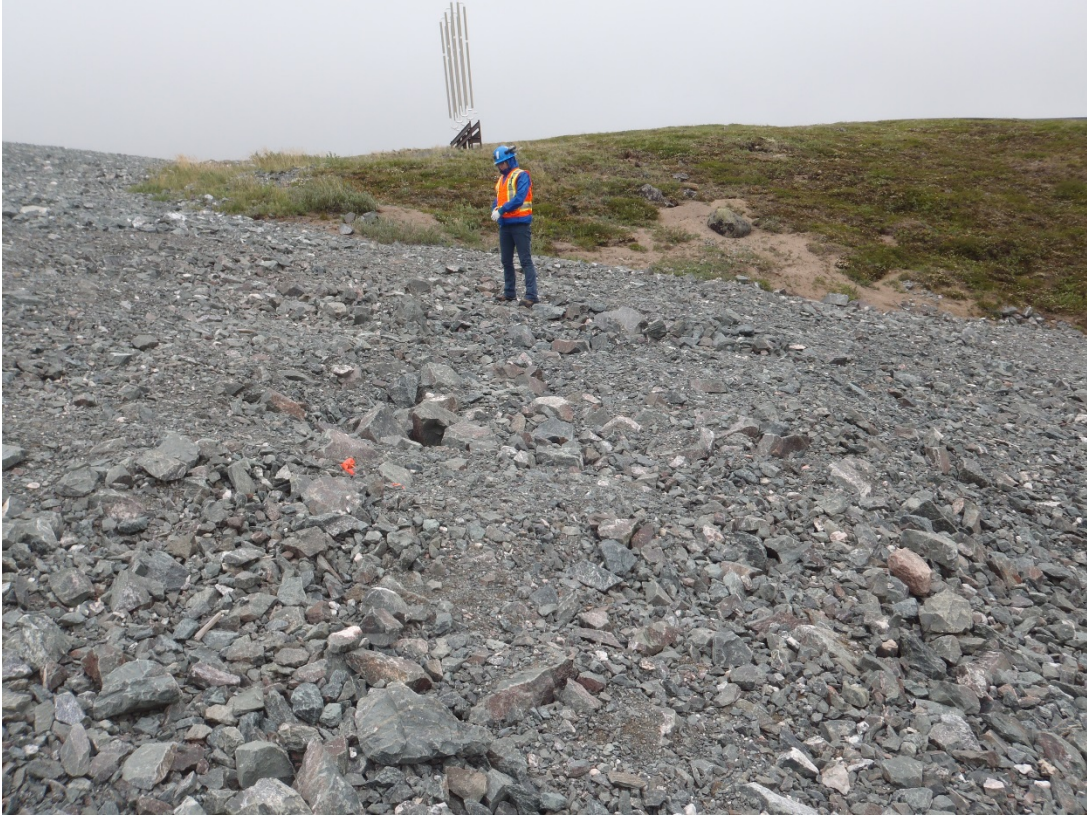
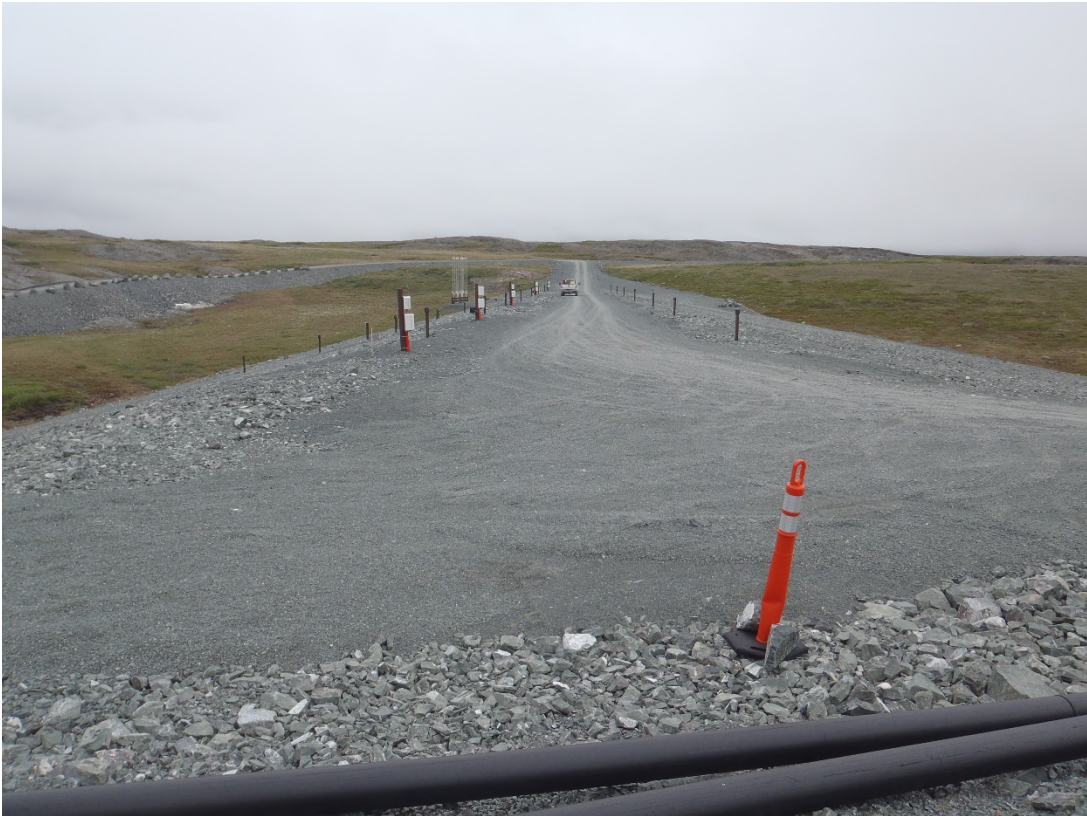
- ① Should check during next Geotechnical inspection, all "depressions". (see picture - downstream)
- ② Upstream, there are also very rough + crude depressions in the surface. Hard to tell if these are irregular

Rough area downstream
