## North Dam Weekly Walkover Survey Report

Date:	July 12/14
Inspected By:	SARAH WARNOCK
Conditions:	(ie. snow on ground, clear) clear, sunny, 10°C

Date:	July 27, 2014 ~ 2:30pm
Inspected By:	Jill Turk and Claire Brown
Conditions:	(ie. snow on ground, clear) Overcast, but no rain in the last 4 days. No snow or ice.

Date:	AUGUST 02, 2014
Inspected By:	CLAIRE BROWN
Conditions:	(ie. snow on ground, clear) Clear. Heavy rain 2 days prior.

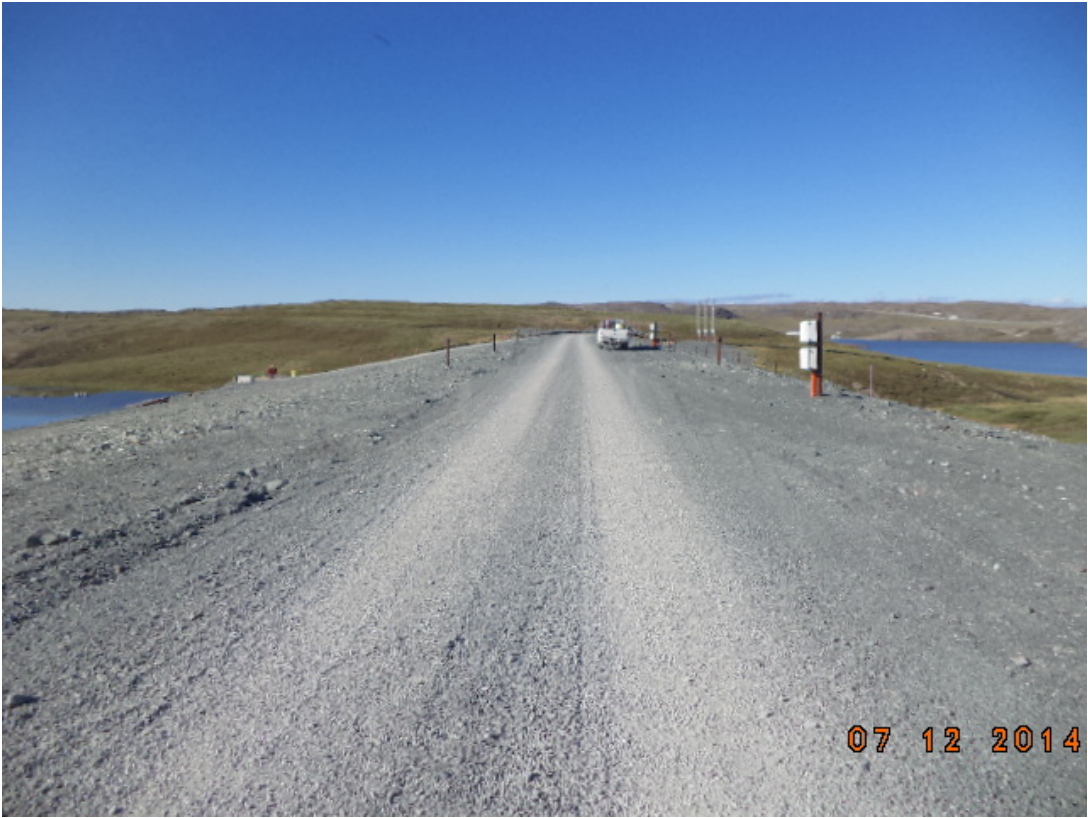
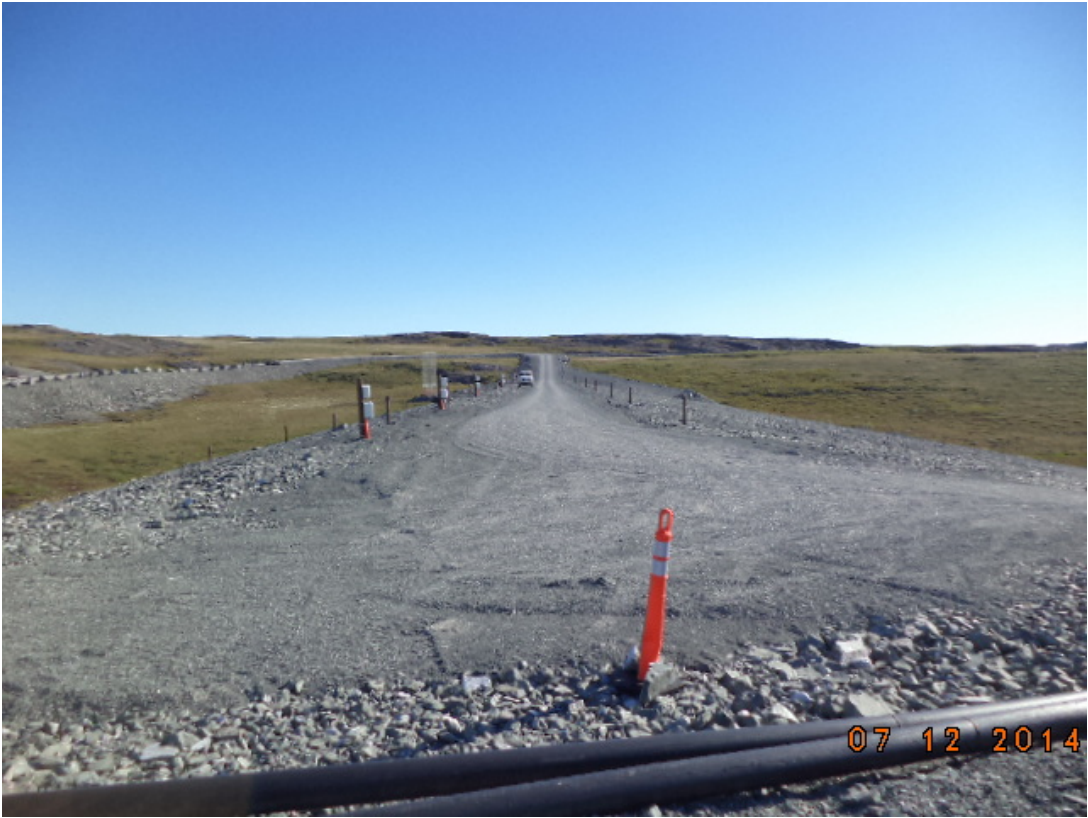
<b>Thermistors and Dataloggers</b>		
Any visible concerns? (frayed or cut cables, damaged boxes, etc.)	<input type="radio"/> Yes	<input checked="" type="radio"/> No
If you answered yes to any of the questions above please provide details and photos. Observations can be sketched on the figure provided on the next page. If seepage has been noted please estimate the flow.		
Check for suspended sediment @ T1A: None, water clear		
Depressions on upstream side of dam - noted in previous inspections.		
Animal burrow on Downstream Side of Dam		
Depressions on Downstream side of dam noted in previous inspection - marked - do not appear to have grown in size

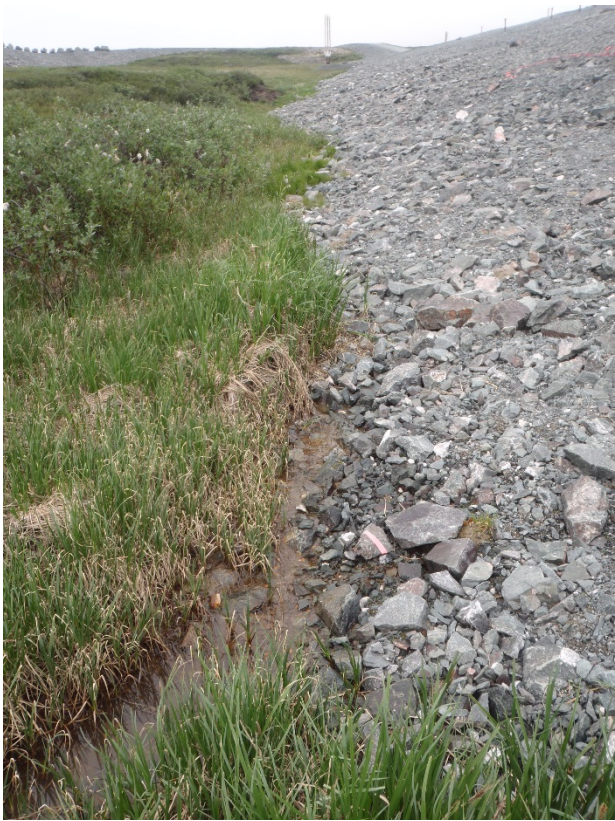
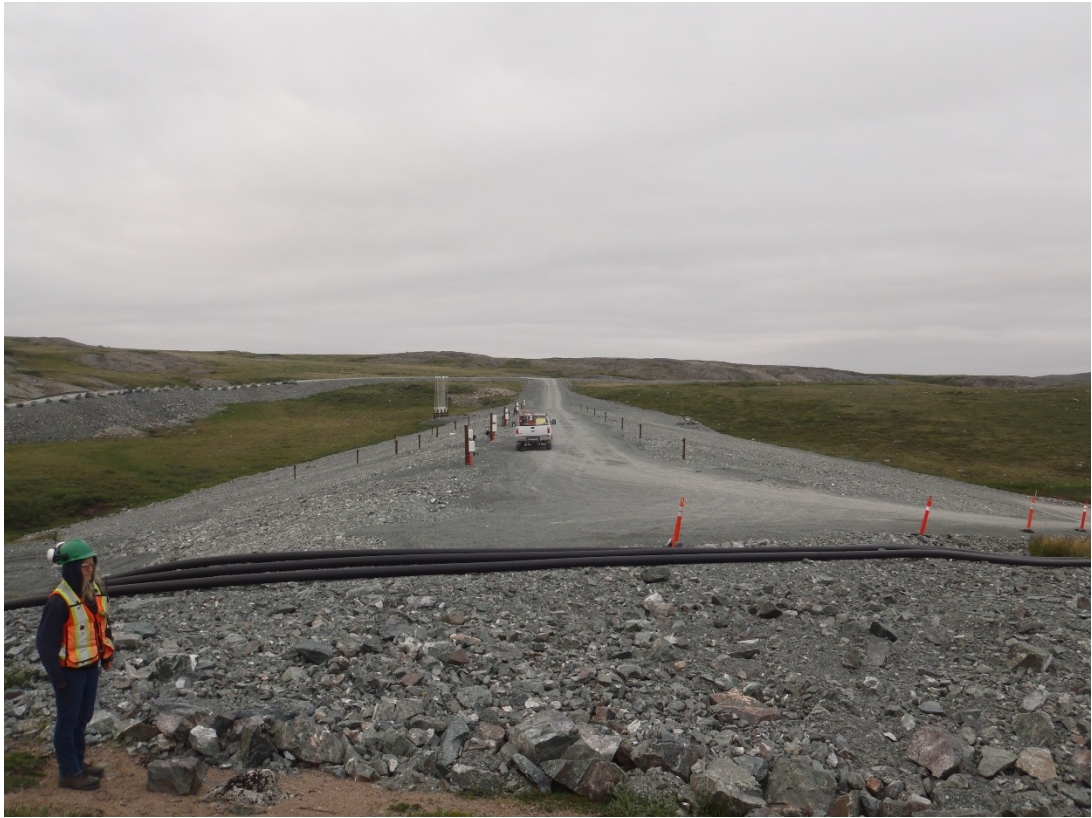
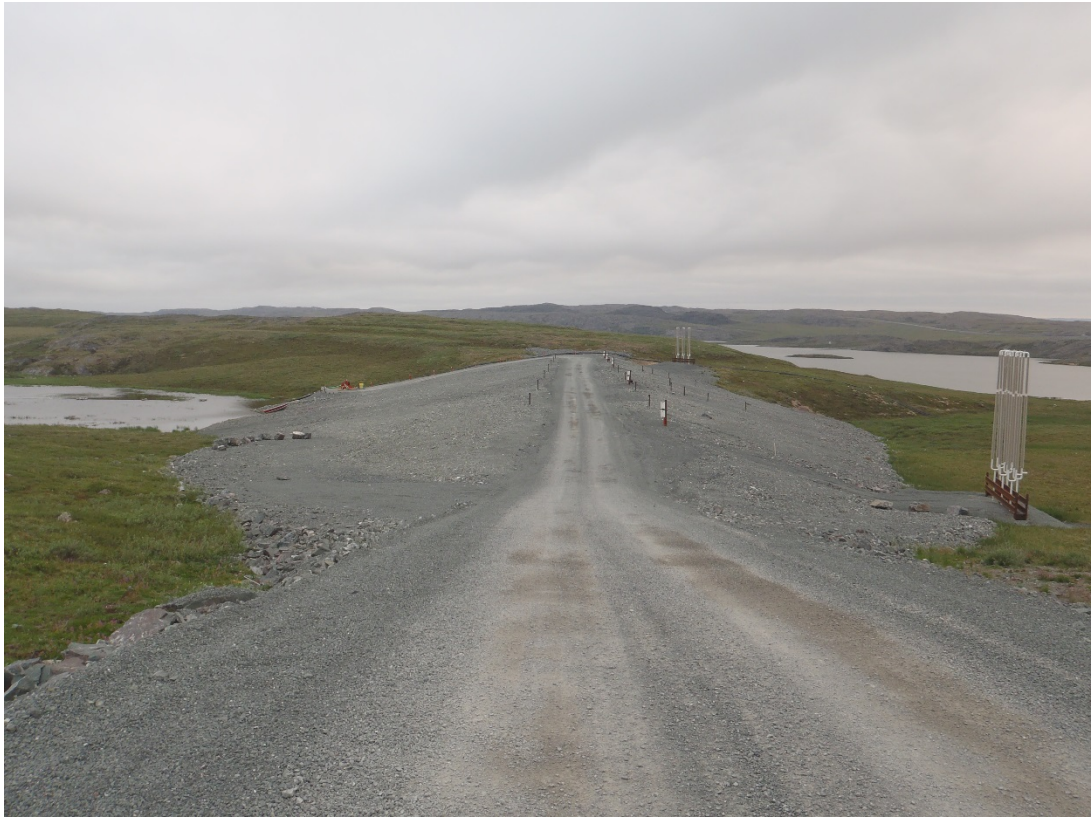
① Appear consistent w demarkations (U1, U2, U3). No cracking or erosion
