North Dam Weekly Walkover Survey Report

Date:	Aug 25/14
Inspected By:	Sarah Warnock, Anneli Jokela
Conditions:	(ie. snow on ground, clear) Overcast, Rain in am.

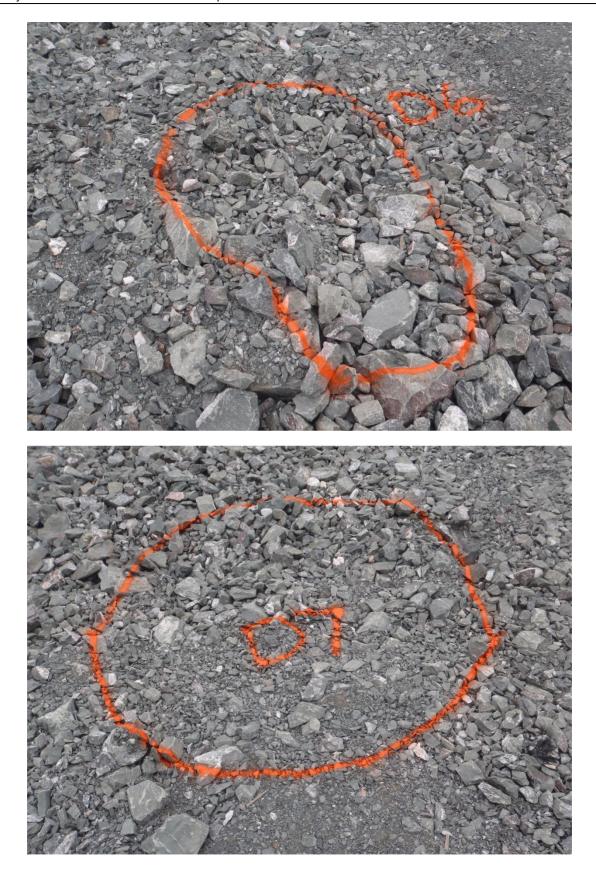
This weekly walkover survey report is a means to track the condition on the North Dam, please provide details on changes that have developed since the previous inspection and/or any observations of particular concern. All photos are appreciated. Please send the completed form (scans are fine) and any photos to hopebaymonitoring@srk.com and mmiller@srk.com Upstream Side of Dam No Yes Any visible concerns? (cracks, depressions, erosion, etc.) Downstream Side of Dam No Yes. Any visible concerns? (cracks, depressions, erosion, seepage, etc.) Crest of Dam No Yes. Any visible concerns? (cracks, depressions, erosion, etc.) Thermosyphons North Side No Yes Any visible concerns? (cracks, punctures, peeling paint, birds nests, etc.) Thermosyphons South Side No Yes Any visible concerns? (cracks, punctures, peeling paint, birds nests, etc.) Instrumentation (on crest and downstream side) No Yes Any visible concerns? (bent, rusted, cracked, etc.) Thermistors and Dataloggers No Any visible concerns? (frayed or cut cables, damaged boxes, etc.) If you answered yes to any of the questions above please provide details and photos. Observations can be sketched on the figure provided on the next page. If seepage has been noted please estimate the flow. DIEpressions noted in previous inspections - no change to depressions (2) Rust noted in previous inspection 3) New depression noted D6-located north of D2 approx 1.5x 1.5pm Remarked D2-paint faded some stumping of material D7 - area marked to monitor potantial change over time - area of interest D8 - marked area of interest - some signs of errosion
