Appendix H: Depression Monitoring

2014 North Dam Geotechnical Inspection		
		Depression Tracking U1		
Job No: 1CT022.001 Filename: Ndam_DepressionTracking.pptx	HOPE BAY MINING LTD.	Date: Oct. 2014	Approved: MMM	Figure: H.2

2014 North Dam Geotechnical Inspection

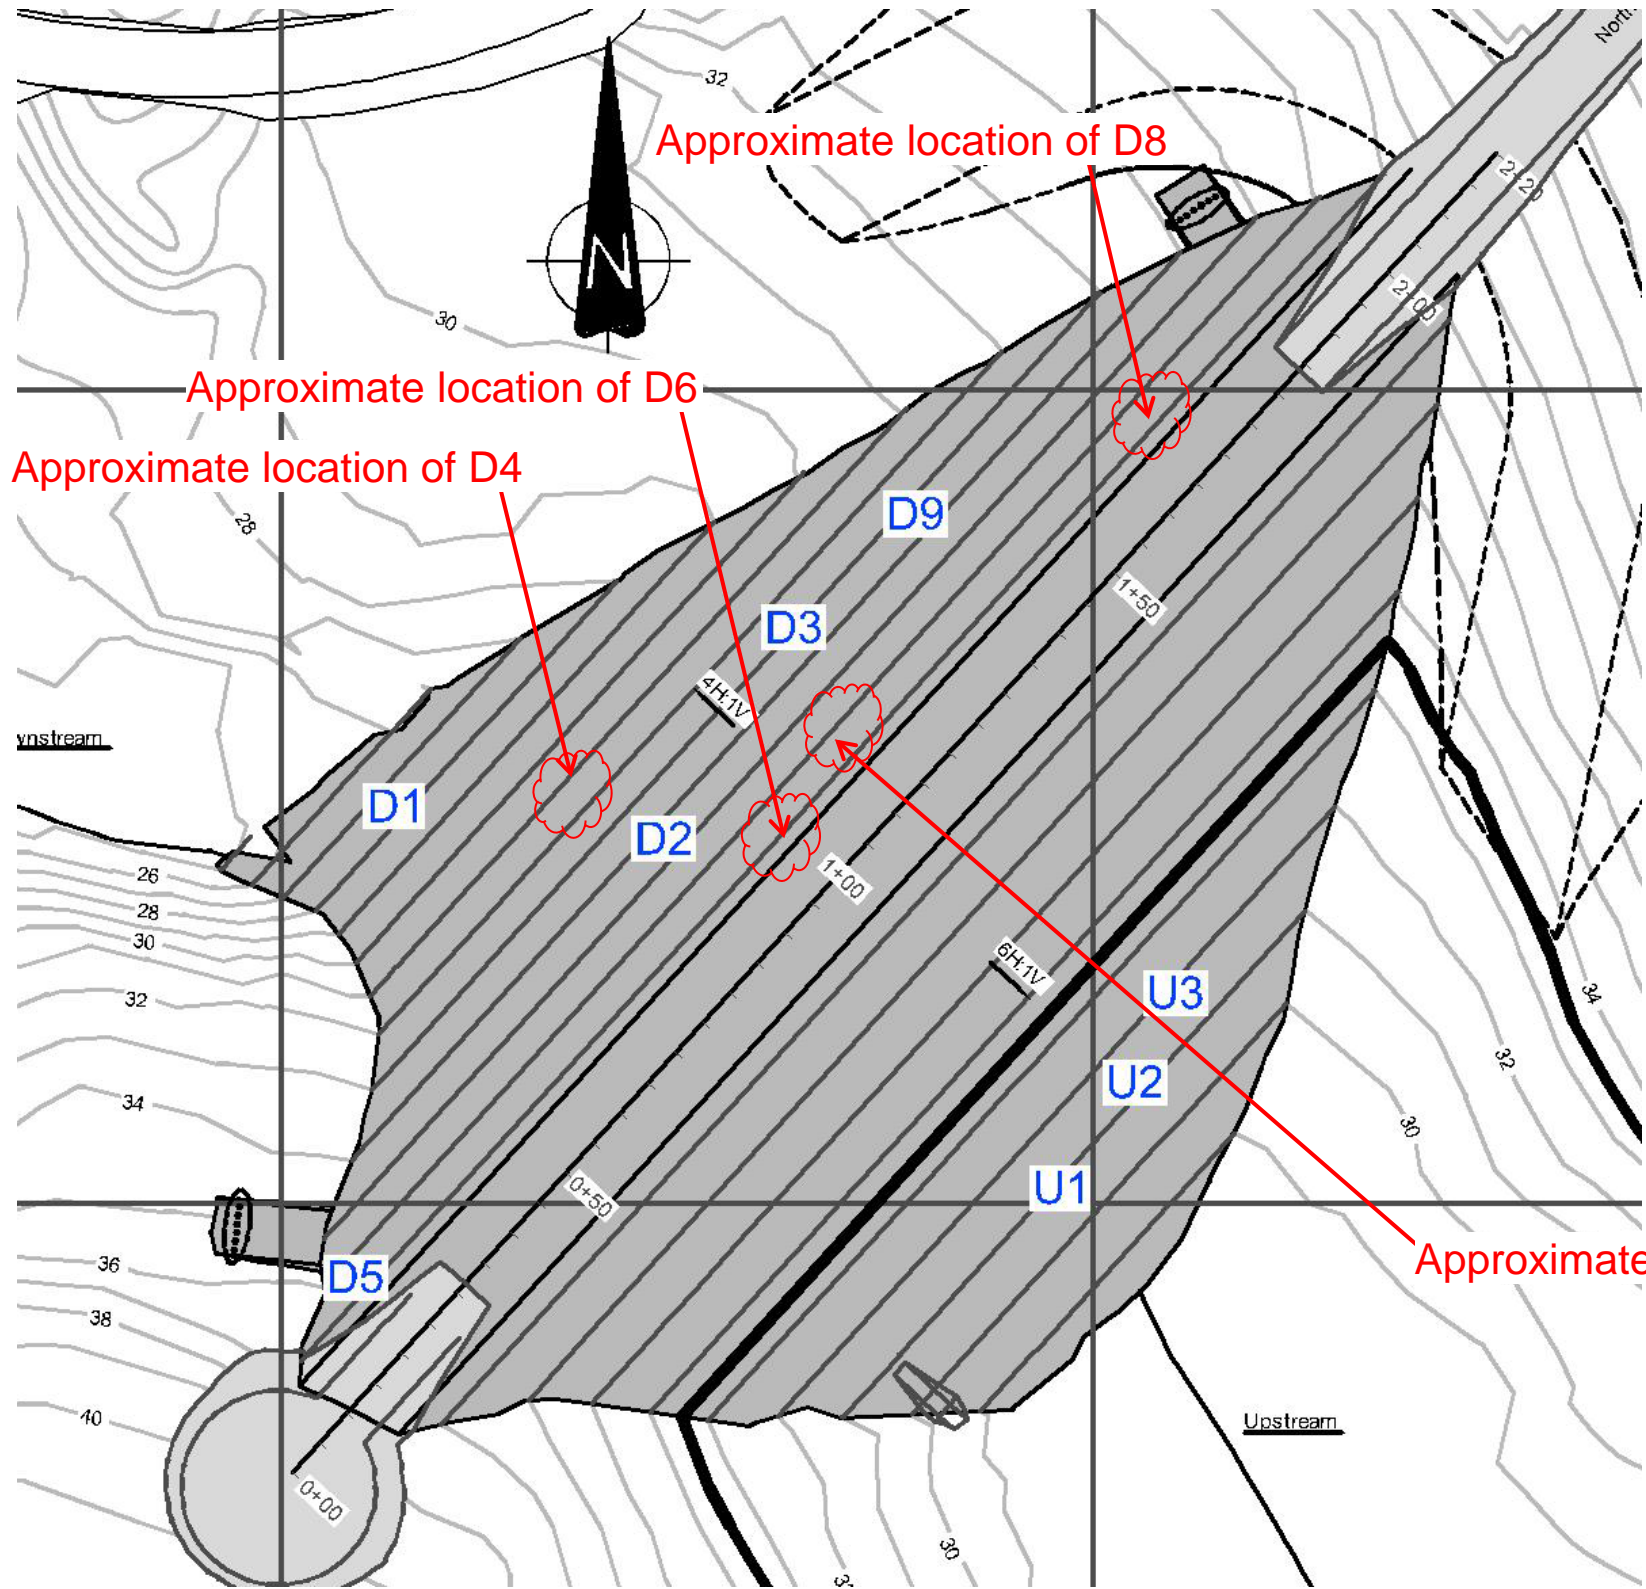
ID	Location	Comments
U1	Upstream	Boundaries spray painted and ID given July 2014, was previously identified.
U2	Upstream	Boundaries spray painted and ID given July 2014, was previously identified.
U3	Upstream	Boundaries spray painted and ID given July 2014, was previously identified.
D1	Downstream	First noted in 2013 Annual Geotechnical Inspection
		September 1, 2014 - expanded towards the south
		September 20, 2014 - TMAC ESR noted the depression looks to have expanded, paint mark updated.
D2	Downstream	First noted in 2013 Annual Geotechnical Inspection
		September 14, 2014 - TMAC ESR noted that the depression may have expanded slightly
D3	Downstream	Identified during 2014 annual geotechnical inspection, spray painted and given ID.
		August 10, 2014 - larger area marked
D4	Downstream	First noted August 16, 2014 in weekly report prepared by TMAC ESR. Roughly 0.5x0.5 m area
D5	Downstream	First noted August 16, 2014 in weekly report prepared by TMAC ESR.

TMAC ESR notes it could be animal burrows ~1x1 m wide disturbed area (August 2014)
D6	Downstream	First noted August 25, 2014 in weekly report prepared by TMAC ESR. 1.5x1.5 m area
		September 6, 2014 - Possible incremental sloughing (minimal)
D7	Downstream	First noted August 25, 2014 in weekly report prepared by TMAC ESR
D8	Downstream	First noted August 25, 2014 in weekly report prepared by TMAC ESR. Area with signs of erosion.
		September 20, 2014 - TMAC ESR noted depression looks to have expanded on top right. Difficult to tell from photos, due to snow (and unlabeled photos).
D9	Downstream	First noted September 14, 2014 in weekly report prepared by TMAC ESR

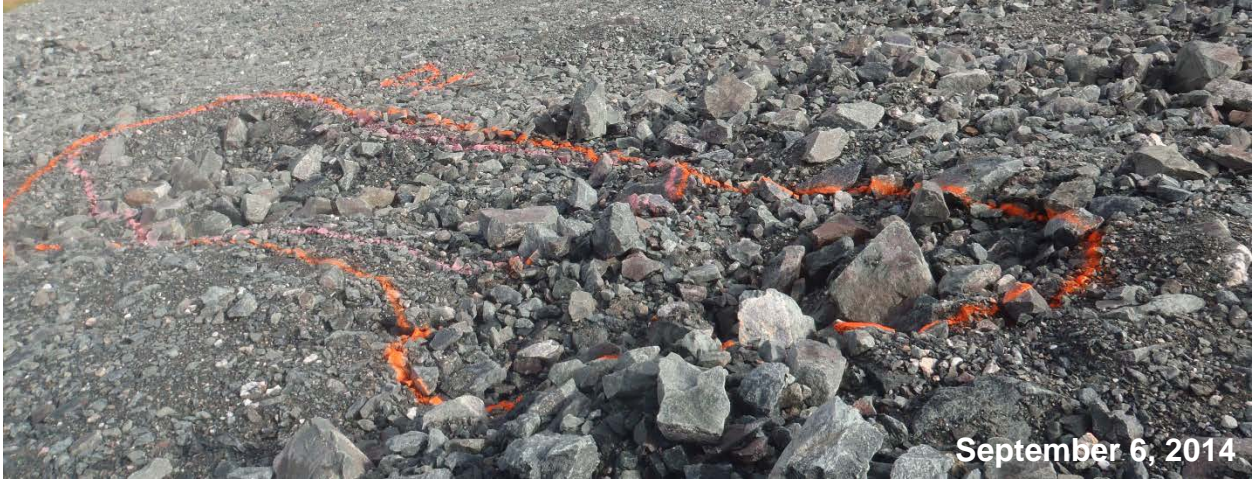
Expanded to the south, note the faded pink paint mark in the center
