North Dam Weekly Walkover Survey Report

Date:	Friday, June 19, 2015
Inspected By:	Darcy Kanayok
Conditions:	(ie. snow on ground, clear) Clear, North end still abit of snow on foot of Dam

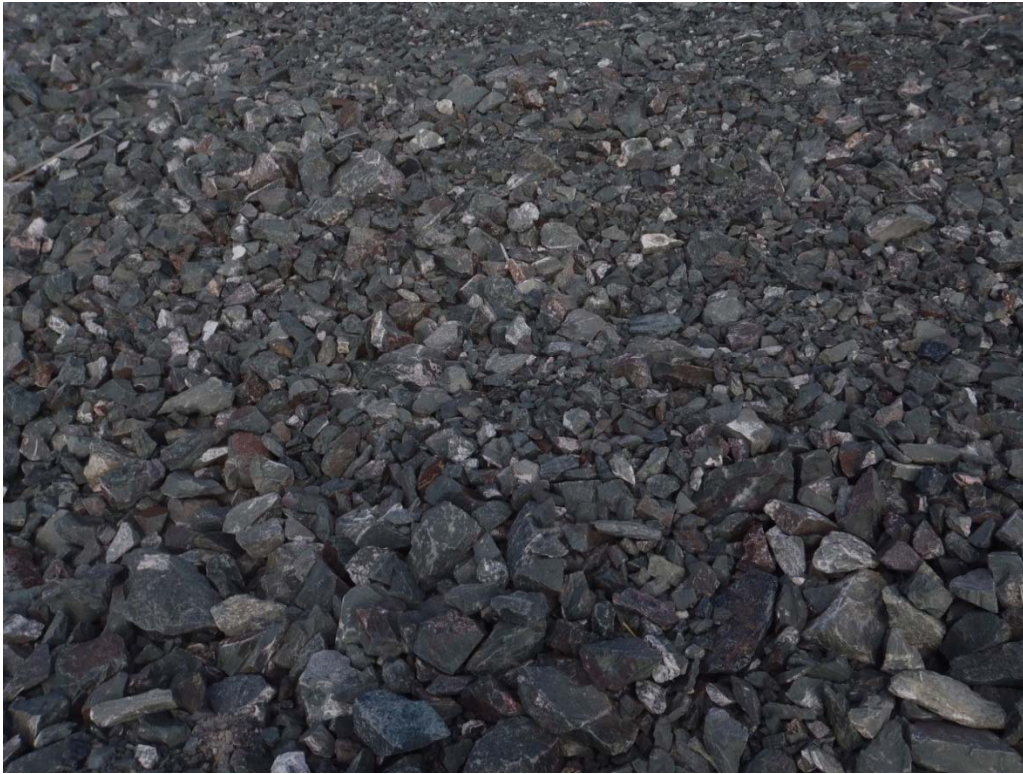
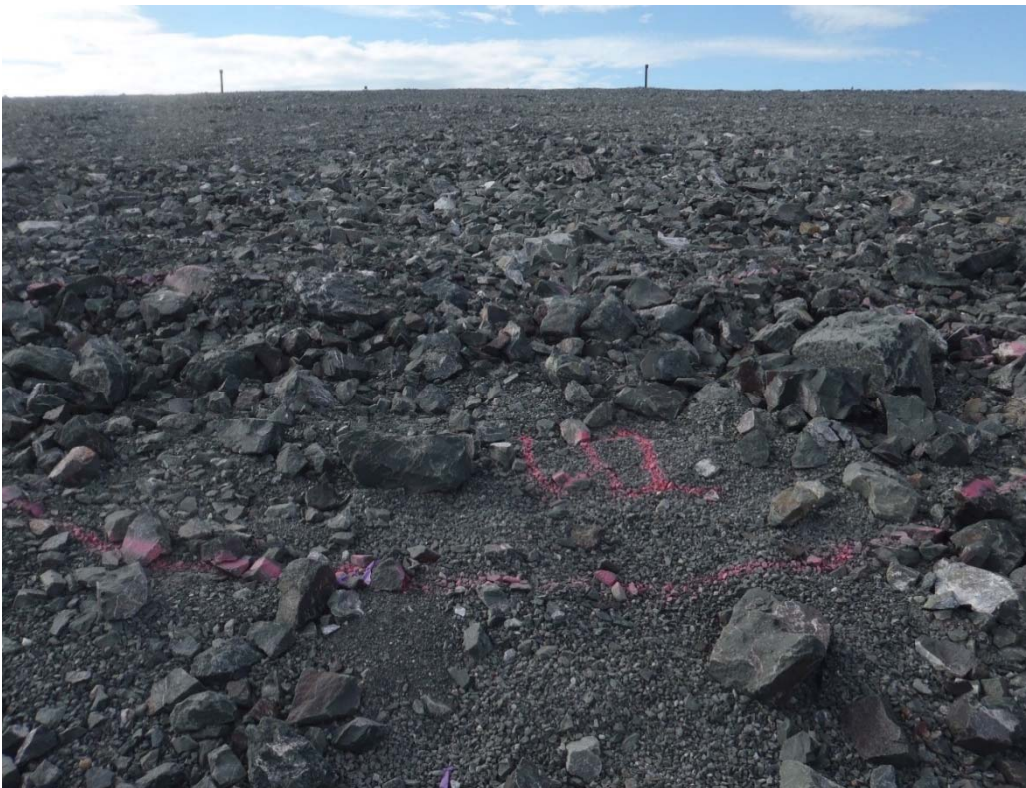
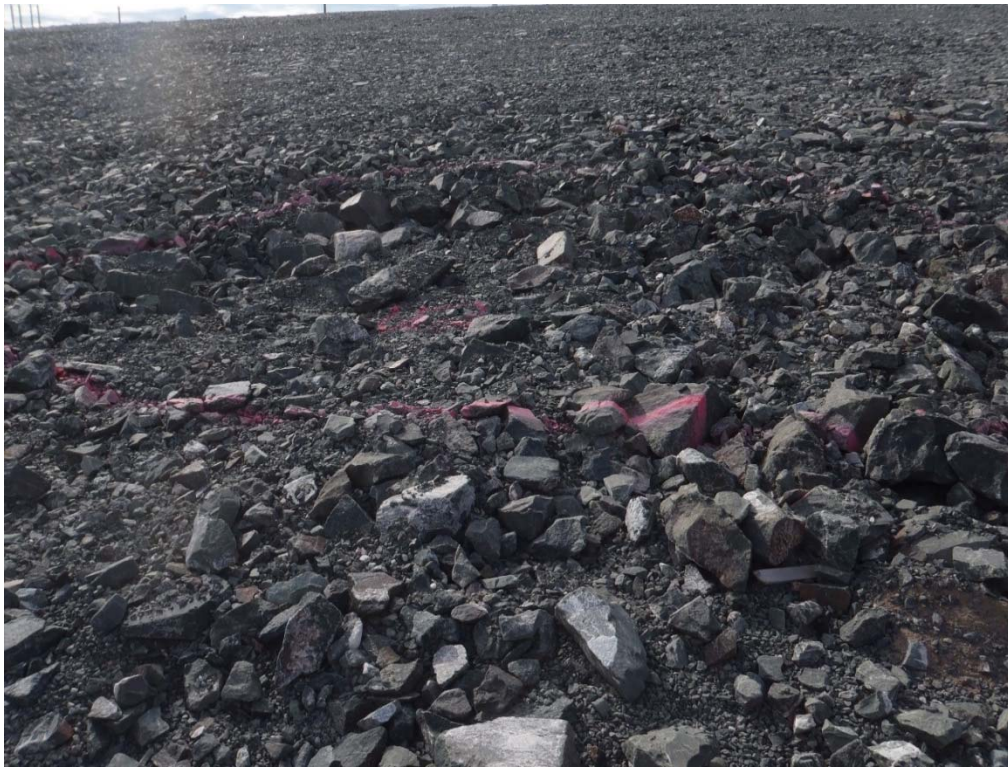
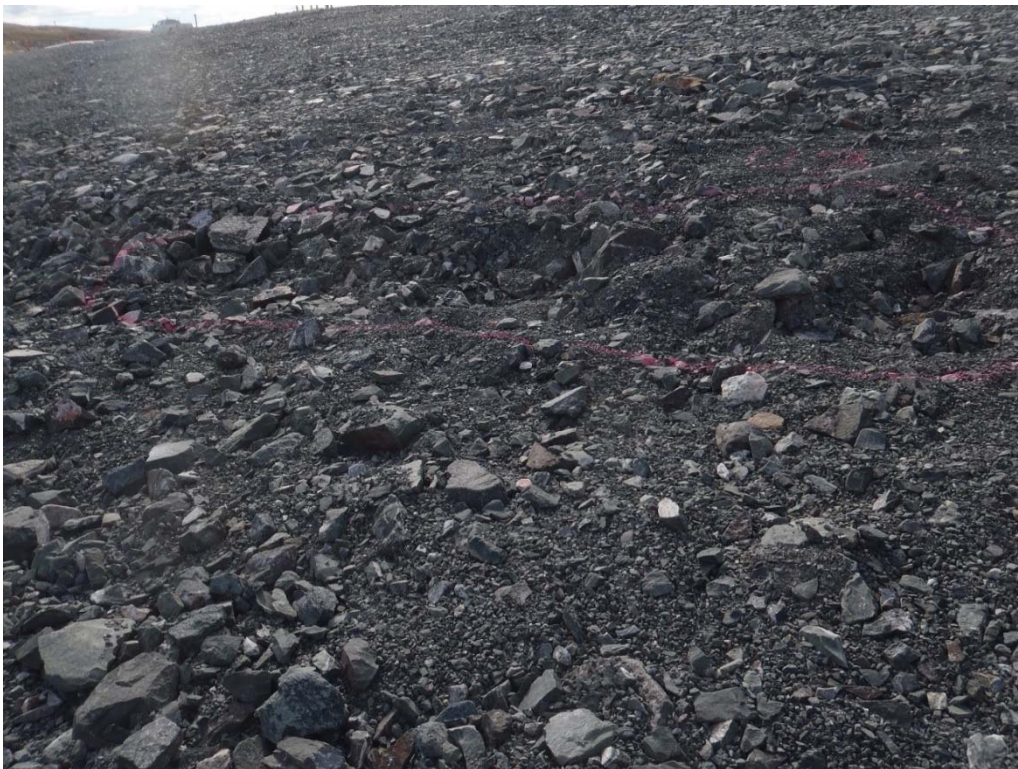
U3 maybe getting bigger

U4 new depression

U2 still looks the same

U1 still looks the same

D2 small change sloping inwards

D10 new depression

D11 new depression
