North Dam Weekly Walkover Survey Report

Date:	Oct 5/14
Inspected By:	Sarah Wannock
Conditions:	(ie. snow on ground, clear) Snow on downstream side of dam, overcast, no precip.

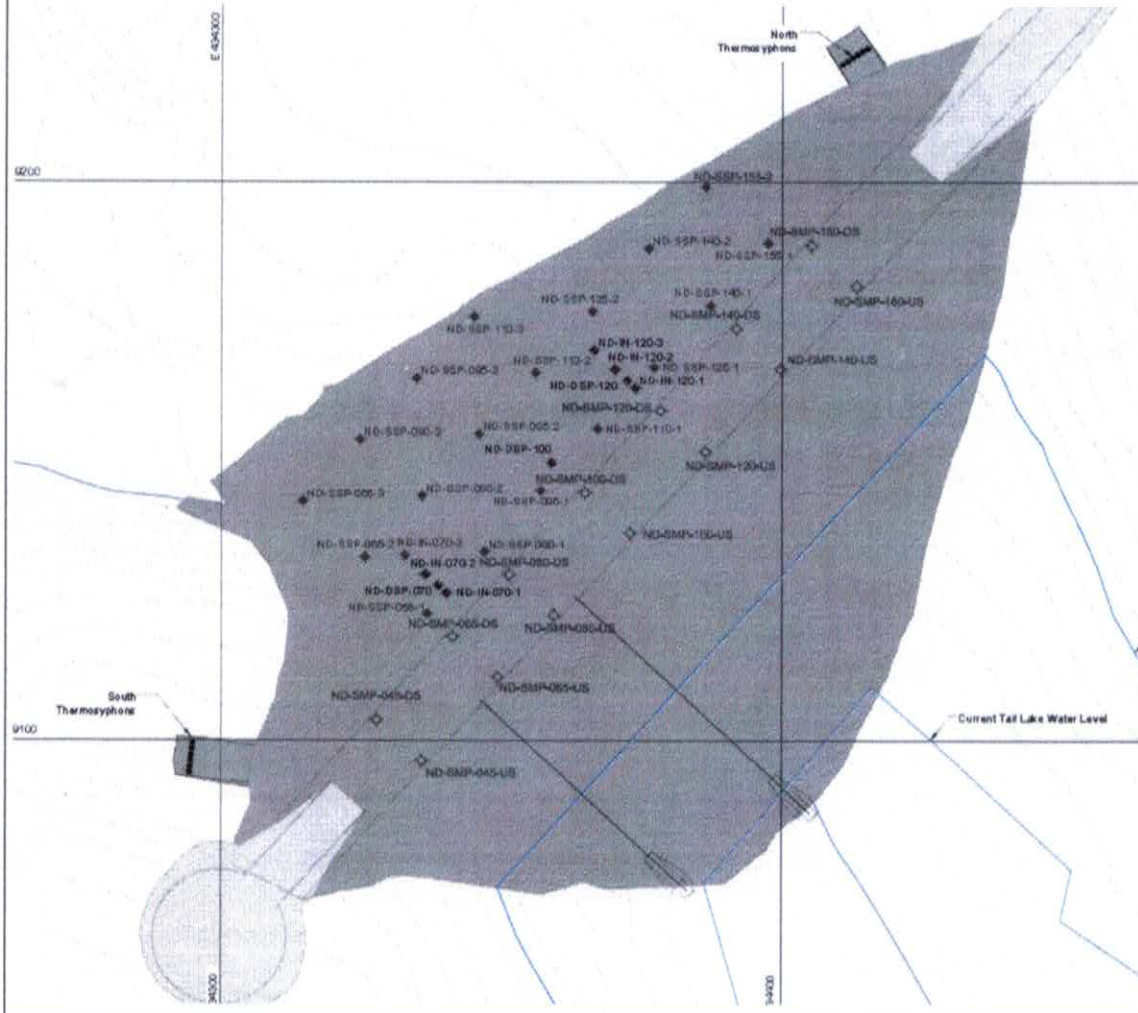
Upstream Side of Dam	Slight snow cover but could identify traces of paint markings	
Any visible concerns? (cracks, depressions, erosion, etc.)	Yes	<input checked="" type="radio"/> No
Downstream Side of Dam	However more snow than upstream side and could not see paint markings	
Any visible concerns? (cracks, depressions, erosion, seepage, etc.)	Yes	<input checked="" type="radio"/> No
Crest of Dam		
Any visible concerns? (cracks, depressions, erosion, etc.)	Yes	<input checked="" type="radio"/> No
Thermosyphons North Side		
Any visible concerns? (cracks, punctures, peeling paint, birds nests, etc.)	Yes	<input checked="" type="radio"/> No
Thermosyphons South Side		
Any visible concerns? (cracks, punctures, peeling paint, birds nests, etc.)	Yes	<input checked="" type="radio"/> No
Instrumentation (on crest and downstream side)		
Any visible concerns? (bent, rusted, cracked, etc.)	Yes	<input checked="" type="radio"/> No

Tail Lake Frozen.
