North Dam Weekly Walkover Survey Report

Date:	May 9, 2015
Inspected By:	Claire Brown
Conditions:	(ie. snow on ground, clear) Snow covered. Significant drifts.

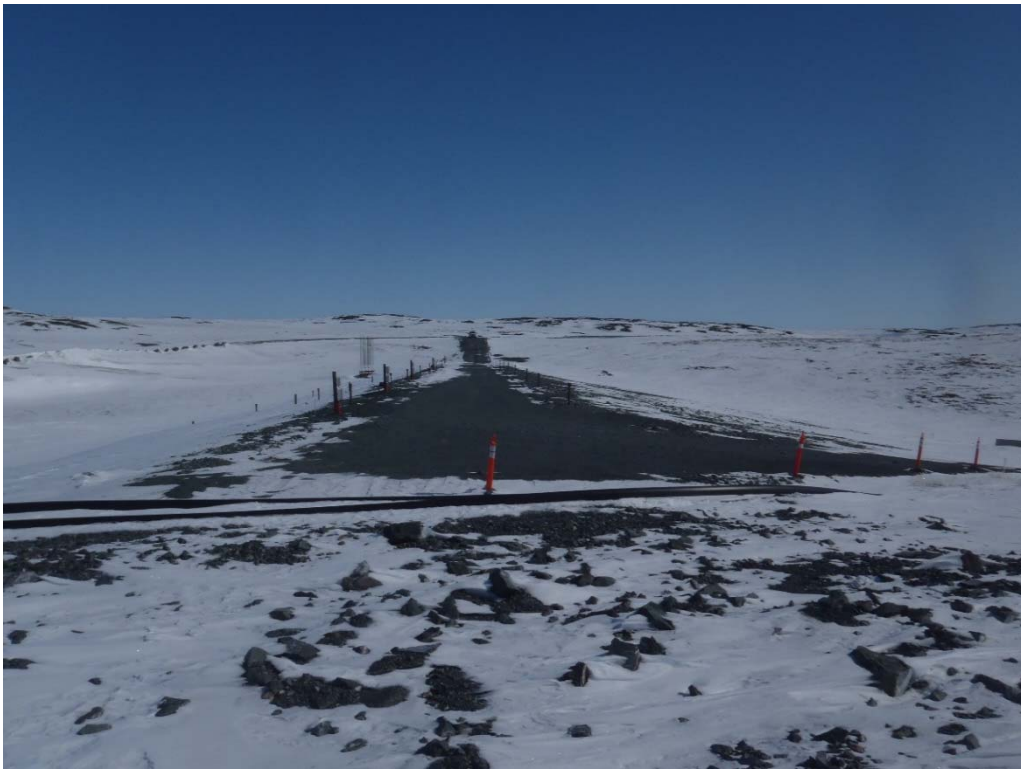
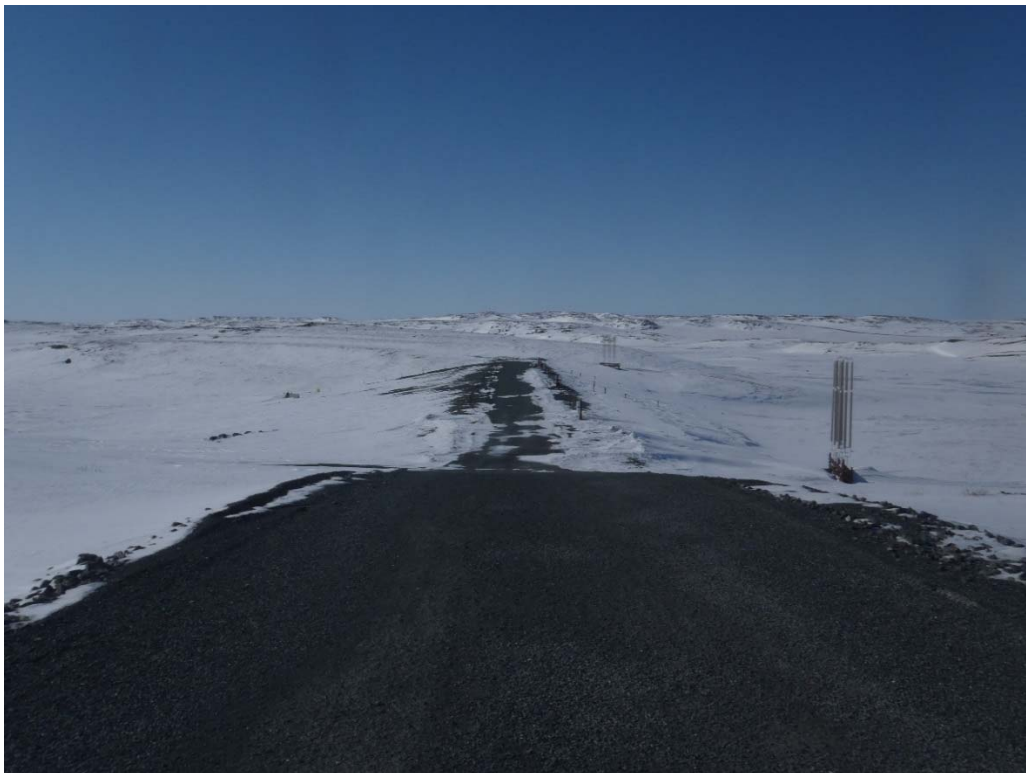
Photo from north end looking south along the dam

Photo from south end looking north along the dam

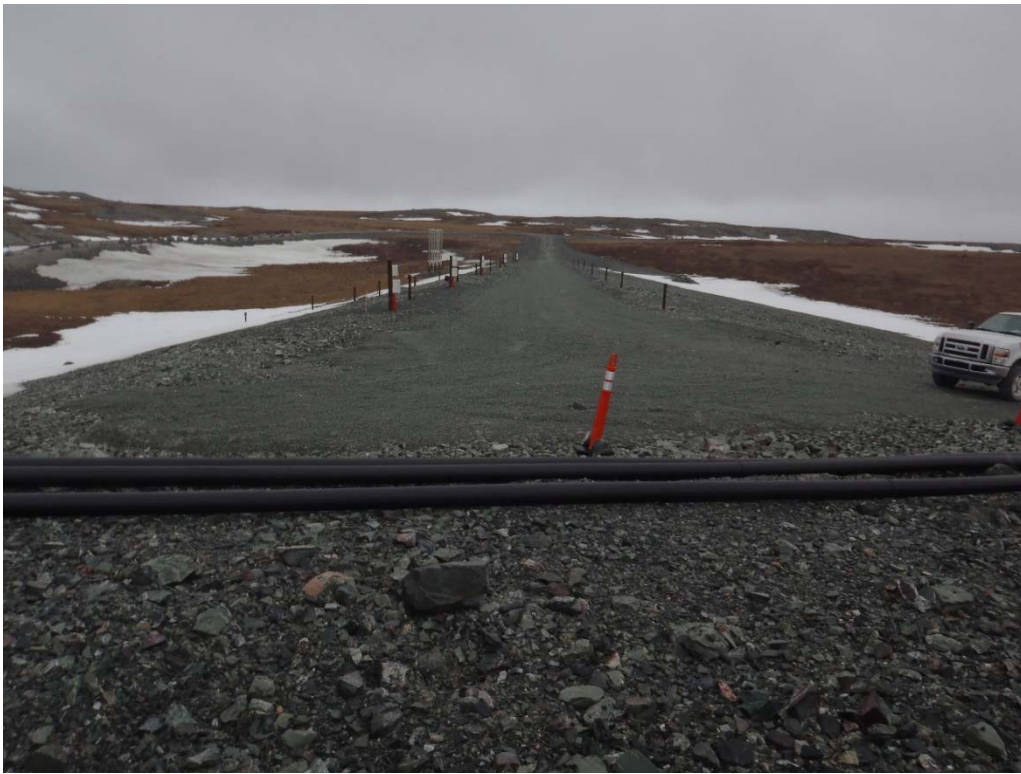
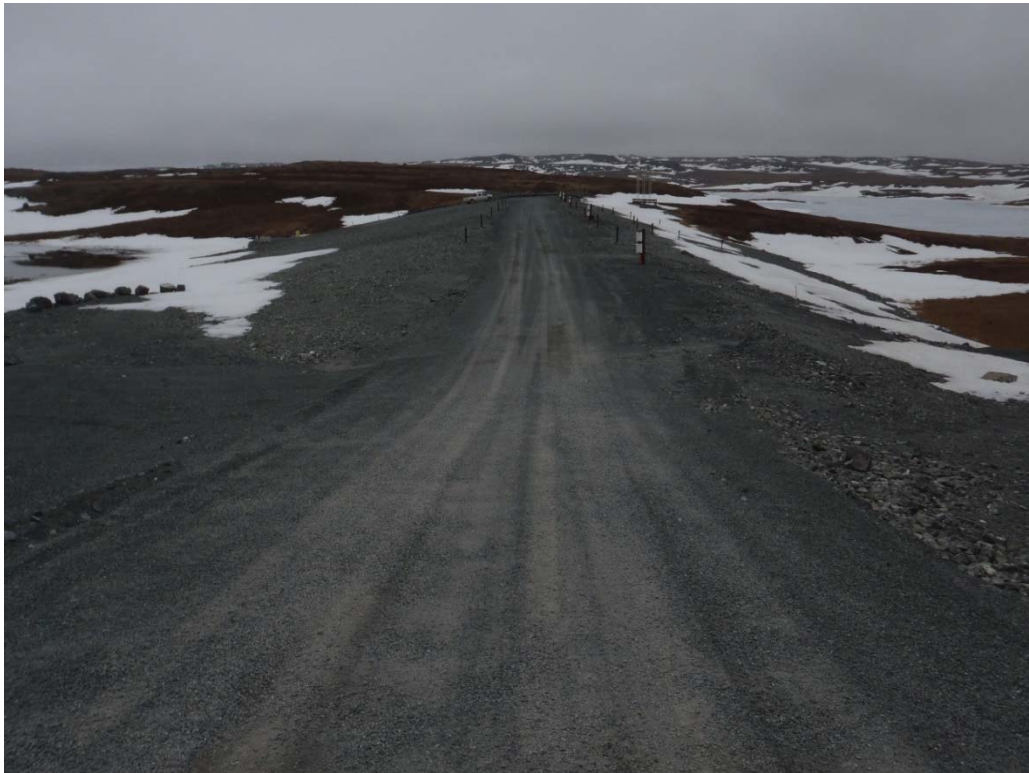
Upstream Side of Dam	2	
Any visible concerns? (cracks, depressions, erosion, etc.)	Yes	No
Downstream Side of Dam	4	
Any visible concerns? (cracks, depressions, erosion, seepage, etc.)	Yes	No
Crest of Dam		
Any visible concerns? (cracks, depressions, erosion, etc.)	Yes	No
Thermosyphons North Side	3	
Any visible concerns? (cracks, punctures, peeling paint, birds nests, etc.)	Yes	No
Thermosyphons South Side		
Any visible concerns? (cracks, punctures, peeling paint, birds nests, etc.)	Yes	No
Instrumentation (on crest and downstream side)		
Any visible concerns? (bent, rusted, cracked, etc.)	Yes	No
Thermistors and Dataloggers		
Any visible concerns? (frayed or cut cables, damaged boxes, etc.)	Yes	No
Suspended Sediment in TIA (When not frozen)	1	
Any suspended sediment in Tail Lake?	Yes	No
Water at the Toe of the Downstream Side of the Dam (If yes refer to Doris North - North Dam and Tail Lake Outflow Seepage Monitoring Work Plan 2015)	Yes	No 5

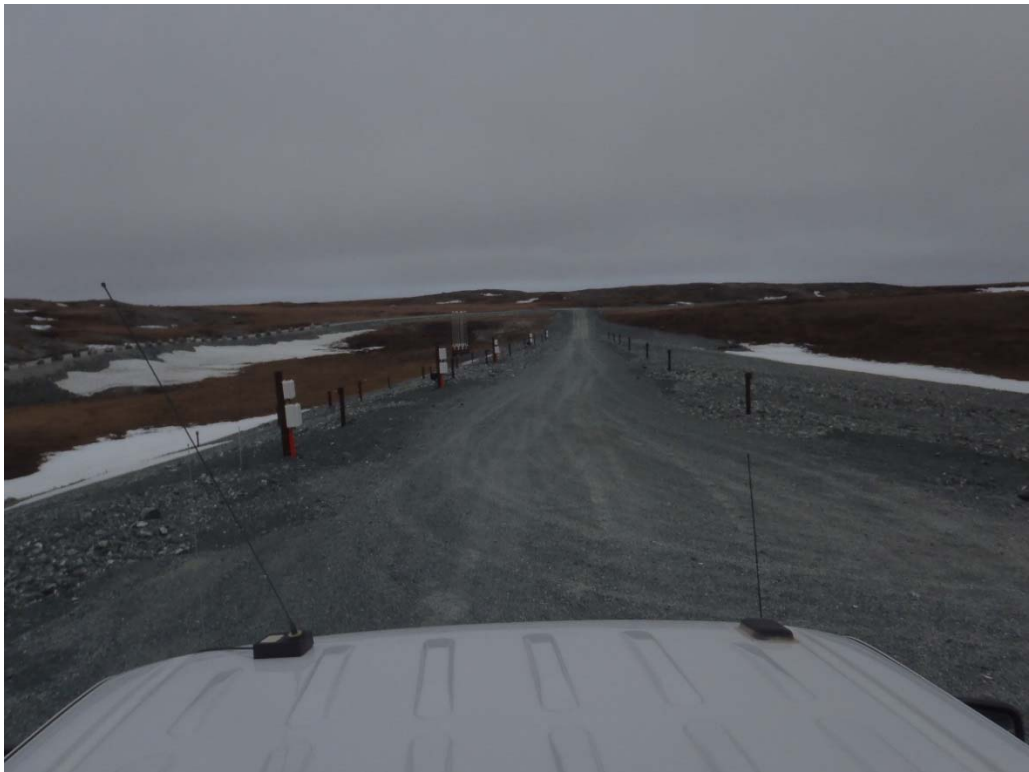
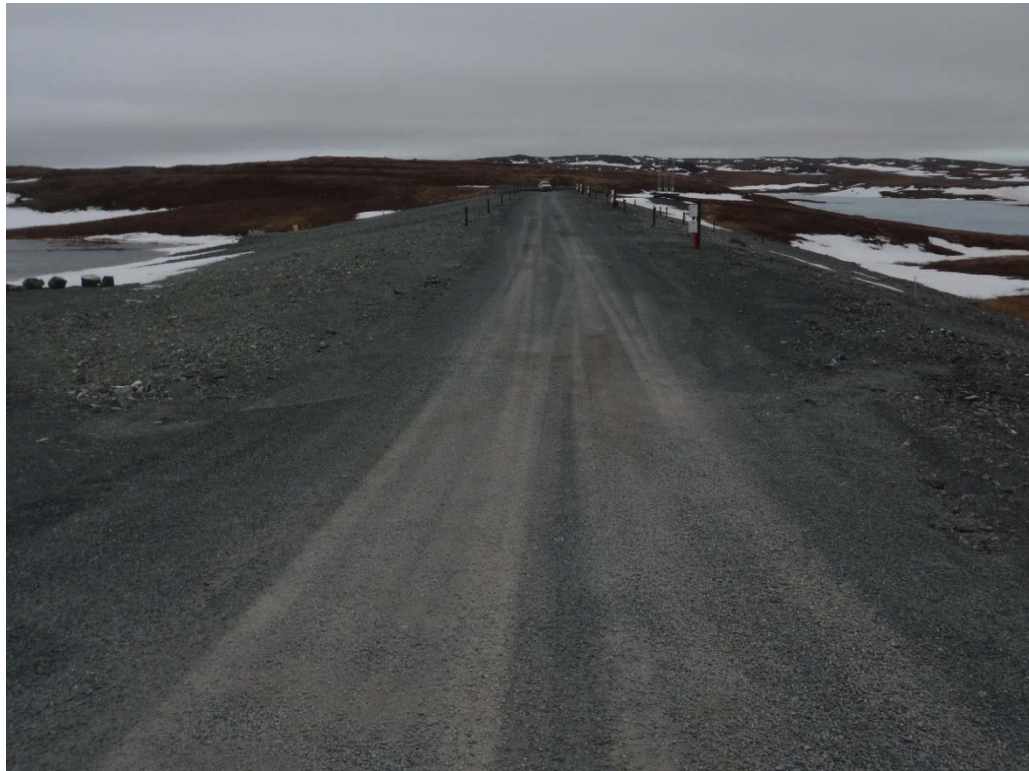
Date:	June 6, 2015
Inspected By:	Robert Maksagak
Conditions:	(ie. snow on ground, clear) Some snow on upstream side, toe of Dam. Some snow on down stream side of Dam.
