North Dam Weekly Walkover Survey Report

2015 Geotechnical Inspection

2015 North Dam Geotechnical Inspection

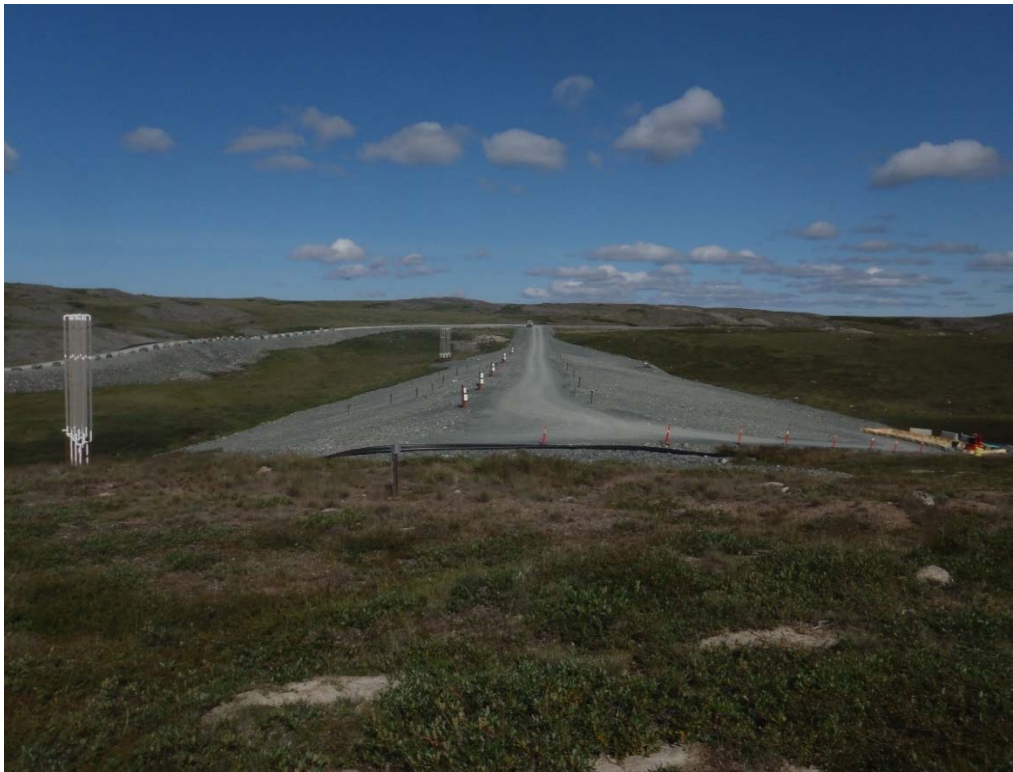
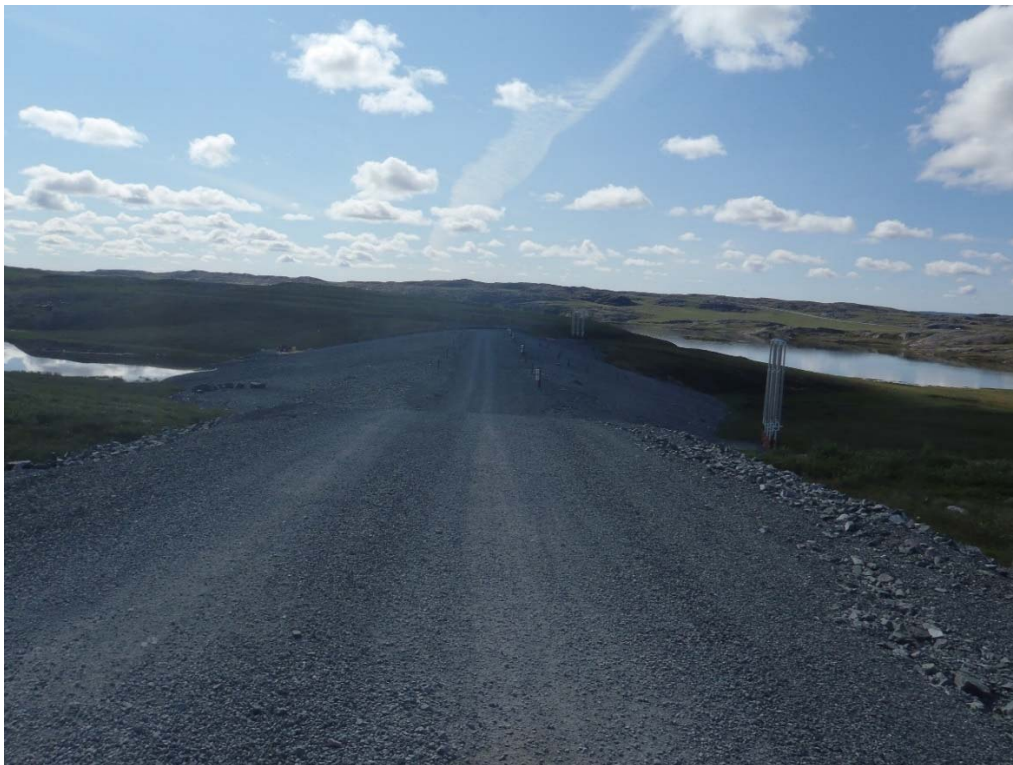
- Photo from north end looking south along the dam
- Photo from south end looking north along the dam

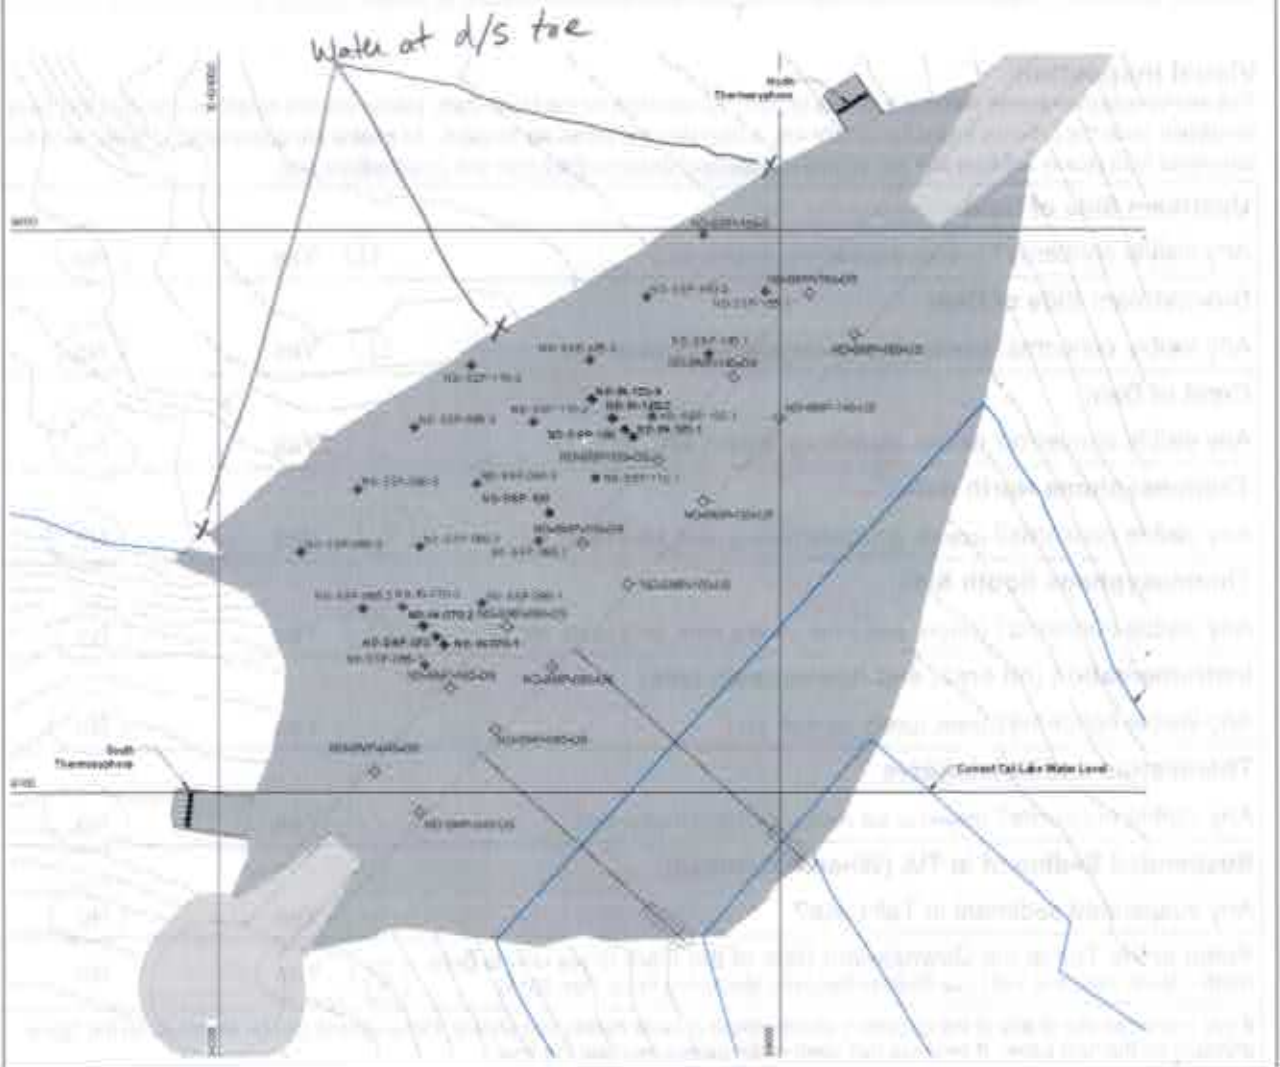
If you answered yes to any of the questions above please provide details and photos. Observations can be sketched on the figure provided on the next page. If seepage has been noted please estimate the flow.		
<p>① No new depressions marked. No change to previously identified depressions.</p> <p>② Rust noted previously - no change</p> <p>③ Water at toe of dam identified in three locations. Thick vegetation along toe made it difficult to identify source location. Appears to run from North end of d/s toe to south end. Field measurements collected for pH, EC, temp, ORP.</p>

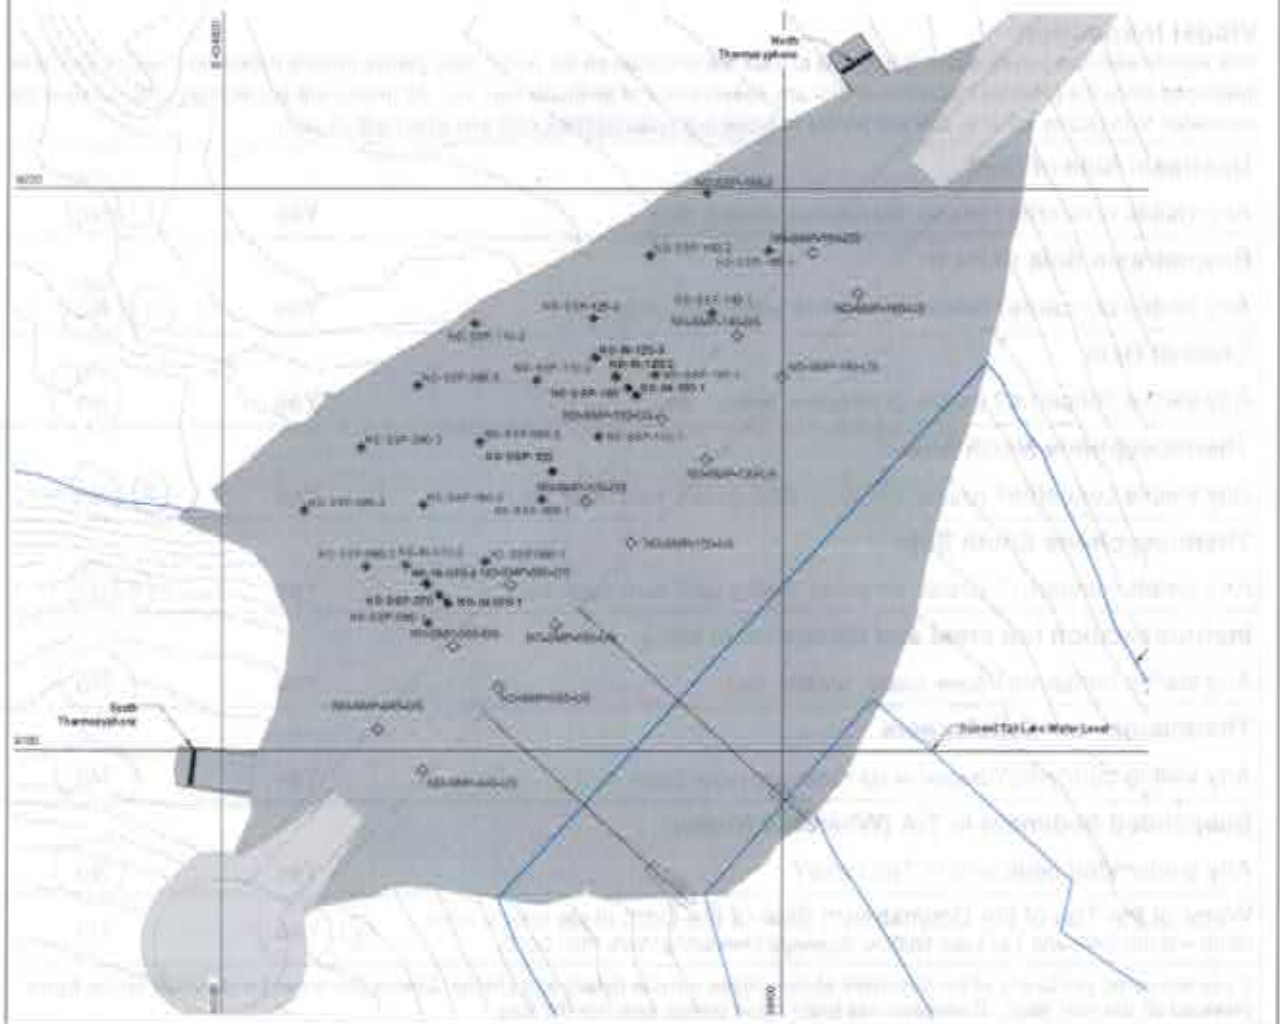
Suspended Sediment in TIA (When not frozen)		
Any suspended sediment in Tail Lake?	Yes	<input checked="" type="radio"/> No
Water at the Toe of the Downstream Side of the Dam (if yes refer to Doris North - North Dam and Tail Lake Outflow Seepage Monitoring Work Plan 2015)	<input checked="" type="radio"/> Yes	No
If you answered yes to any of the questions above please provide details and photos. Observations can be sketched on the figure provided on the next page. If seepage has been noted please estimate the flow.		
<p>① No new depressions marked. No change to depressions marked in previous inspections.</p> <p>② Rust noted in previous inspections - no visible change</p> <p>③ water at the ^{d/s} noted in past inspection. No new areas. Thick vegetation prevents evaluation of source.</p>

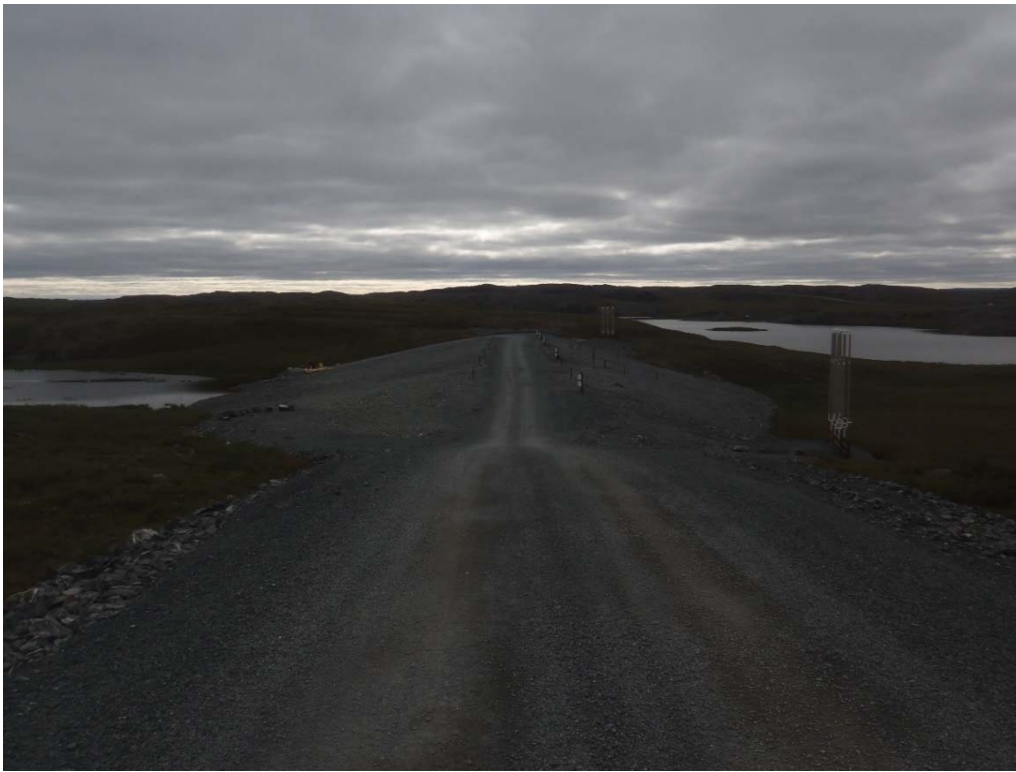
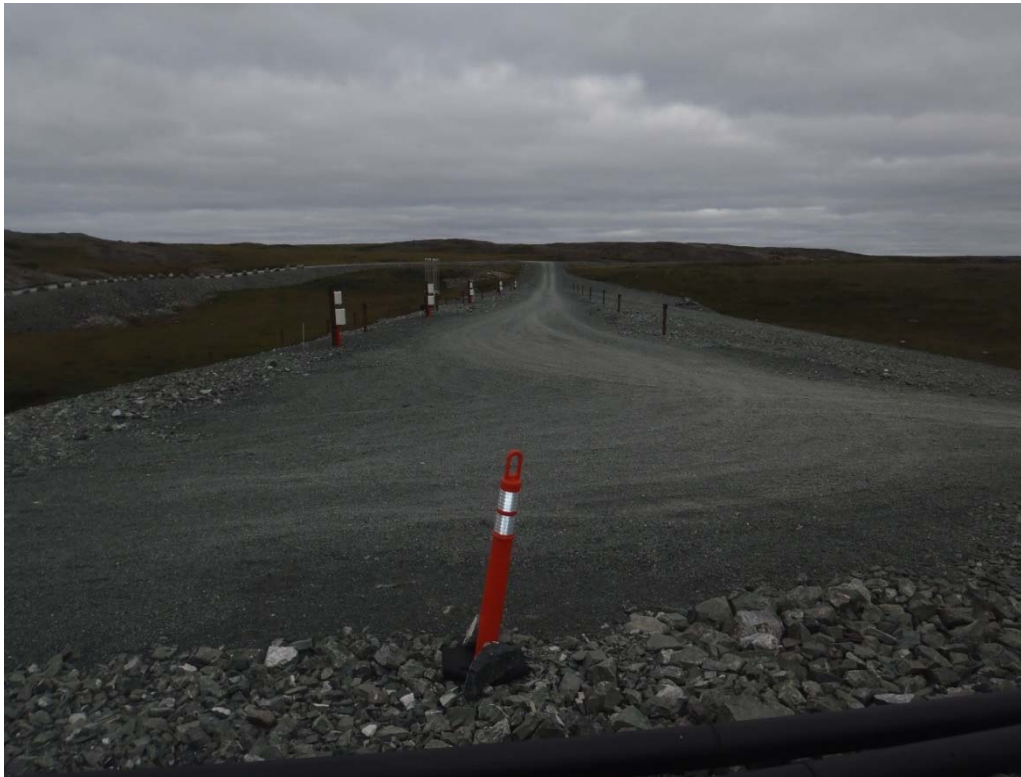
Photo from north end looking south along the dam

Photo from south end looking north along the dam
