North Dam Weekly Walkover Survey Report

2017 Annual Geotechnical Inspection		
		Historic Depression Summary		
Job No: 1CT022.016 Filename: AppH_ND_AGI_DepressionTracking.pptx	DORIS MINE	Date: December 2017	Approved: PDL	Figure: H.1

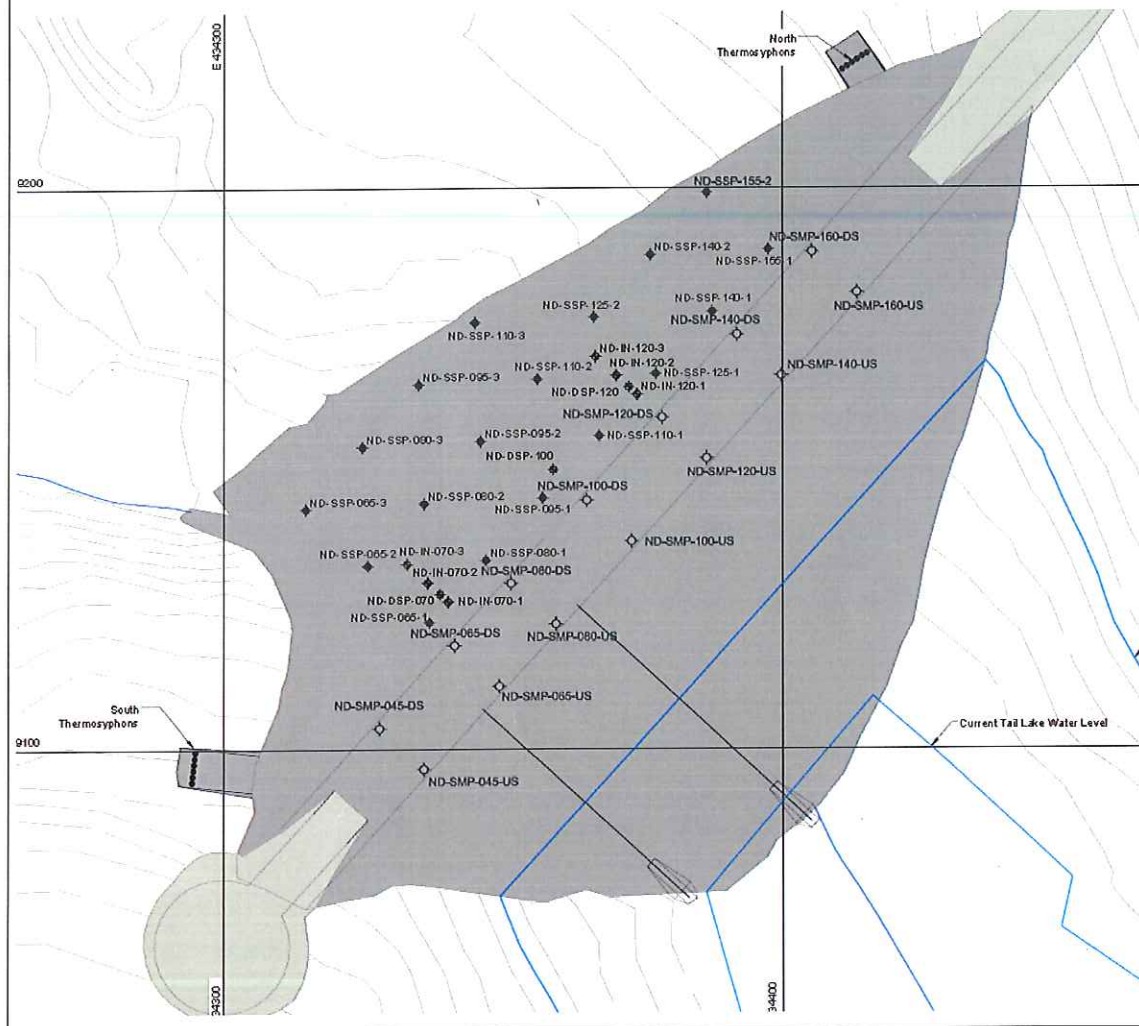
North erosion, animal holes, water on down river side

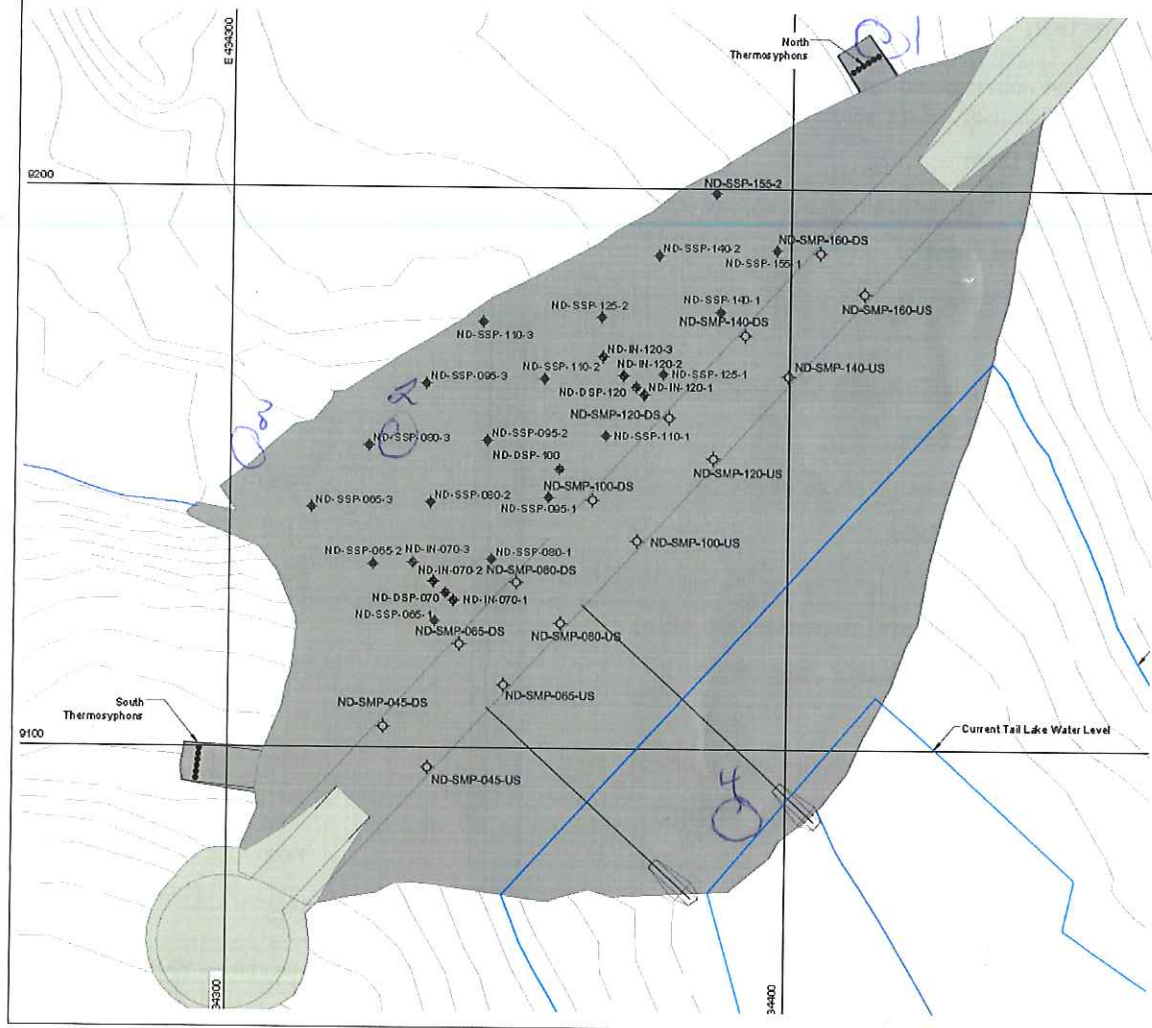
Upstream Side of Dam	Same cracks @ toe	Yes	No
Any visible concerns? (cracks, depressions, erosion, etc.)			
Downstream Side of Dam		Yes	No
Any visible concerns? (cracks, depressions, erosion, seepage, etc.)			
Crest of Dam		Yes	No
Any visible concerns? (cracks, depressions, erosion, etc.)			
Thermosyphons North Side		Yes	No
Any visible concerns? (cracks, punctures, peeling paint, birds nests, etc.)			
Thermosyphons South Side		Yes	No
Any visible concerns? (cracks, punctures, peeling paint, birds nests, etc.)			
Instrumentation (on crest and downstream side)		Yes	No
Any visible concerns? (bent, rusted, cracked, etc.)			
Thermistors and Dataloggers		Yes	No
Any visible concerns? (frayed or cut cables, damaged boxes, etc.)			
Suspended Sediment in TIA (When not frozen)		Yes	No
Any suspended sediment in Tail Lake?			
Water at the Toe of the Downstream Side of the Dam (If yes refer to Doris North – North Dam and Tail Lake Outflow Seepage Monitoring Work Plan 2015)		Yes	No

If you answered yes to any of the questions above please provide details and photos. Observations can be sketched on the figure provided on the next page. If seepage has been noted please estimate the flow.			
Snow melt has downstream side wet.

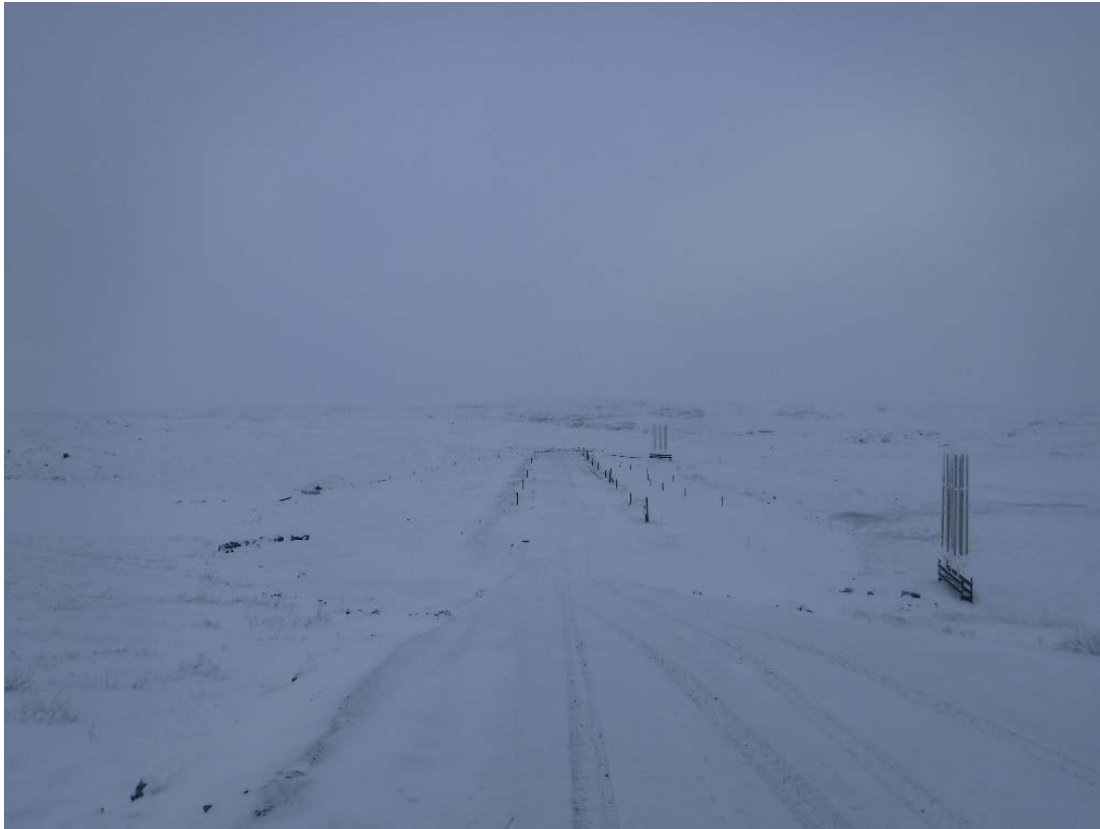
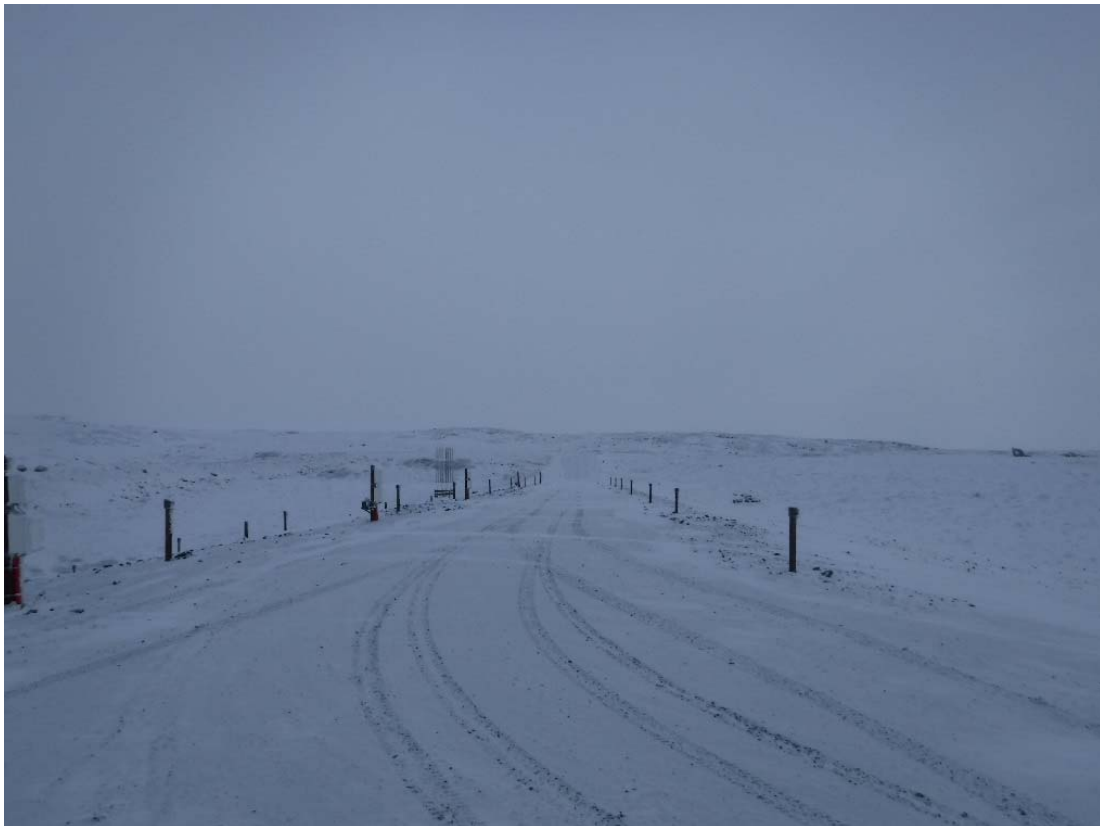
Upstream Side of Dam		
Any visible concerns? (cracks, depressions, erosion, etc.)	Yes	No
Downstream Side of Dam		
Any visible concerns? (cracks, depressions, erosion, seepage, etc.)	Yes	No
Crest of Dam		
Any visible concerns? (cracks, depressions, erosion, etc.)	Yes	No
Thermosyphons North Side		
Any visible concerns? (cracks, punctures, peeling paint, birds nests, etc.)	Yes	No
Thermosyphons South Side		
Any visible concerns? (cracks, punctures, peeling paint, birds nests, etc.)	Yes	No
Instrumentation (on crest and downstream side)		
Any visible concerns? (bent, rusted, cracked, etc.)	Yes	No
Thermistors and Dataloggers		
Any visible concerns? (frayed or cut cables, damaged boxes, etc.)	Yes	No
Suspended Sediment in TIA (When not frozen)		
Any suspended sediment in Tail Lake?	Yes	No
Water at the Toe of the Downstream Side of the Dam (If yes refer to Doris North – North Dam and Tail Lake Outflow Seepage Monitoring Work Plan 2015)
