**Report Title:** 2011 NIRB's Monitoring Officer Site Visit Report for the Jericho Diamond Mine Project

**Project:** Jericho Diamond Mine  
**Project Location:** Kitikmeot Region, Nunavut

**Visit conducted by:** Sophia Granchinho, Monitoring Officer, Nunavut Impact Review Board  
**Telephone:** (867) 793-4633

**Site visit dates:** August 17 – 19, 2011  
**Last site visit:** July 28 – 29, 2009

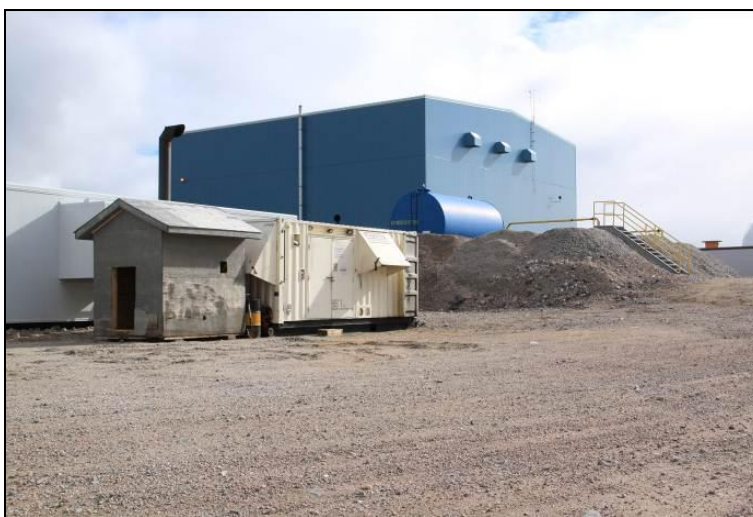
**Photo 2: Camp generator**

This condition was not applicable to the Jericho site at the time of the Monitoring Officer's visit, as the site was in the care and maintenance phase, no mining activities were occurring and only 13 people were on site at the time. The only noticeable sources of noise during the visit were vehicles driving around site and the camp generator (see [Photo 2](#)). In addition, Shear has a 'no idling' policy in place.

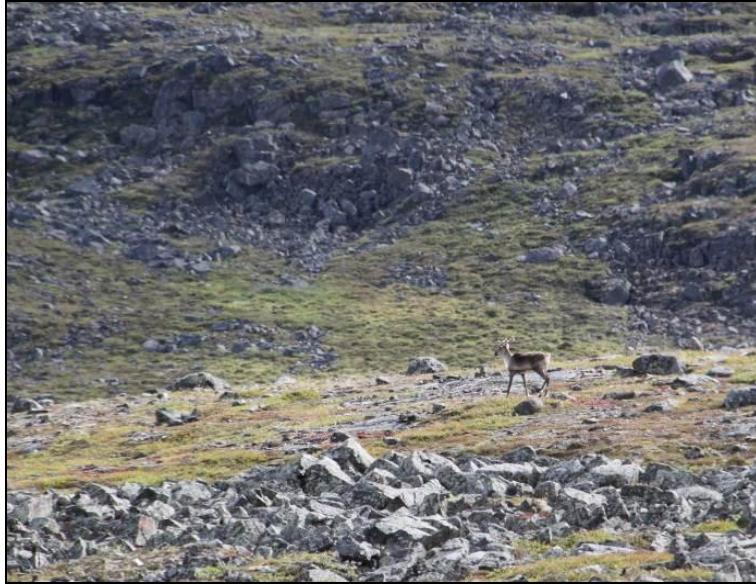
**Photo 3: Caribou sighting near the PKCA**

Wildlife, including caribou, have been observed at Jericho during the care and maintenance phase. During the site visit, the Monitoring Officer observed caribou northeast of the PKCA and caribou tracks in the East Cell of the PKCA (see [Photo 3](#) and [Photo 4](#)). In addition, Arctic hare were observed near the camp kitchen and generator (see [Photo 5](#)).

The Monitoring Officer noted that during the 2011 site visit as well as other previous visits to Jericho, the caribou appeared to have little difficulty climbing onto very steep piles of rock and tailings (see [Photo 3](#), [Photo 4](#) and [Photo 12](#)), although studies have indicated that they tend to prefer roads or eskers<sup>9,10</sup>.

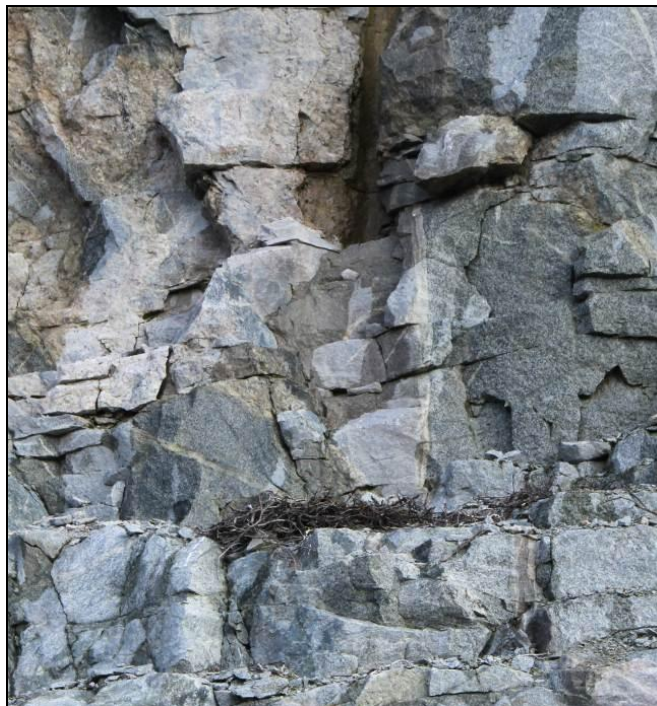
**Photo 6: Old raptor nest on pit wall**

Initial surveys for raptor nests were previously completed and subsequently mapped by Tahera. No new nesting sites have been identified within the project area or within the 500 metre buffer zone. An old raptor nest (potentially Peregrine Falcon) was pointed out to the Monitoring Officer on one of the pit walls (see [Photo 6](#)). This nest was known to site personnel and the area has been made off limits to project staff. The Monitoring Officer did not observe any markers or visible indication that a nest was located within the pit walls.

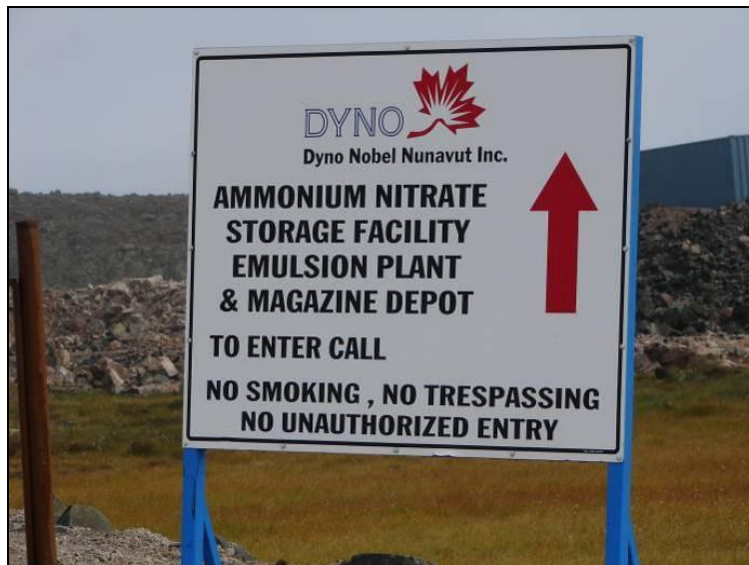
facility at the time of the site visit. The area formerly used to store blasting materials was empty and locked, and remained separate from the camp site (see [Photo 7](#), [Photo 8](#) and [Photo 9](#)).

**Photo 7: Example of signage posted at the entrance to the ammonium nitrate storage and magazine compound (picture taken in 2008)**

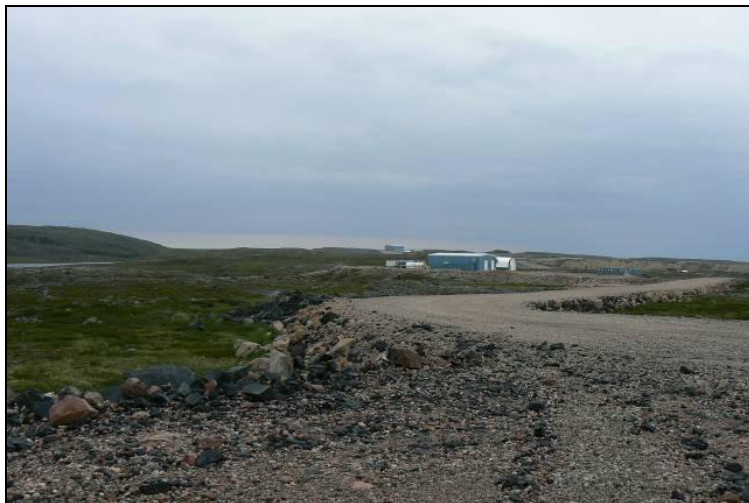
**Photo 8: Emulsion plant from ammonium nitrate storage pad with camp in background (picture taken in 2009)**

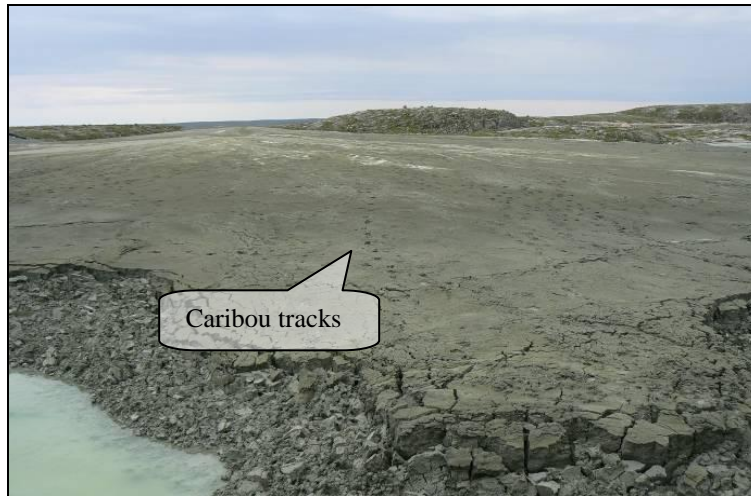
**Photo 12: Caribou tracks on tailings pile (photo taken in 2009)**

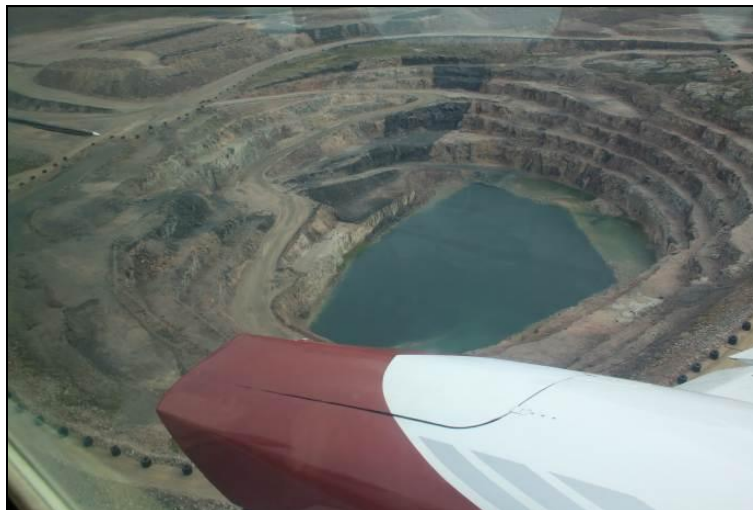
**Photo 15: Aerial view of open pit at Jericho**

At the time of the site visit, the Jericho pit was deemed unsafe, and no access was permitted down into the pit with the exception of personnel conducting dewatering activities, from the pit to the PKCA. When Tahera suspended activities at the Jericho site in January 2008, the open pit naturally filled with water (see [Photo 15](#), [Photo 16](#) and [Photo 17](#)). Shear commenced dewatering activities of the open pit on July 29, 2011, and the pit water was pumped, discharged, and then diluted within the PKCA. This allowed the pit water to be incorporated and discharged as part of the PKCA discharge while still meeting the water licence discharge criteria. Dewatering activities halted within a week and half due to mechanical failure of the pump.

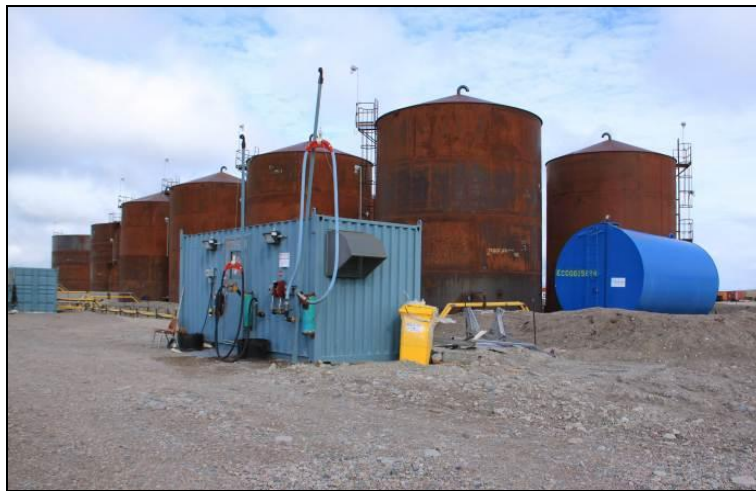
**Photo 18: Fuelling station**

Shear personnel confirmed that all fuel trucks on site were equipped with spill kits, and the Monitoring Officer noted that secondary containment was in place at the fuel transfer station. No large fuel trucks were being used for refuelling at the time of the site visit and all trucks were being refuelled at the main station (see [Photo 18](#)). Spill kits were noted at most fuel storage areas (see [Photo 19](#)).

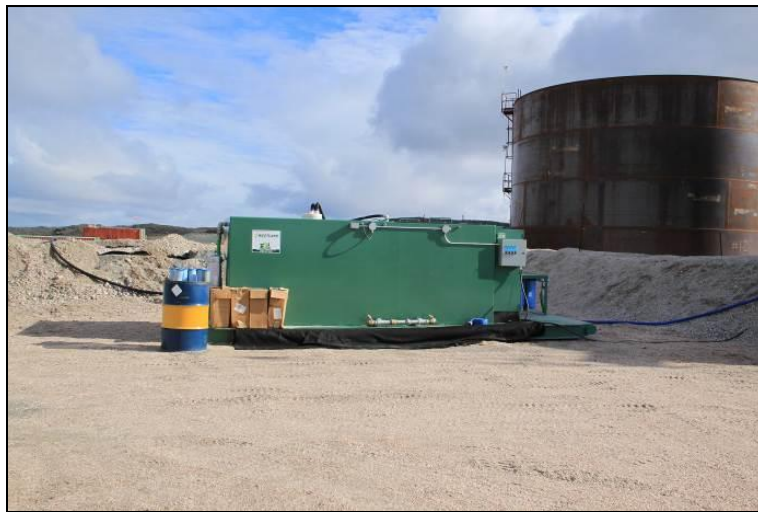
**Photo 22: Water reclamation unit (ozonator)**

hydrocarbon odours were evident at several locations around the site. Pooling of water (standing water) was also evident within several of the fuel bermed areas. Mr. Morton indicated that the standing water within the bermed areas would be pumped to a reclamation unit (ozonator) that then filters the water to remove any hydrocarbons (see [Photo 22](#)) prior to being pumped to a containment unit next to the main fuel tank farm (see [Photo 23](#)). Once the water is tested and confirmed to meet the discharge criteria, it would be discharged into the PKCA (East Cell).

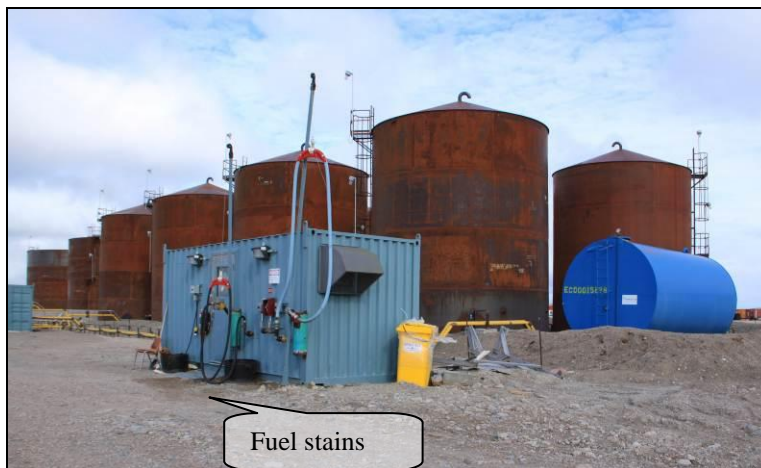
**Photo 26: Fuelling station**

hydrocarbon sheen. Strong hydrocarbon odours were also noted around the fuel tank farm (see [Photo 24](#) through [Photo 27](#)).

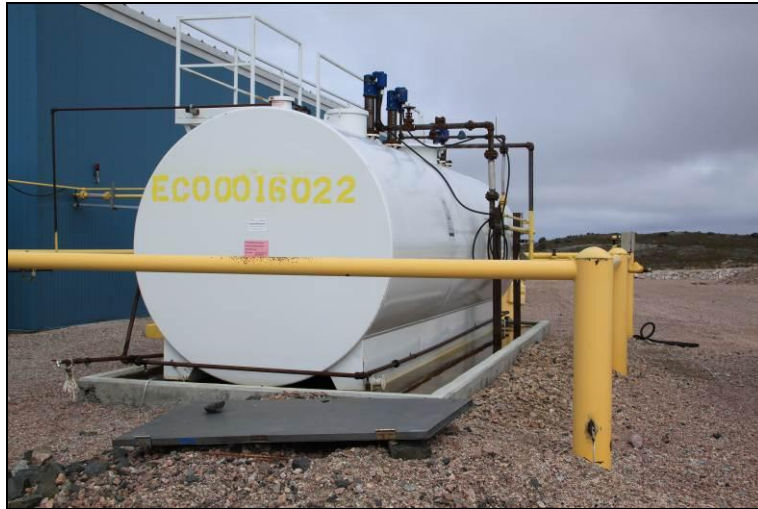
**Photo 35: Emulsion plant fuel tank**

The emulsion plant including the fuel tank is owned and operated by Dyno Noble who is responsible for the maintenance and care of these buildings. Fuel from the fuel tank at the emulsion plant has been emptied out by Shear and any standing water in the bermed fuel tank area is removed to the reclamation unit on an as-need basis. Compared to the 2009 site visit, there were no hydrocarbon odours present and contaminated soil around the fuel tank has been removed (see [Photo 35](#)).

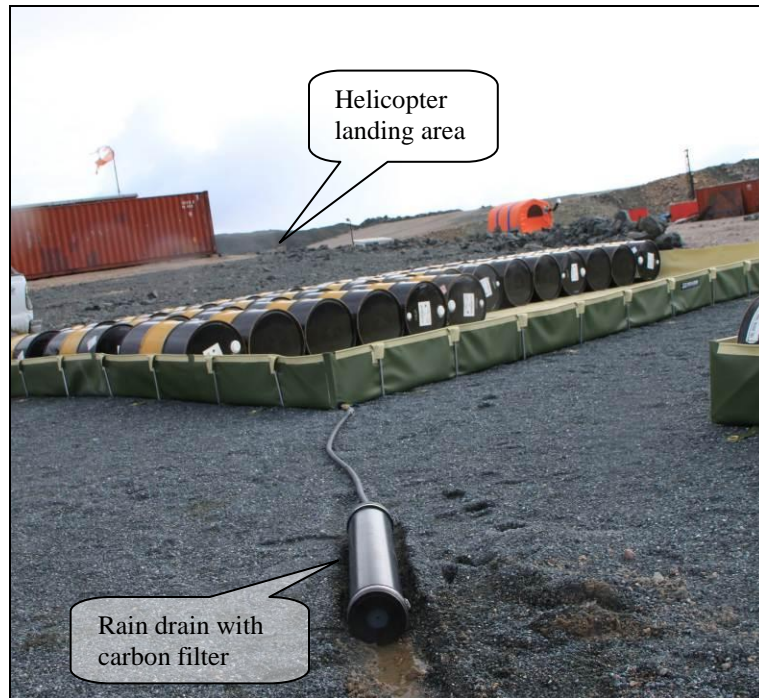
**Photo 37: Fuel drums near helicopter landing area**

Fuel drums were stored near the helicopter landing area within secondary containment berms which was installed on June 16, 2011. Inspections of all fuel containment structures are conducted daily and rain drains are used to filter water (carbon filters) that collects within the berms (see [Photo 37](#)). When fuel is required, fuel barrels are transported to the helicopter landing area.

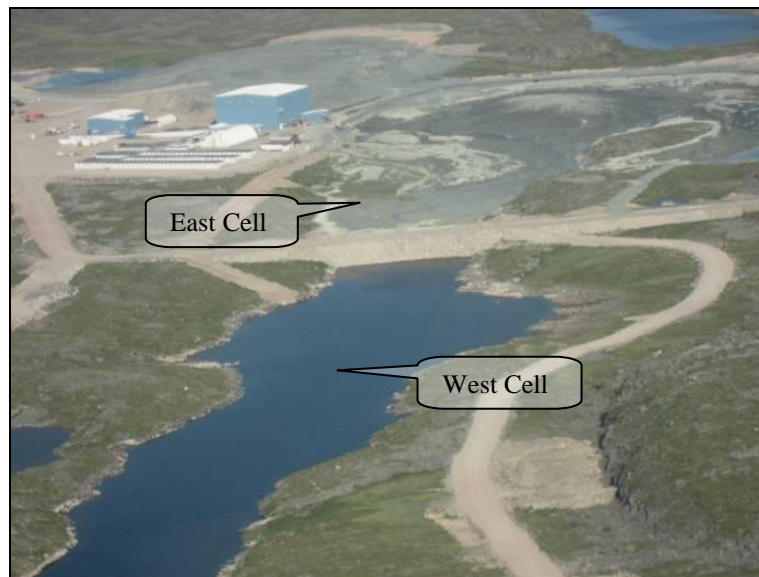
A permeable barrier in the Processed Kimberlite Containment Area (PKCA) divides the area into two containment cells; an East Cell and a West Cell, with only the East Containment Cell having been used for the deposition of tailings material (see [Photo 38](#) through [Photo 40](#)). At the time of the site visit, Shear was discharging water from the West Containment Cell into Stream C3 (see [Photo 41](#)).

**Photo 38: Aerial view of PKCA (photo taken in 2009)**

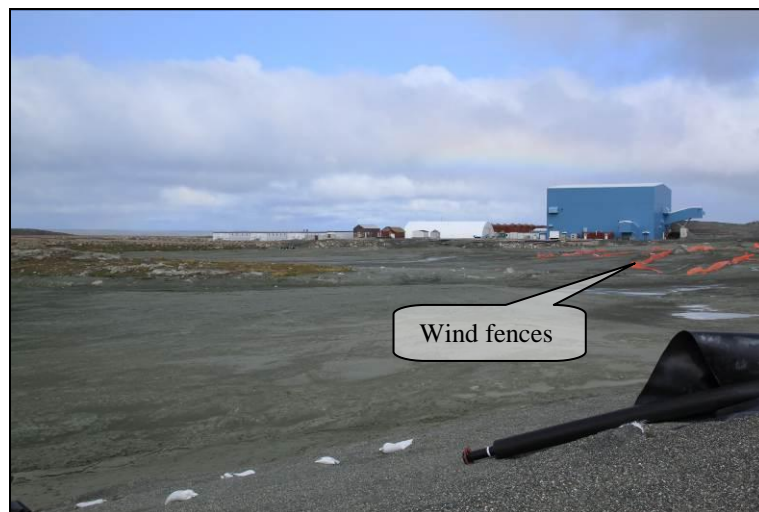
**Photo 39: East Containment Cell (looking downstream with processing plant in the background)**

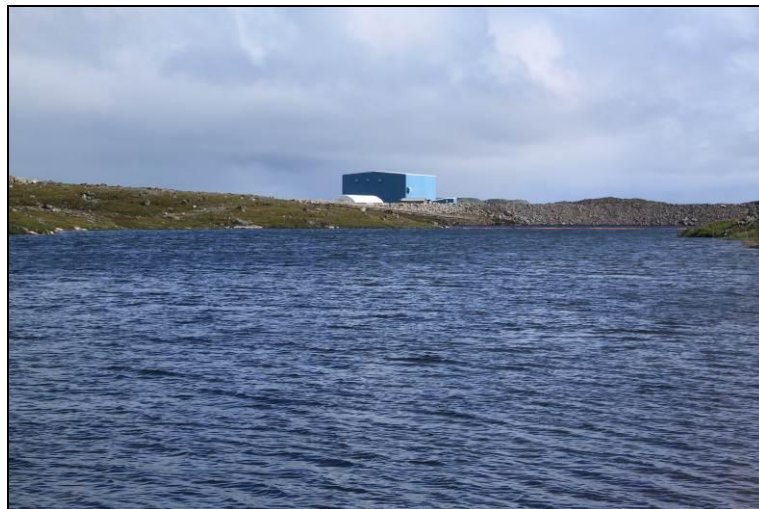
**Photo 40: West Containment Cell (looking upstream with processing plant in the background)**

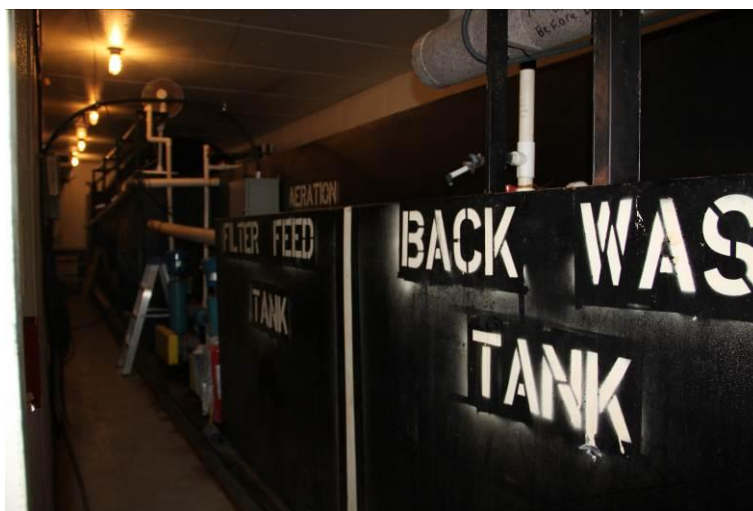
**Photo 43: Inside the sewage treatment plant**

The production of camp sewage has been limited, owing to the small number of staff operating the site while in the care and maintenance phase (see [Photo 43](#)). Once the process plant is up and running, water will be reclaimed as part of Shear's waste management plan. Ammonia and phosphorus levels have been well recorded and are available upon request from Tahera.

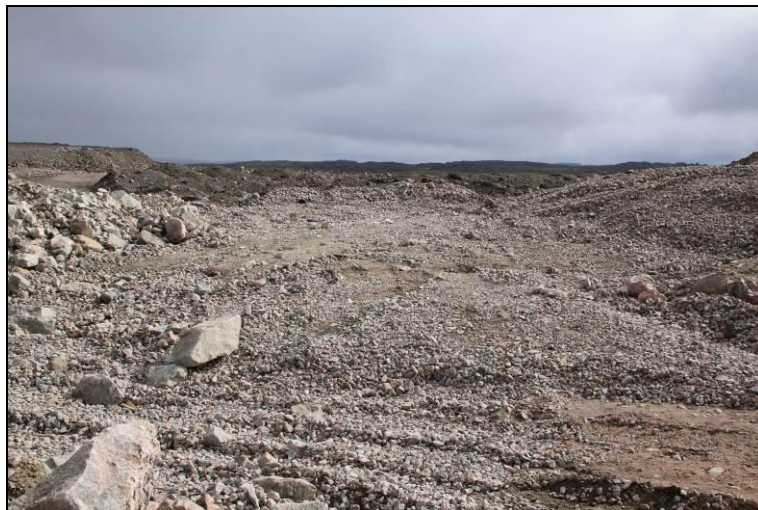
**Photo 45: Landfill in 2011**

During the 2009 site visit, it was noted that the landfill area was not fenced off and that no other wildlife deterrents were apparent (see [Photo 44](#)). During the 2011 site visit, Mr. Morton informed the Monitoring Officer that the landfill had been covered by a 6 inch cover and that the incinerator was relocated closer to the camp site (see [Photo 45](#)). A new landfill will be developed once the landfill management plan has been approved by the Nunavut Water Board. All approved waste for incineration will be stored in a fenced area prior to incineration and the ash from the incinerator will be captured in drums, sealed and stored in seacans until the new
