**Report Title:** 2011 NIRB's Monitoring Officer Site Visit Report for the Jericho Diamond Mine Project

**Project:** Jericho Diamond Mine  
**Project Location:** Kitikmeot Region, Nunavut

**Visit conducted by:** Sophia Granchinho, Monitoring Officer, Nunavut Impact Review Board  
**Telephone:** (867) 793-4633

**Site visit dates:** August 17 – 19, 2011  
**Last site visit:** July 28 – 29, 2009

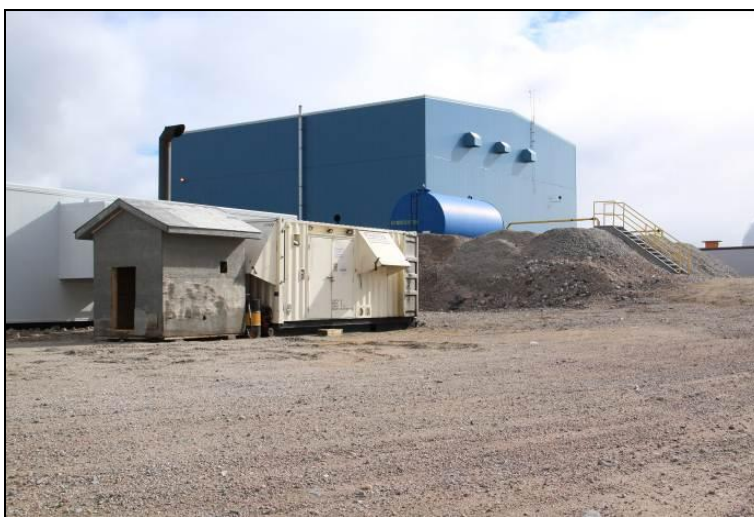
This condition was not applicable to the Jericho site at the time of the Monitoring Officer's visit, as the site was in the care and maintenance phase, no mining activities were occurring and only 13 people were on site at the time. The only noticeable sources of noise during the visit were vehicles driving around site and the camp generator (see [Photo 2](#)). In addition, Shear has a 'no idling' policy in place.

**Photo 2: Camp generator**

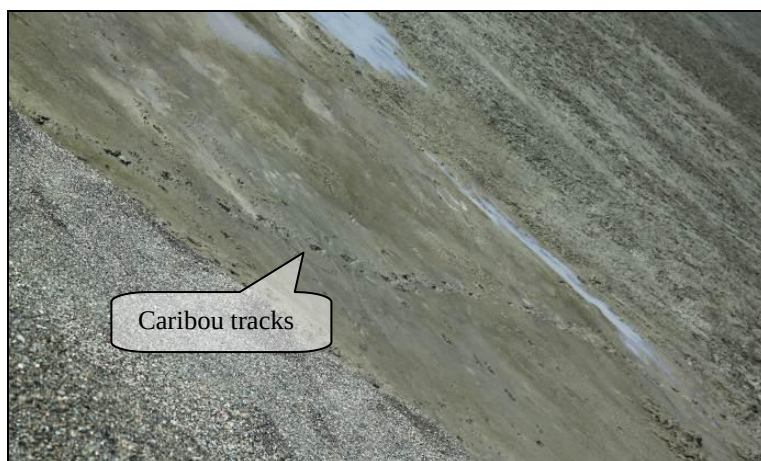
Wildlife, including caribou, have been observed at Jericho during the care and maintenance phase. During the site visit, the Monitoring Officer observed caribou northeast of the PKCA and caribou tracks in the East Cell of the PKCA (see [Photo 3](#) and [Photo 4](#)). In addition, Arctic hare were observed near the camp kitchen and generator (see [Photo 5](#)).

**Photo 4: Caribou tracks on dried tailings within PKCA**

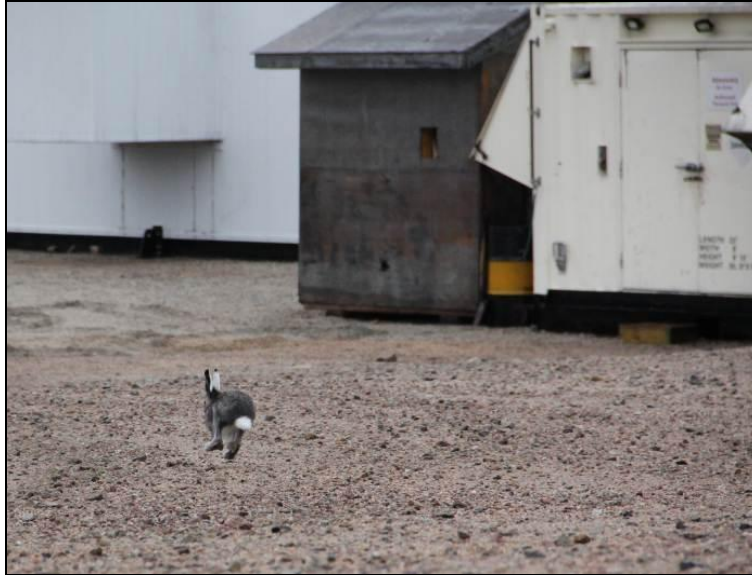
**Photo 5: Arctic hare sighting near generator shack**

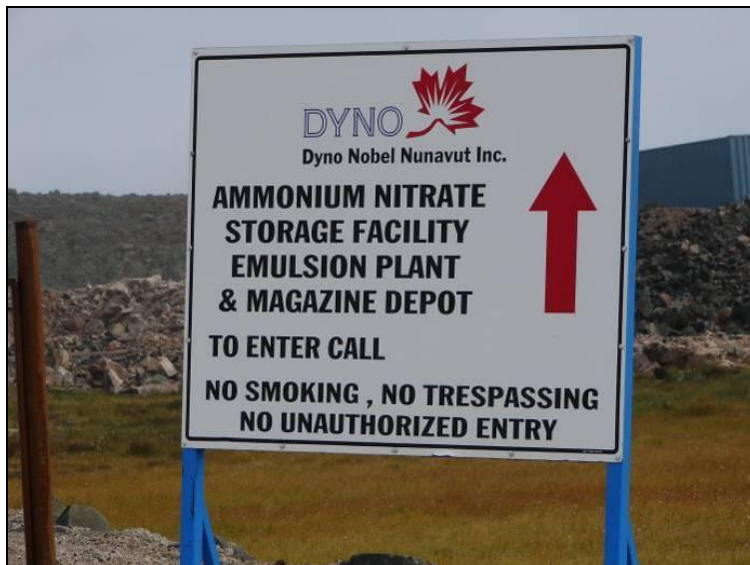
facility at the time of the site visit. The area formerly used to store blasting materials was empty and locked, and remained separate from the camp site (see [Photo 7](#), [Photo 8](#) and [Photo 9](#)).

**Photo 7: Example of signage posted at the entrance to the ammonium nitrate storage and magazine compound (picture taken in 2008)**

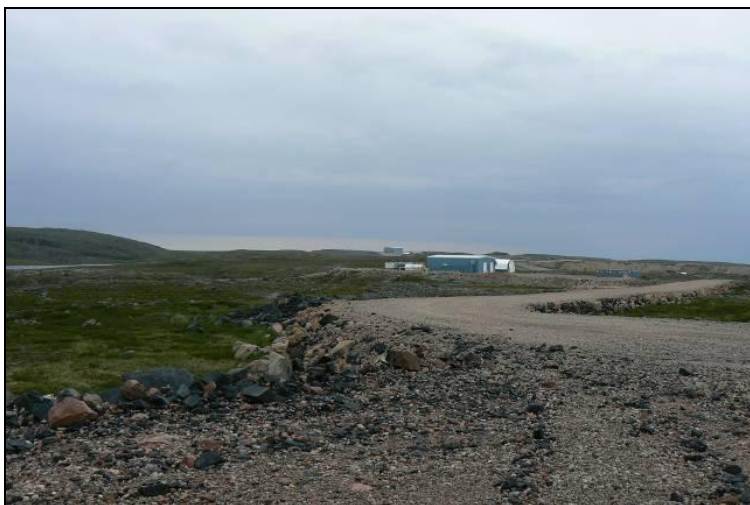
**Photo 8: Emulsion plant from ammonium nitrate storage pad with camp in background (picture taken in 2009)**

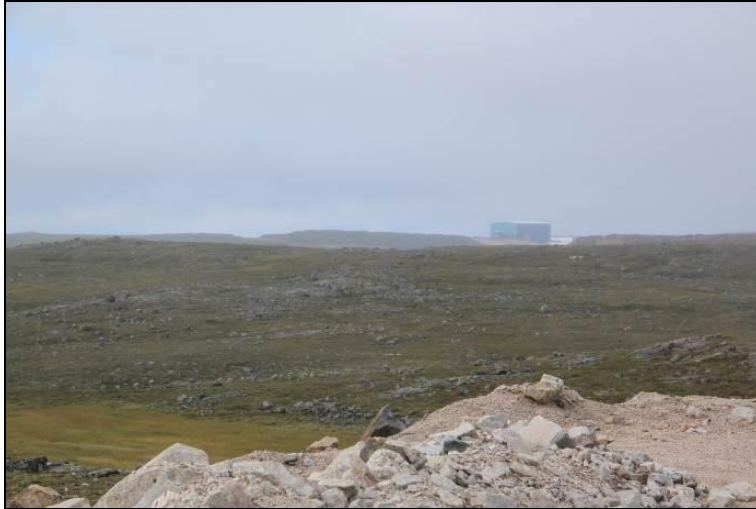
**Photo 9: Processing plant from emulsion plant**

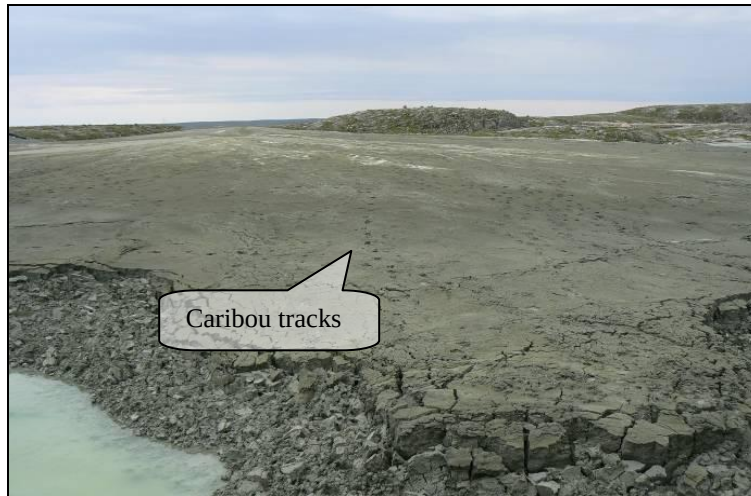
The Monitoring Officer noted that during the 2011 site visit as well as other previous visits to Jericho, the caribou appeared to have little difficulty climbing onto very steep piles of rock and tailings (see [Photo 3](#), [Photo 4](#) and [Photo 12](#)), although studies have indicated that they tend to prefer roads or eskers<sup>9,10</sup>.

**Photo 12: Caribou tracks on tailings pile (photo taken in 2009)**

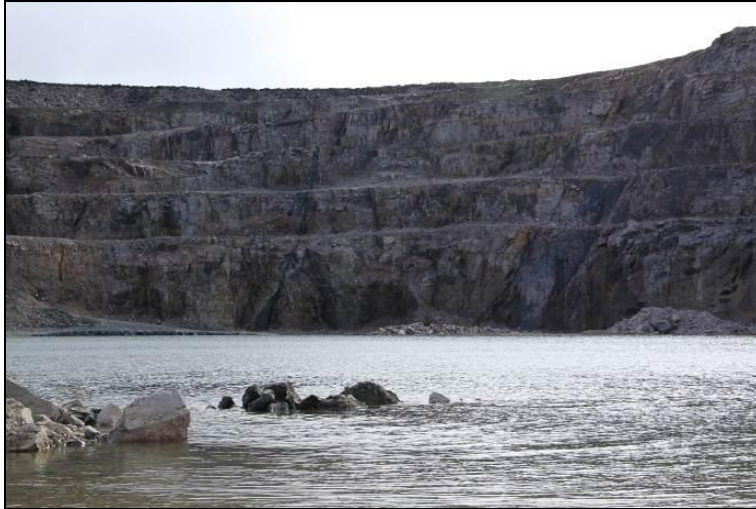
At the time of the site visit, the Jericho pit was deemed unsafe, and no access was permitted down into the pit with the exception of personnel conducting dewatering activities, from the pit to the PKCA. When Tahera suspended activities at the Jericho site in January 2008, the open pit naturally filled with water (see [Photo 15](#), [Photo 16](#) and [Photo 17](#)). Shear commenced dewatering activities of the open pit on July 29, 2011, and the pit water was pumped, discharged, and then diluted within the PKCA. This allowed the pit water to be incorporated and discharged as part of the PKCA discharge while still meeting the water licence discharge criteria. Dewatering activities halted within a week and half due to mechanical failure of the pump.

**Photo 16: Open pit at Jericho**

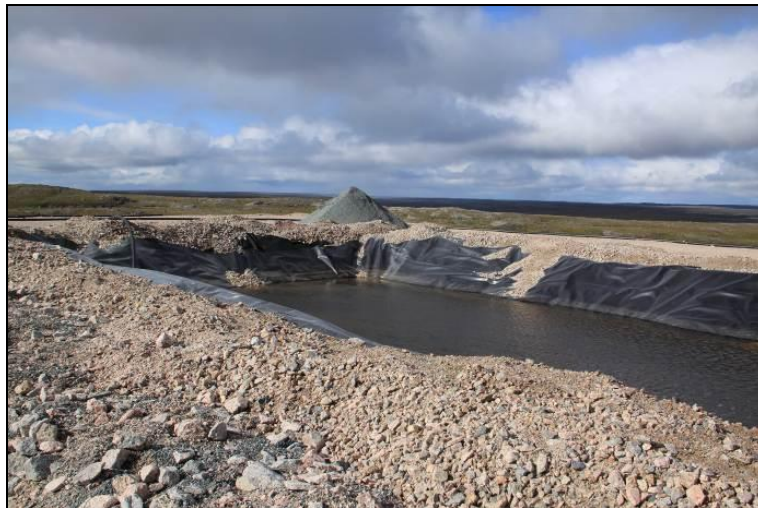
hydrocarbon odours were evident at several locations around the site. Pooling of water (standing water) was also evident within several of the fuel bermed areas. Mr. Morton indicated that the standing water within the bermed areas would be pumped to a reclamation unit (ozonator) that then filters the water to remove any hydrocarbons (see [Photo 22](#)) prior to being pumped to a containment unit next to the main fuel tank farm (see [Photo 23](#)). Once the water is tested and confirmed to meet the discharge criteria, it would be discharged into the PKCA (East Cell).

**Photo 23: Filtered water after going through the reclamation unit**

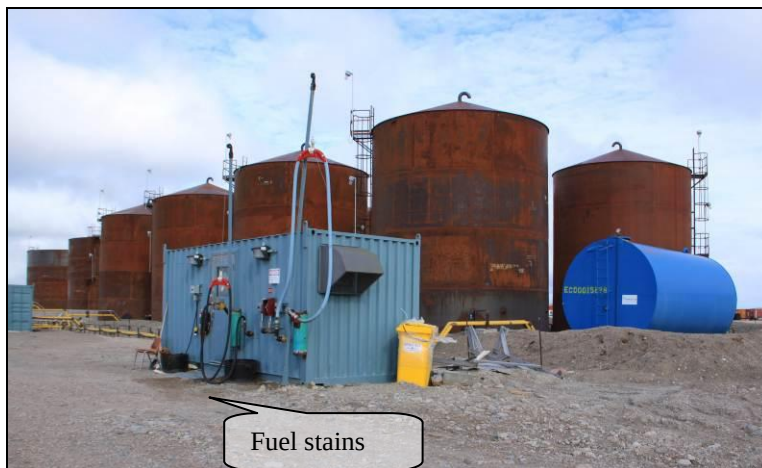
**Photo 26: Fuelling station**

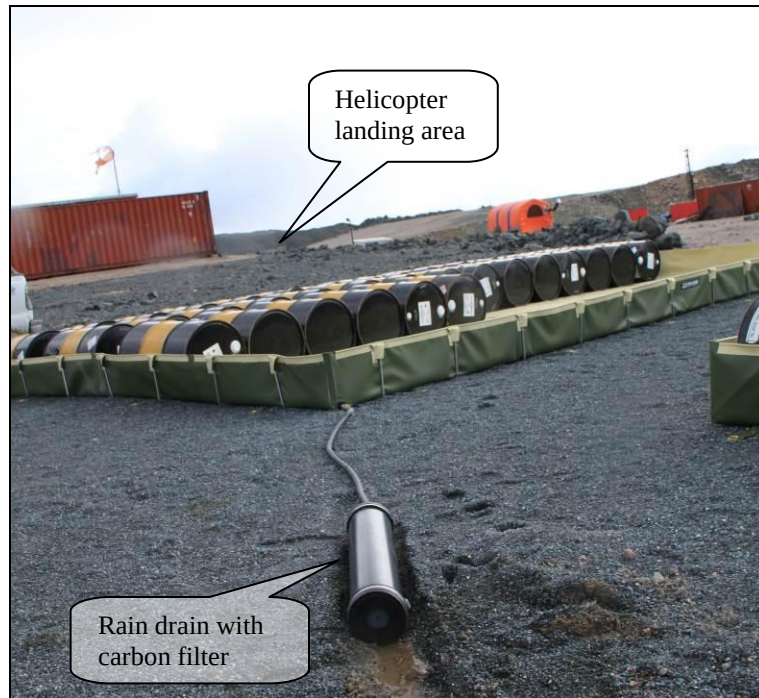
Fuel drums were stored near the helicopter landing area within secondary containment berms which was installed on June 16, 2011. Inspections of all fuel containment structures are conducted daily and rain drains are used to filter water (carbon filters) that collects within the berms (see [Photo 37](#)). When fuel is required, fuel barrels are transported to the helicopter landing area.

**Photo 37: Fuel drums near helicopter landing area**

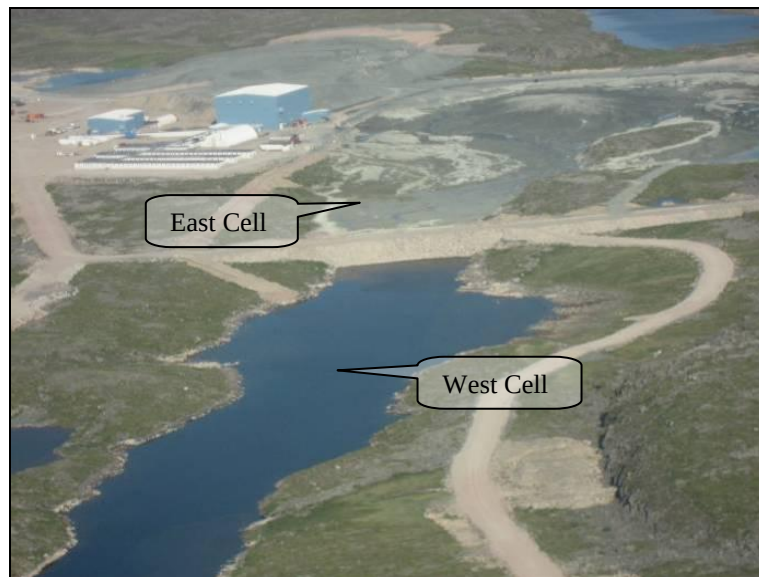
A permeable barrier in the Processed Kimberlite Containment Area (PKCA) divides the area into two containment cells; an East Cell and a West Cell, with only the East Containment Cell having been used for the deposition of tailings material (see [Photo 38](#) through [Photo 40](#)). At the time of the site visit, Shear was discharging water from the West Containment Cell into Stream C3 (see [Photo 41](#)).

**Photo 38: Aerial view of PKCA (photo taken in 2009)**

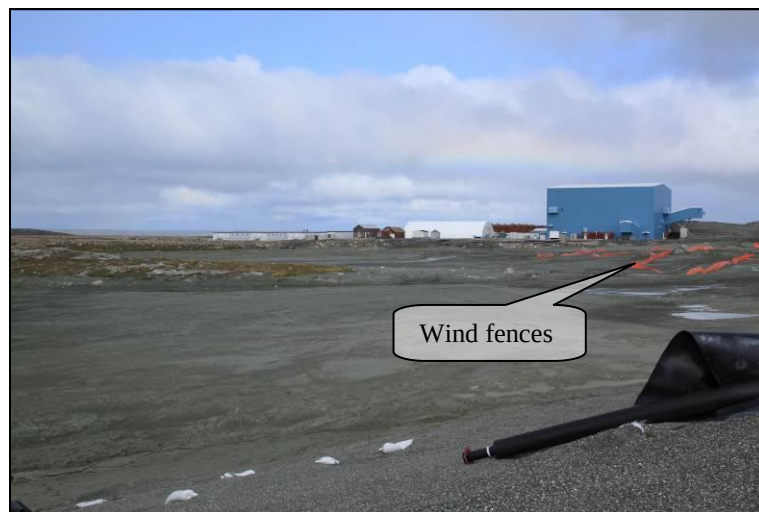
**Photo 39: East Containment Cell (looking downstream with processing plant in the background)**

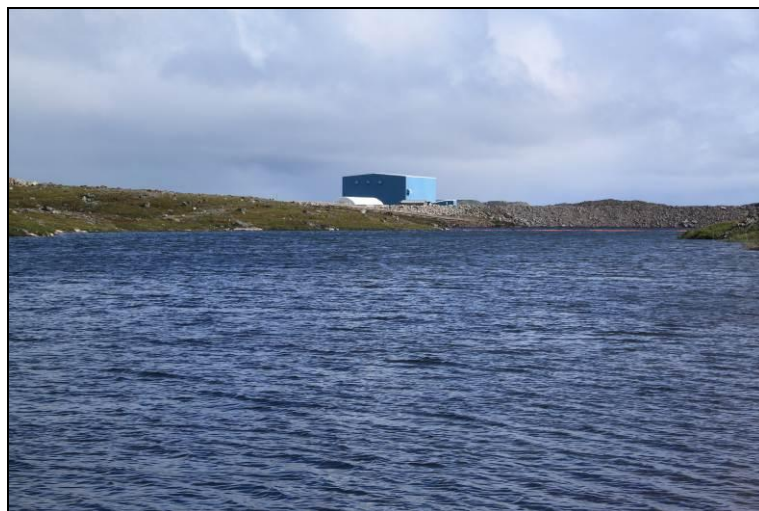
**Photo 40: West Containment Cell (looking upstream with processing plant in the background)**

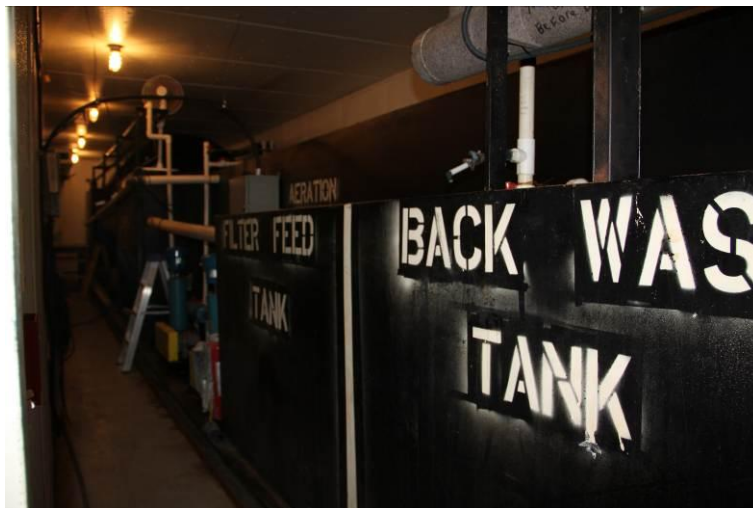
The production of camp sewage has been limited, owing to the small number of staff operating the site while in the care and maintenance phase (see [Photo 43](#)). Once the process plant is up and running, water will be reclaimed as part of Shear's waste management plan. Ammonia and phosphorus levels have been well recorded and are available upon request from Tahera.

**Photo 43: Inside the sewage treatment plant**

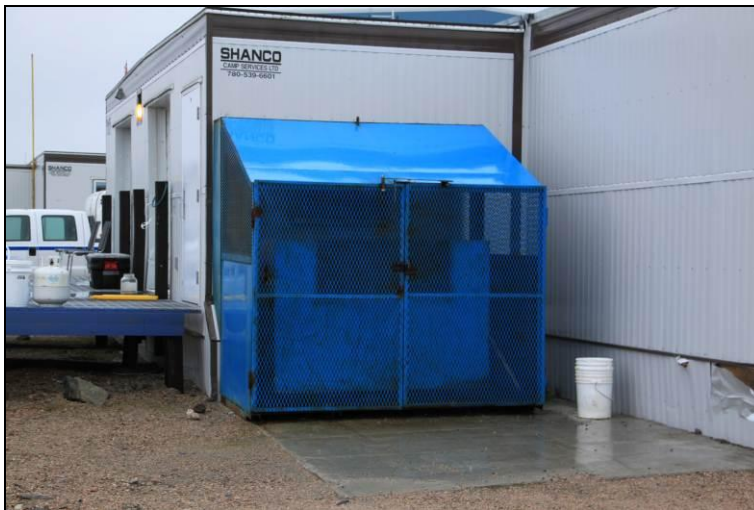
During the 2009 site visit, it was noted that the landfill area was not fenced off and that no other wildlife deterrents were apparent (see [Photo 44](#)). During the 2011 site visit, Mr. Morton informed the Monitoring Officer that the landfill had been covered by a 6 inch cover and that the incinerator was relocated closer to the camp site (see [Photo 45](#)). A new landfill will be developed once the landfill management plan has been approved by the Nunavut Water Board. All approved waste for incineration will be stored in a fenced area prior to incineration and the ash from the incinerator will be captured in drums, sealed and stored in seacans until the new

landfill has been approved (see [Photo 46](#)). All other waste materials will be segregated and disposed of at an approved facility or recycled.

**Photo 46: Example of waste management**
