# **Fish Habitat Compensation Work at The Jericho Diamond Mine, Nunavut Territory Construction and Monitoring of Eight Rock Shoals in 2007**

EBA Engineering Consultants Ltd.

E12101016

**July 2007**

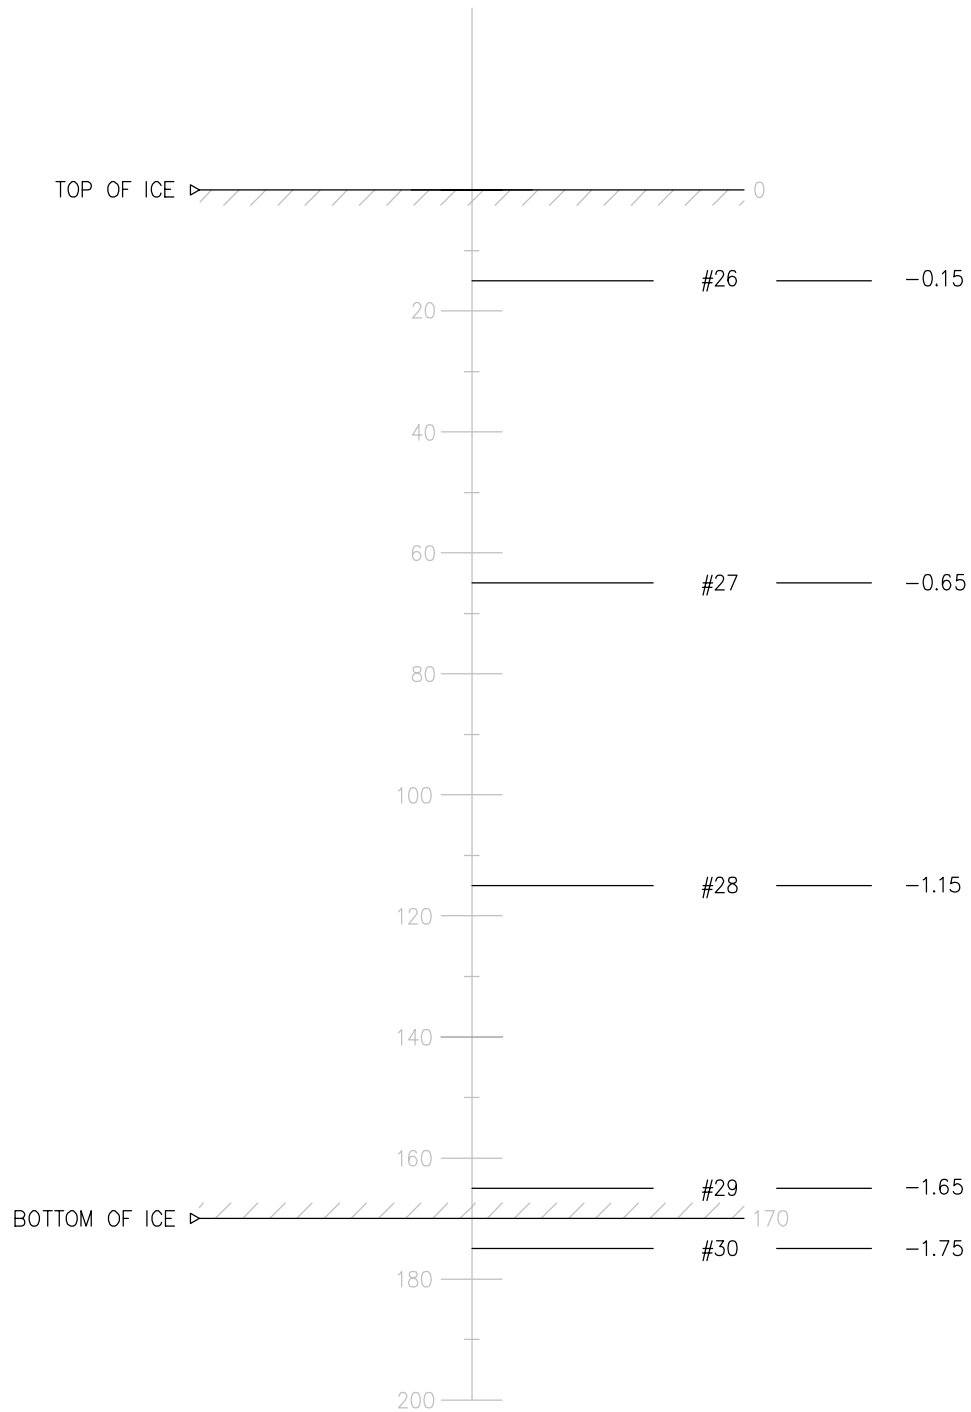
# CROSS-SECTION OF ICE COVER

ICE THICKNESS  $H = 1.70\text{m}$   
 FREEBOARD,  $FB = 0.15\text{m}$   
 WATER DEPTH  $W = 2.45\text{m}$   
 INSTALLED: 25th of March, 2007 @ 10:15am

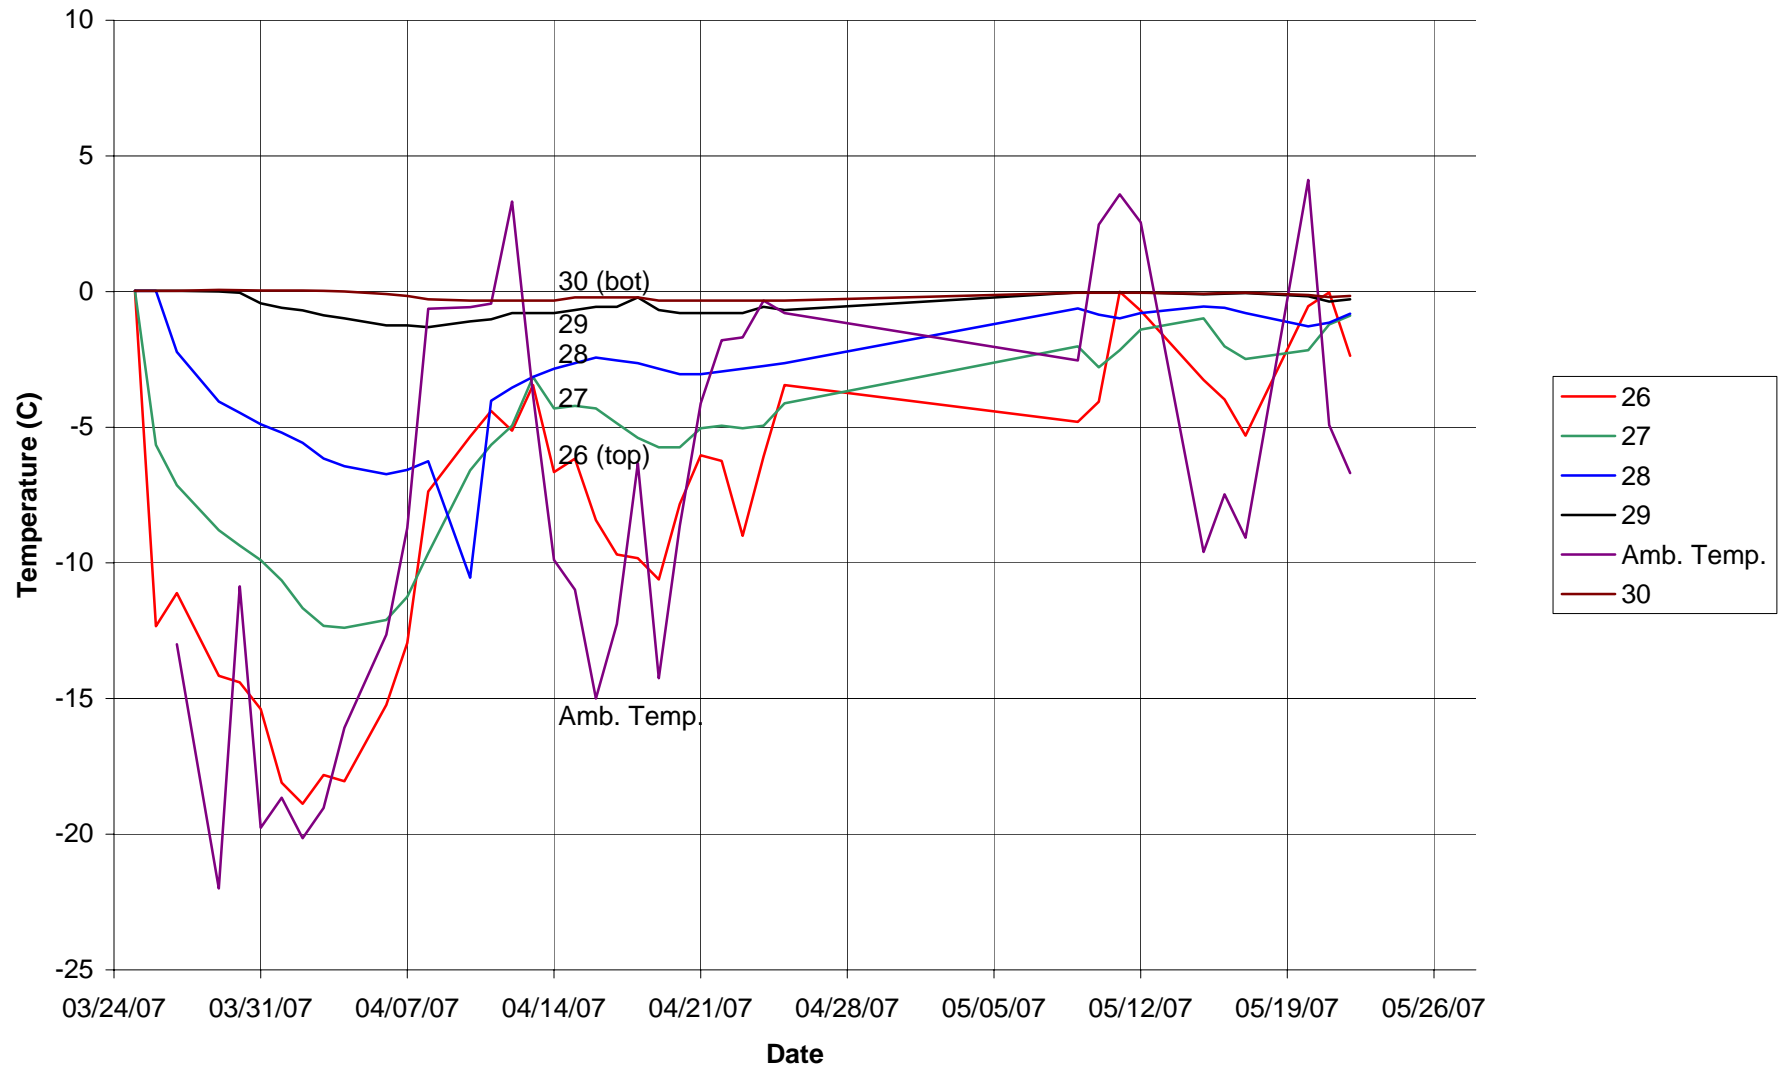
**Fig.4:Temperature Readings - Jericho 2007**

The strength of the ice cover is related to its temperature profile. Temperature profiles within the ice cover were collected to monitor the change in ice strength due to warming of ice cover. Ice cover temperature was monitored by mounting temperature calibrated thermistors on a 2x4 as shown in Photo 18, and freezing the assembly in a previously drilled hole into the ice. Cables and plugs for resistance measurements were mounted at the end of the post as can be seen in Photo 19. The location of the thermistors in relation to the ice thickness is shown on Figure 3. The corresponding temperature readings are plotted on Figure 4.

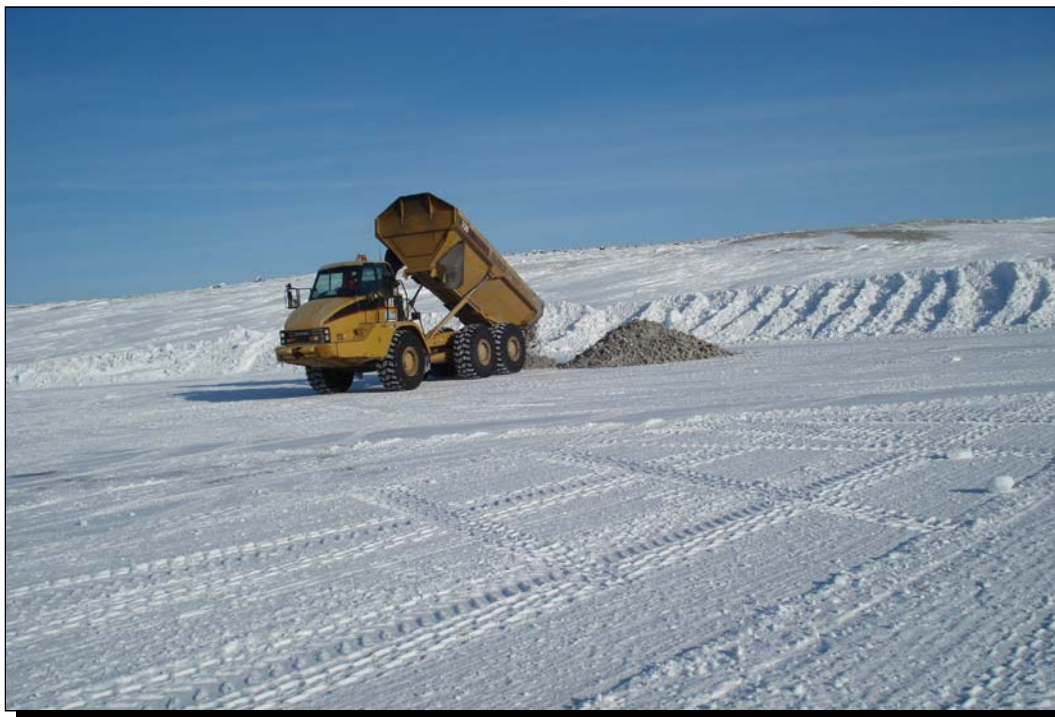
**Photo 1**  
Carat Lake – Dumping six inch crush material on shore fast ice.

After a shoal location was cleared of snow and measurements of the ice and water depth measurements were taken, the first step to shoal construction was the placement of 150 mm Maximum Size crush material (see Photo 1) on the ice within the shoal area. This protective layer was used to minimize damage of the ice and avoid brittle failure during placement of the ROM material with boulders of up to 2 m diameter.

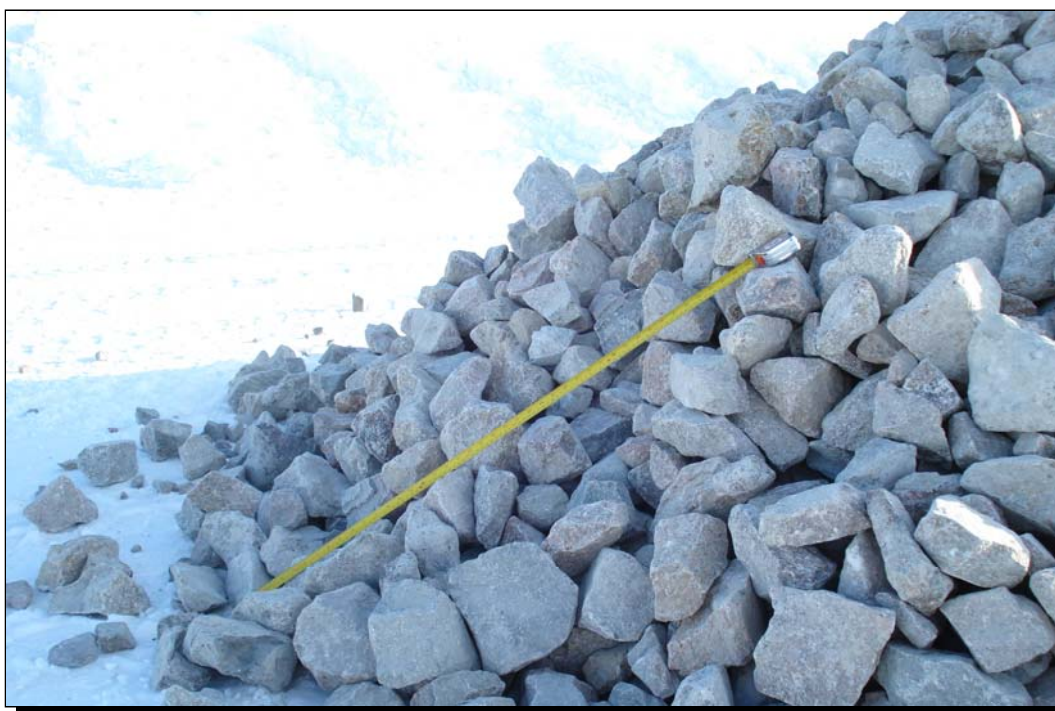
**Photo 2**  
Carat Lake – Typical six inch crush material.

Initially, the six shoals on Carat Lake were built by dumping a protective layer of 150 mm Maximum Size crush material on shore fast ice (see Photo 2), picking it up with the loader and distributing it over the shoal area as shown in Photo 3. On Lake O1, trucks dumped the material directly on the floating ice and the grader distributed it over the shoal area.

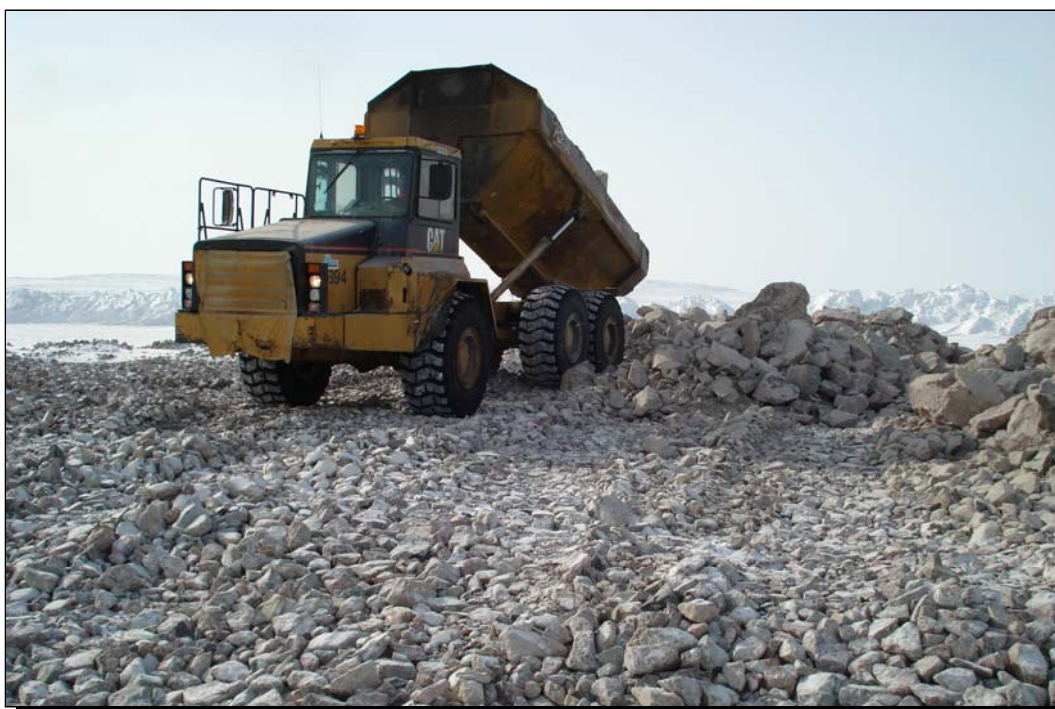
**Photo 4**  
Carat Lake – Dumping rock (ROM) on six inch crush material.

Dumping the ROM material (see Photo 4), however, resulted in the application of heavy concentrated loads on the ice. These loads and the superposition effects of these loads were assessed. Due to safety considerations, a gap of ROM material at the centre of the Carat Lake shoals can be seen in Photo 5.

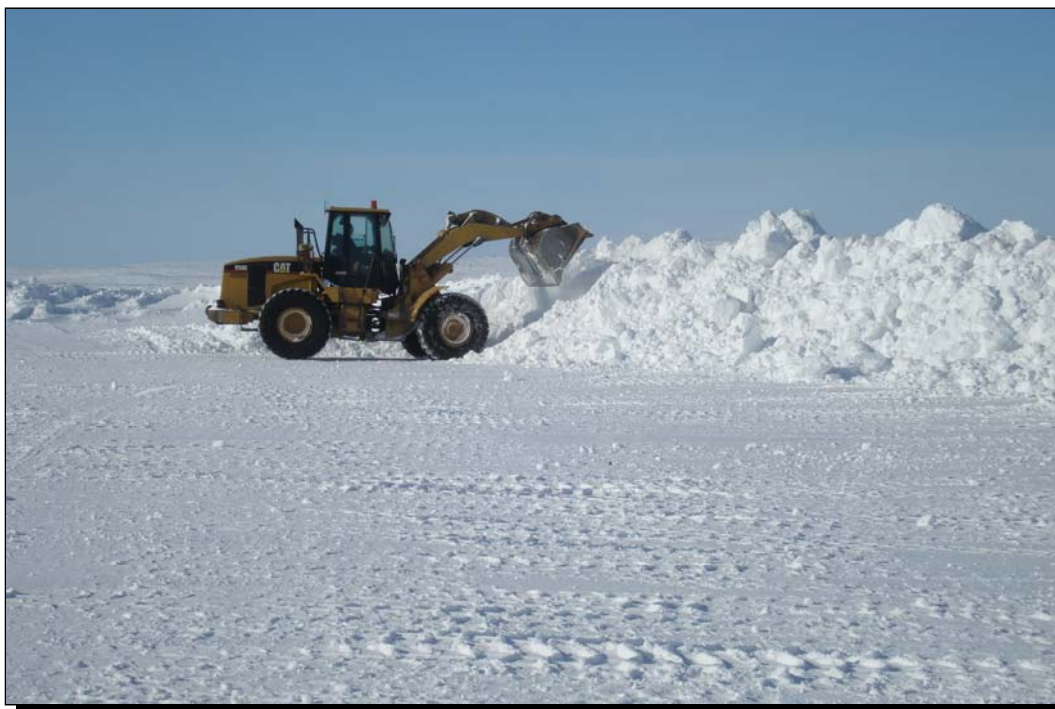
**Photo 7**

Carat Lake – Loader cleans snow north of Shoal #1 and Shoal #2, March 22, 2007.

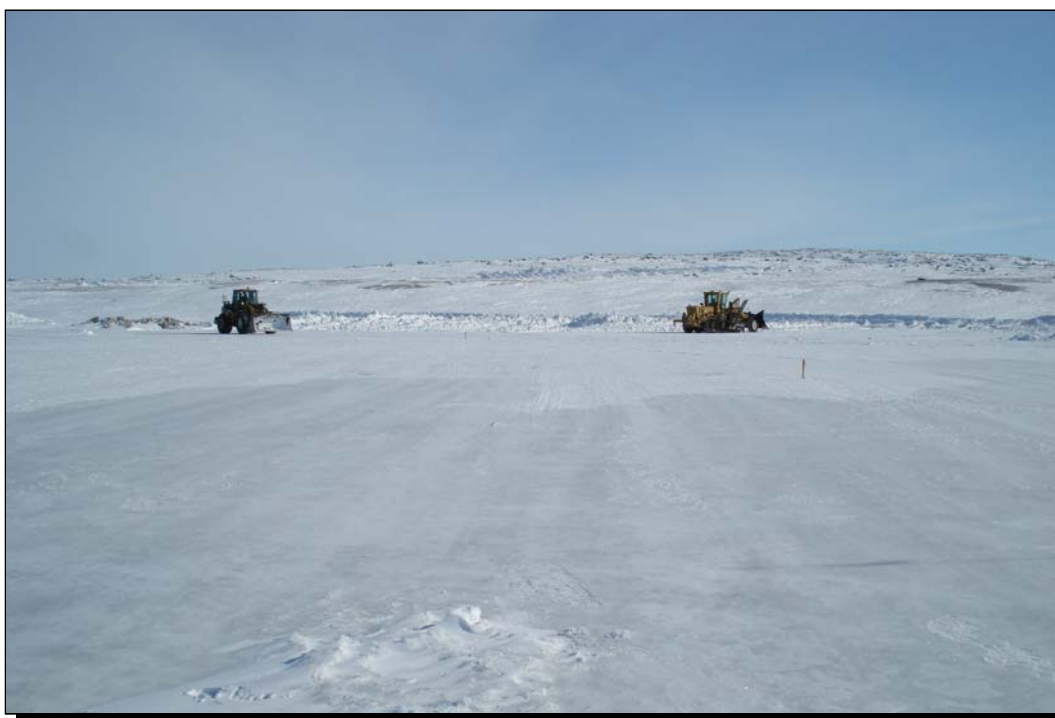
**Photo 8**

Carat Lake – Loader and grader removing large amounts of snow around Shoal #3, March 22, 2007.

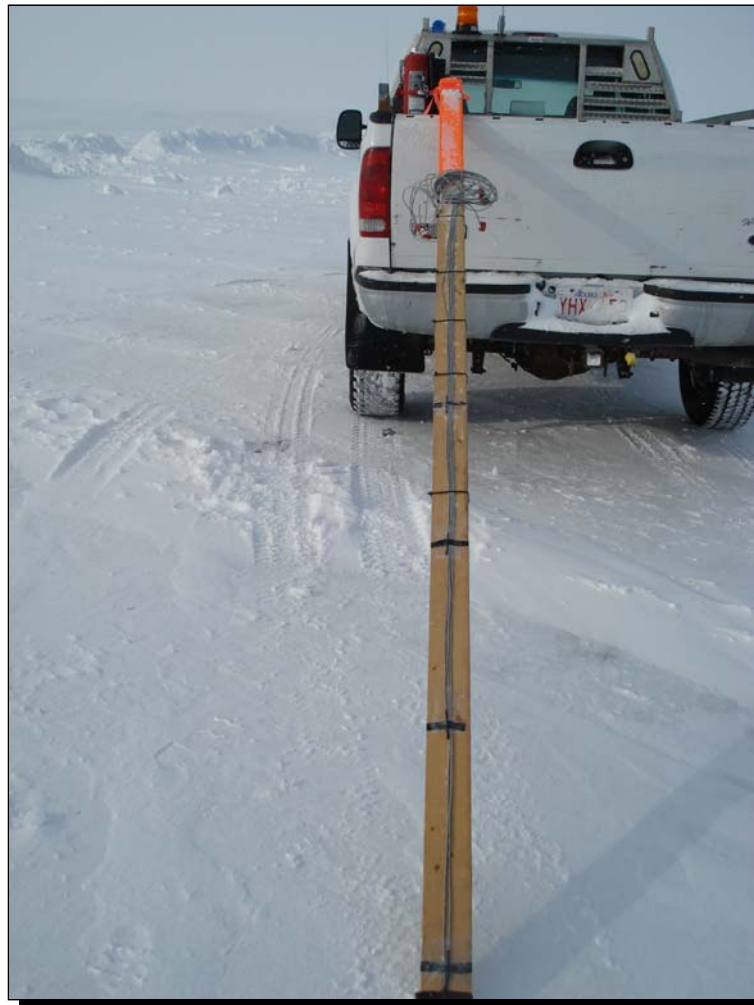
**Photo 18**

Carat Lake – Six thermistors and cables are attached to a 2 x 4 ready for installation.

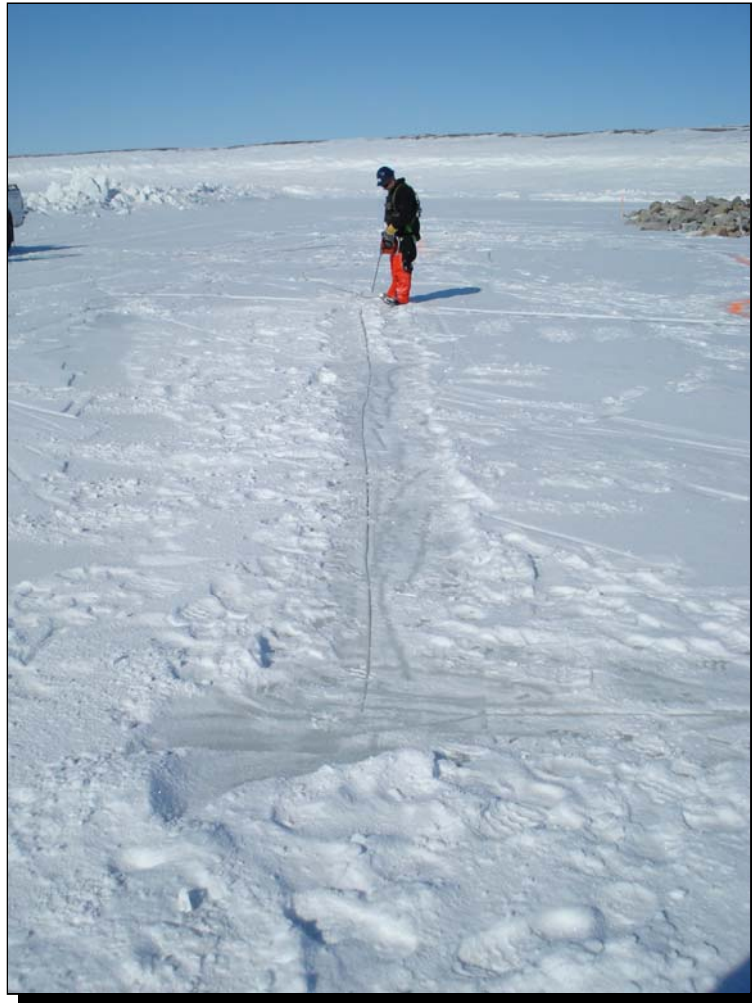
**Photo 20**

Carat Lake – Cutting ice with chain saw to weaken ice cover, April 17, 2007.

As shown in Photo 20, the ice was cut with a chainsaw, equipped with a 1 m long blade. Cuttings from the slot were removed and the slot was covered with gravel to prevent it from refreezing and from filling it with blowing snow.

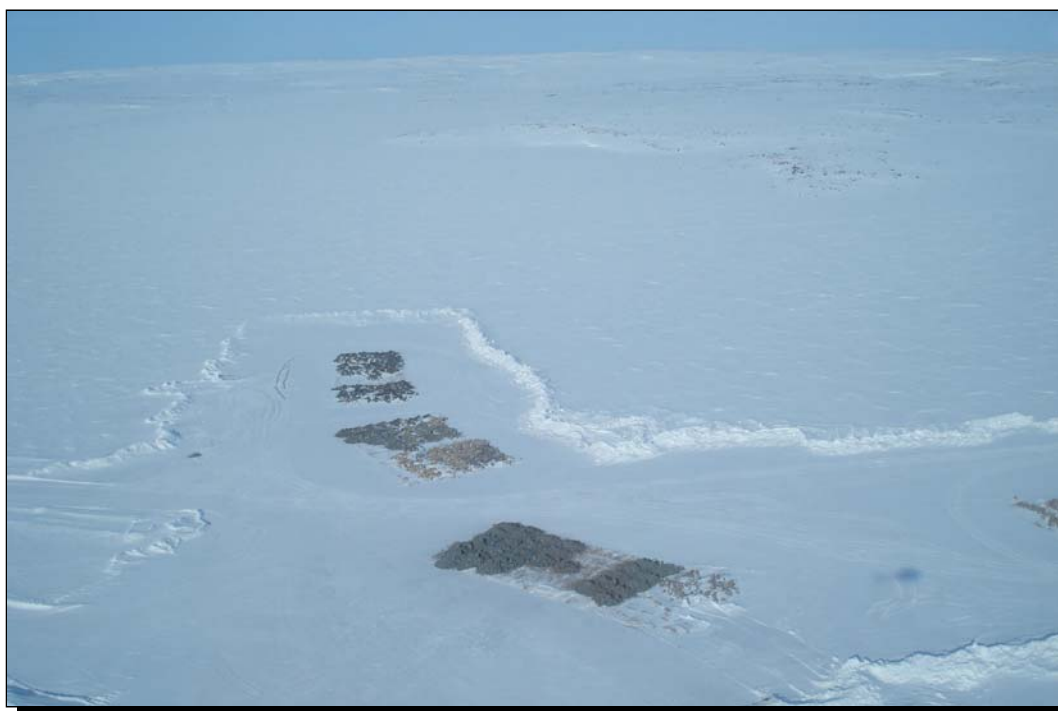
**Photo 22**

Carat Lake – Aerial photo of Shoal #1 to Shoal #3 on April 18, 2007. Taken east of Shoal #3, April 18, 2007.

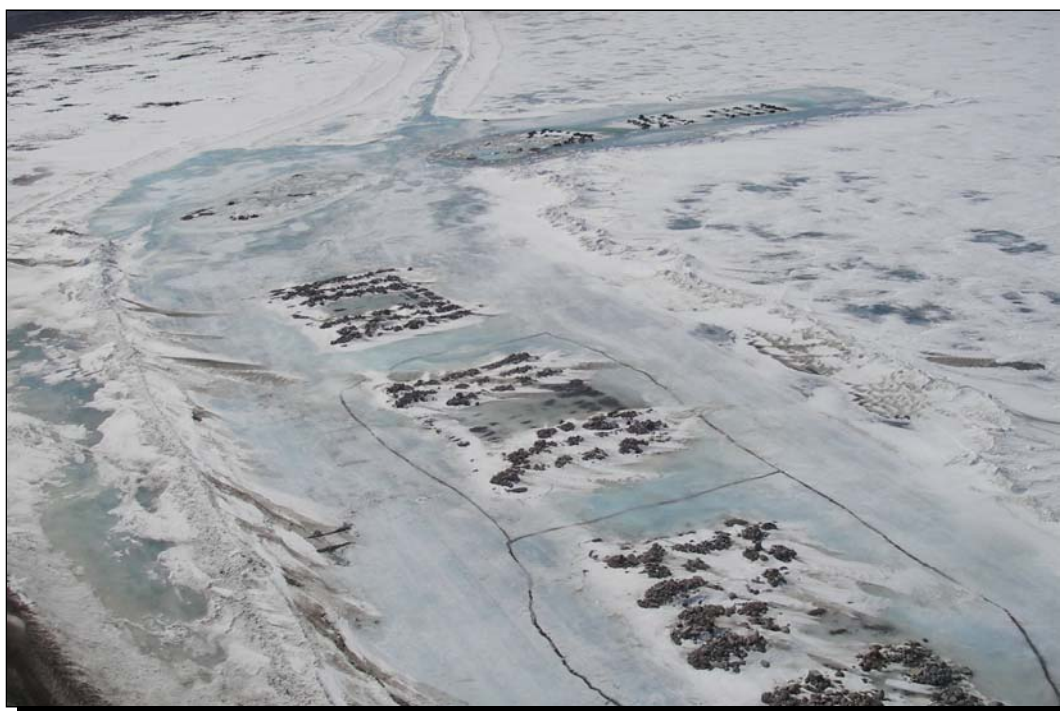
**Photo 28**

Carat Lake – Shoal #1 to Shoal #6, May 25, 2007.

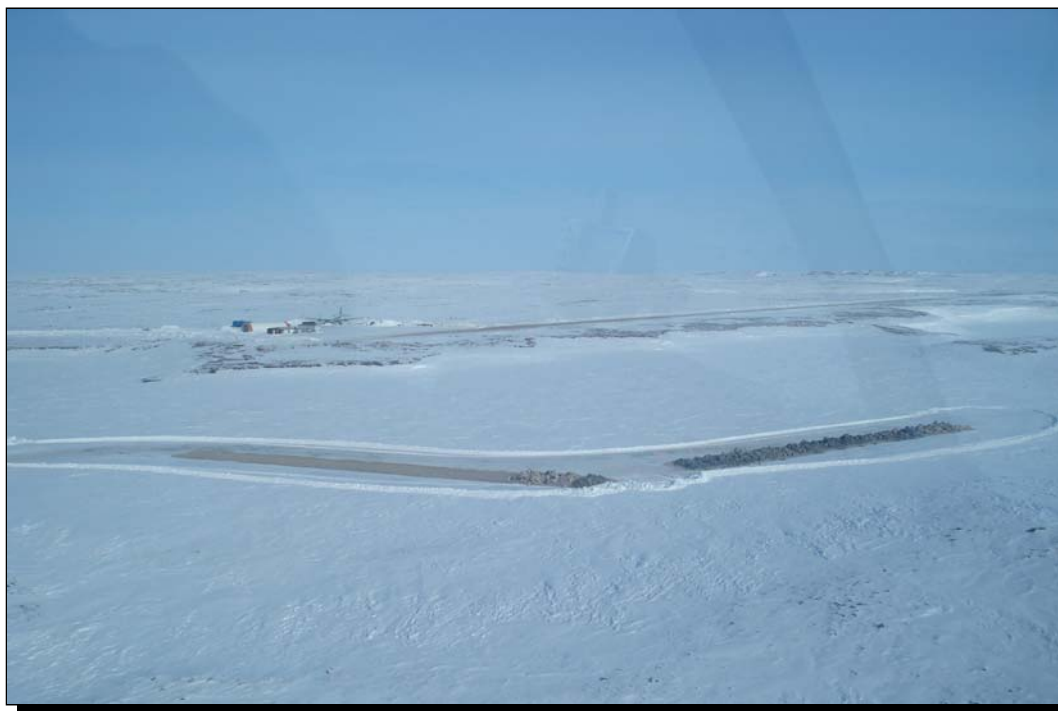
**Photo 29**

Lake O1 – Aerial view of completed Shoal #1 and Shoal #2 under construction, April 18, 2007.
