TYPE A WATER LICENSE

2AM-JER1119

Jericho Diamond Mine

Monthly Report

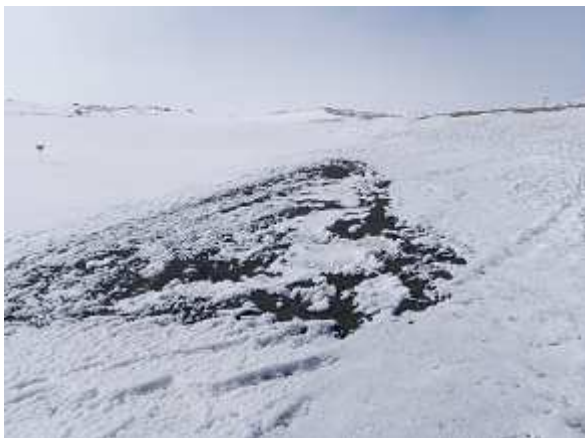
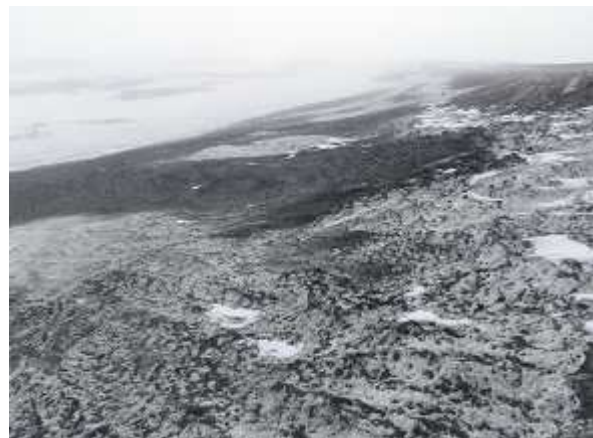
Photo 5

Tire Wall Inspection	A	Tire wall has a large buildup of snow.
FPK (contained within PKCA)	U	FPK should be saturated to mitigate dispersion.
Inspect tundra surrounding dams	U	Shows up on down slopes facing away from the dams. Evidence of FPK as far as 200m past SE dam. Now that snow is starting to melt the black FPK is becoming more and more visible. (Photo 5)

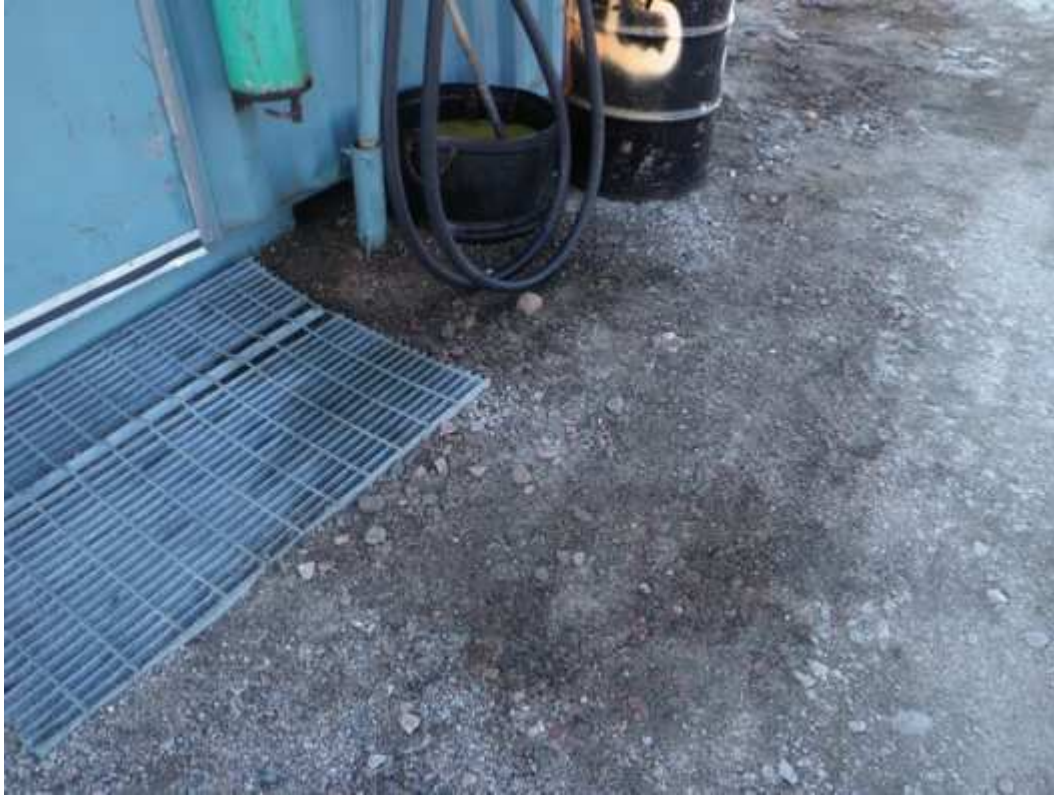
Tank farm	U	Fuel present on the ground. Contaminated snow stored in phase II has all been drummed. There is a lot of oil contaminated water in phase II and diesel contaminated water in phase I. Phase II will need to be smoothed out (Photo 4)
Reclaim Area	A	No issues present.
Vehicle fueling station	A	Spills are frequent here, may be a good idea to get some secondary containment for underneath fuel nozzles. (Photo 5)

Photo 4 – Phase II following the clean up

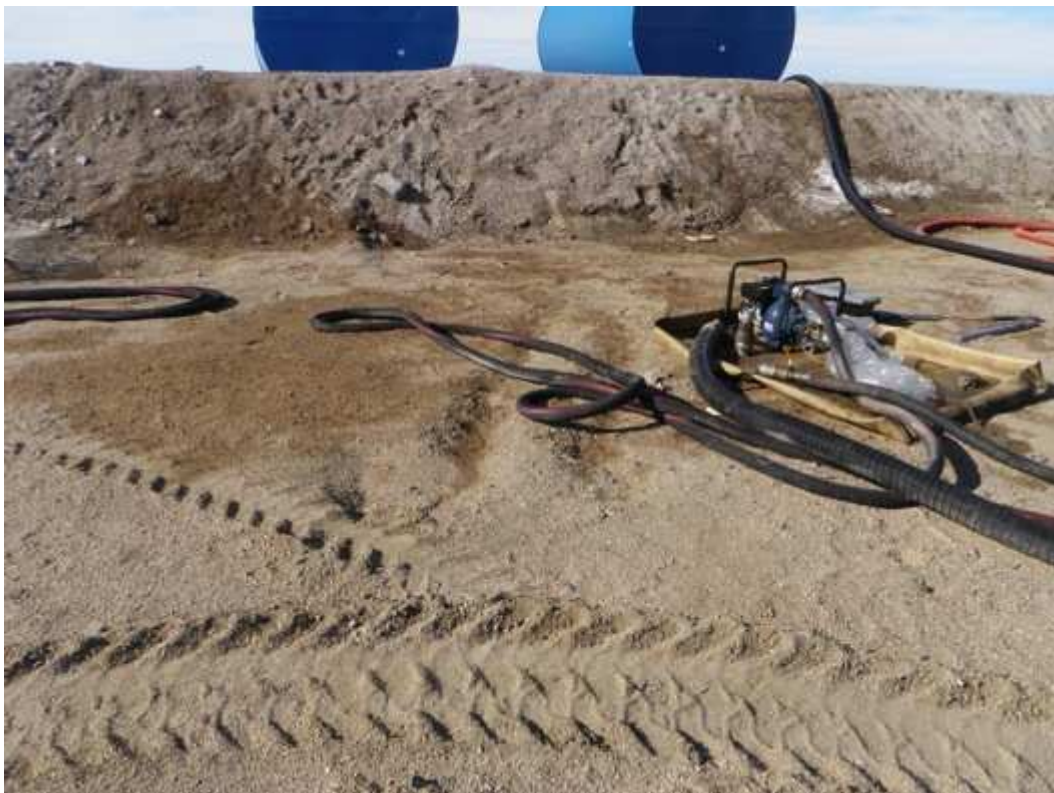
Photo 5 – Vehicle refueling station
