2011 ANNUAL GEOTECHNICAL INSPECTION
JERICHO DIAMOND MINE, NU

PROJECT NO.
E14101140

APPENDIX J LANDFILL

APPENDIX K HAZARDOUS WASTE MATERIAL AREA

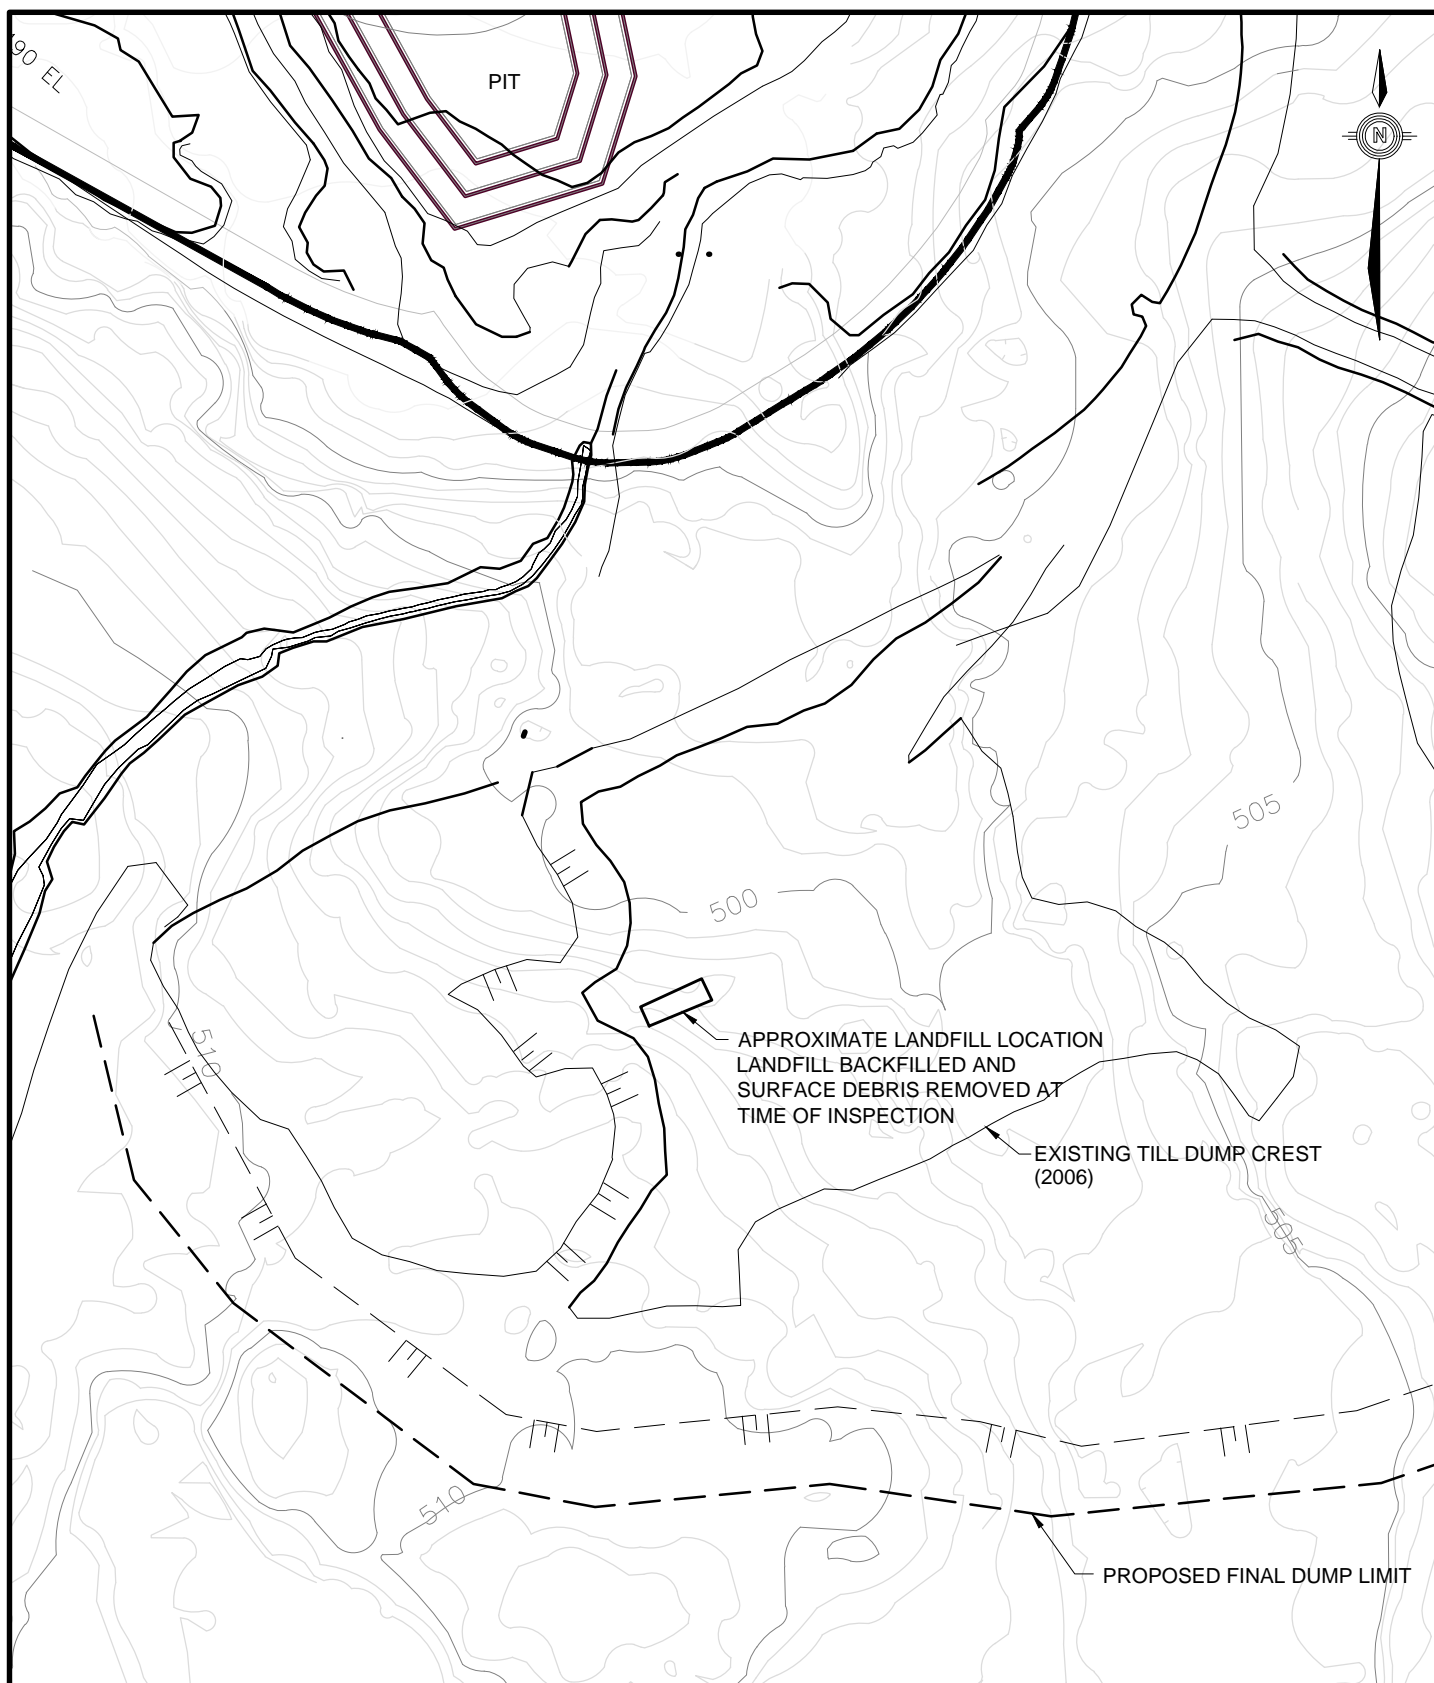
Figure J.1

LANDFILL

All debris has either been removed or covered. No remedial action required.

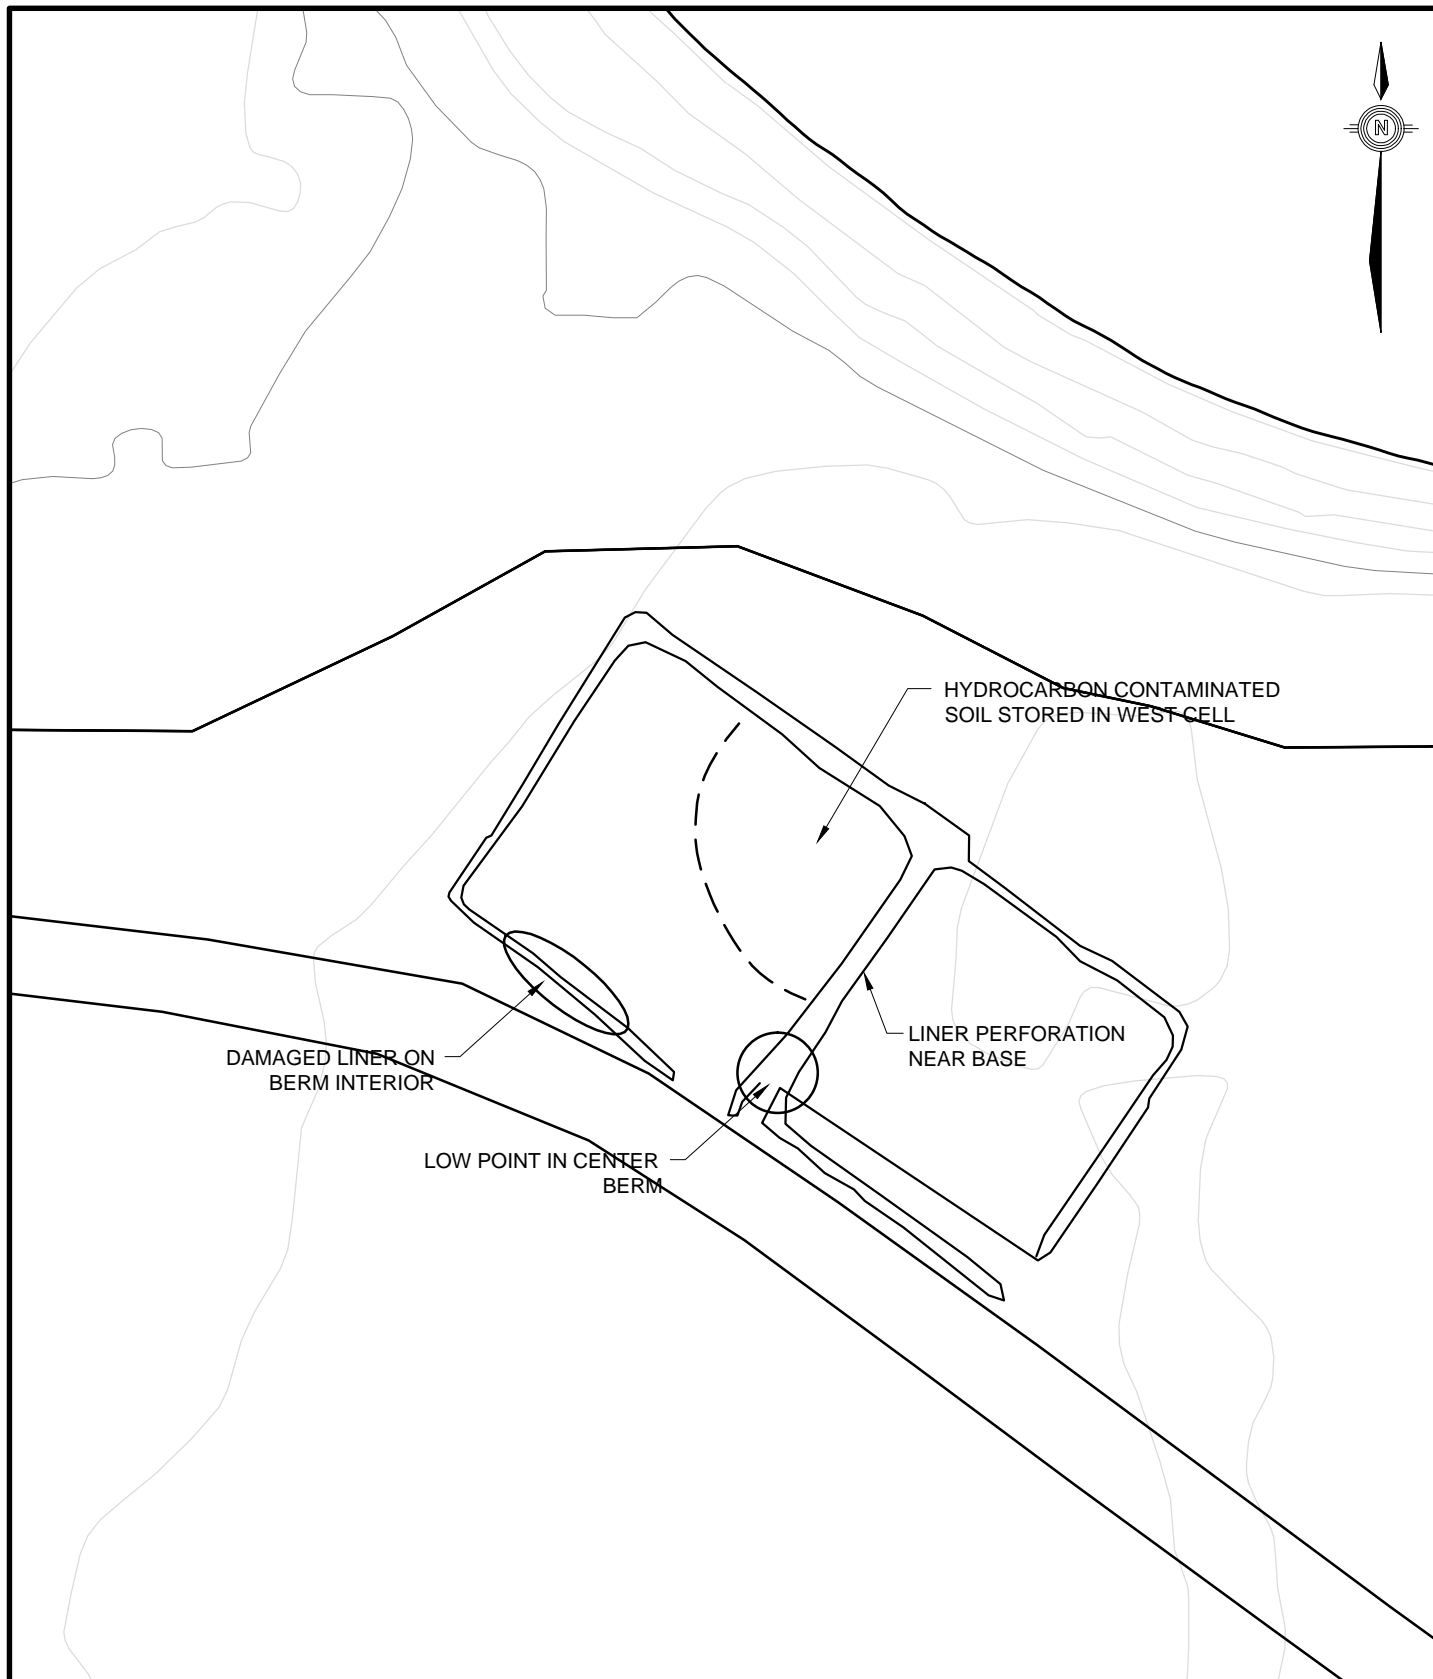
Features	Present (yes/no)	Dimensions	Extent	Description	Photographic Records
Erosion	None noted				
Cracking	None Noted				
Settlement	Center Berm		Localized	Settlement of center berm near access road	K.4
Seepage	None Noted			Shear reports water impounded in HWTa base during freethet	
Other Features	Liner Damage			Liner damage at several locations on interior berms, in both cells. Perforations noted 0.3 m above base do not provide required containment. Extent of liner damage should be evaluated and a remediation plan developed.	K.3, K.4

HAZARDOUS WASTE TRANSFER AREA

Perforations in berm do not provide required containment. Extent of liner damage should be evaluated and a remediation plan developed.
--
