Geotechnical Inspection Summary

Location: Jericho Diamond Mine
Facility: Divider Dyke A
Observation Date: July 15, 2011
Inspected by: Gary Koop, P.Eng.
 EBA, A Tetra Tech Company

| 2011 ANNUAL GEOTECHNICAL INSPECTION JERICHO DIAMOND MINE, NU | | | | |

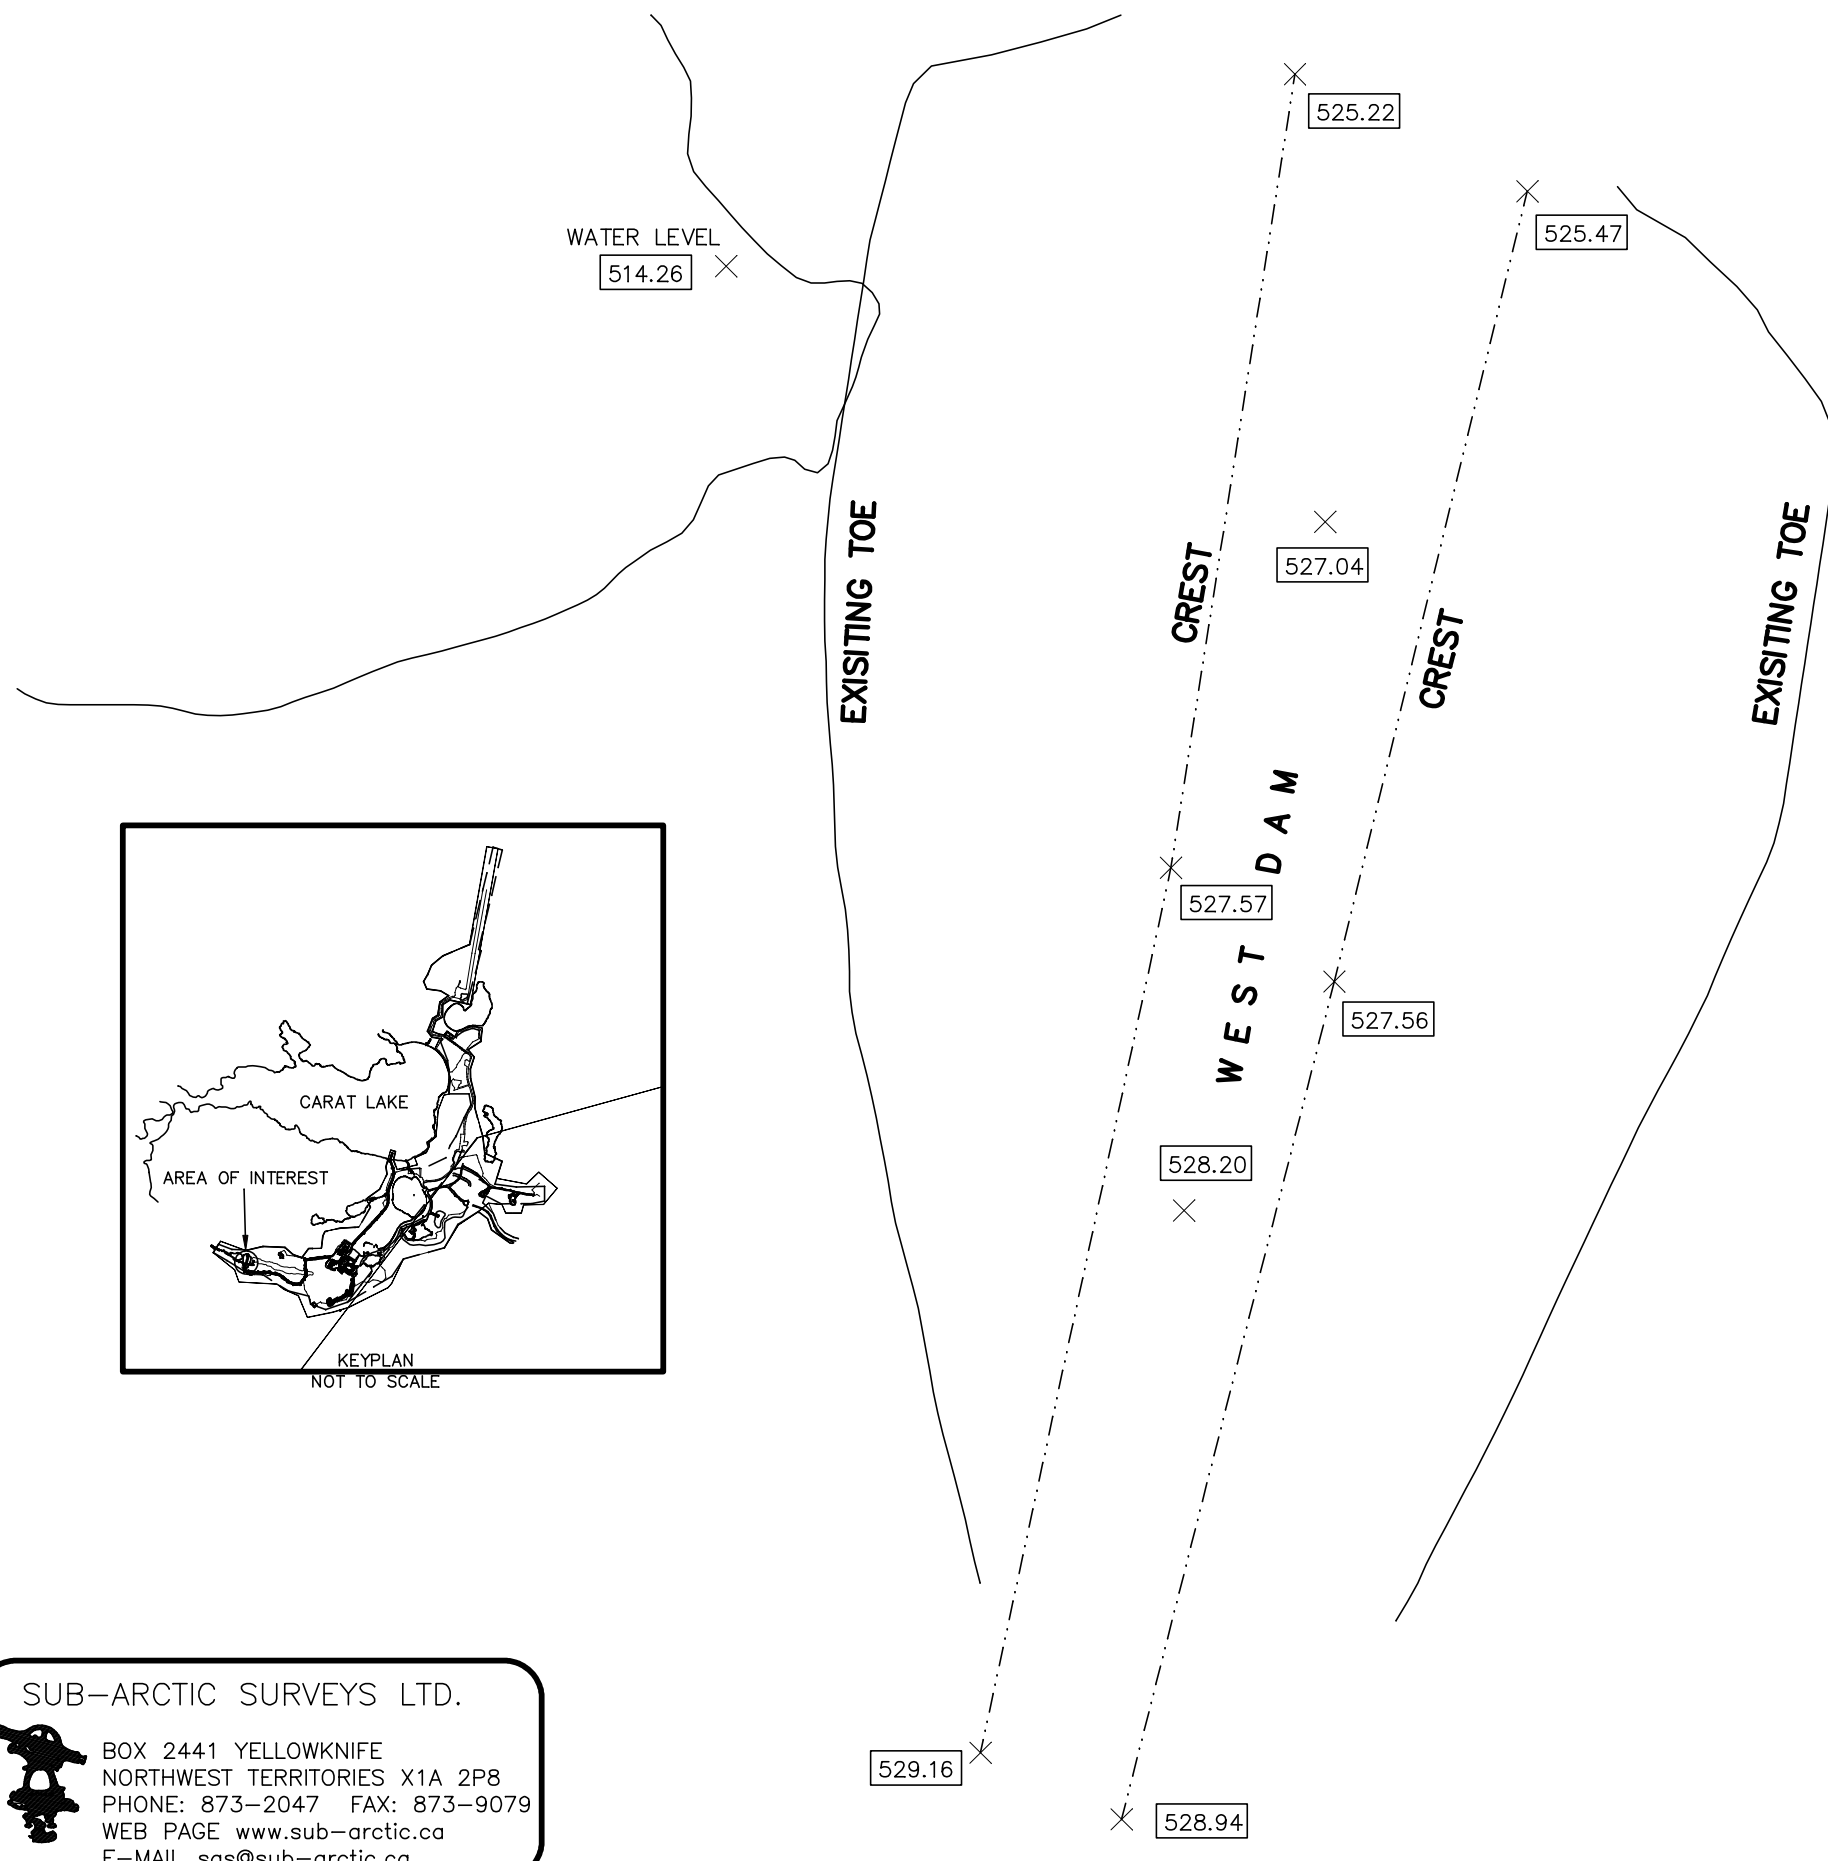
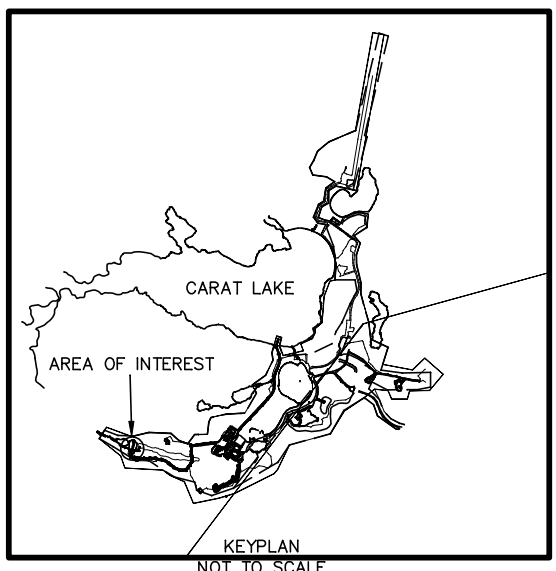
**WEST DAM WATER LEVELS
 JERICHO MINE SITE
 NU.**

× WATER LEVEL
516.84

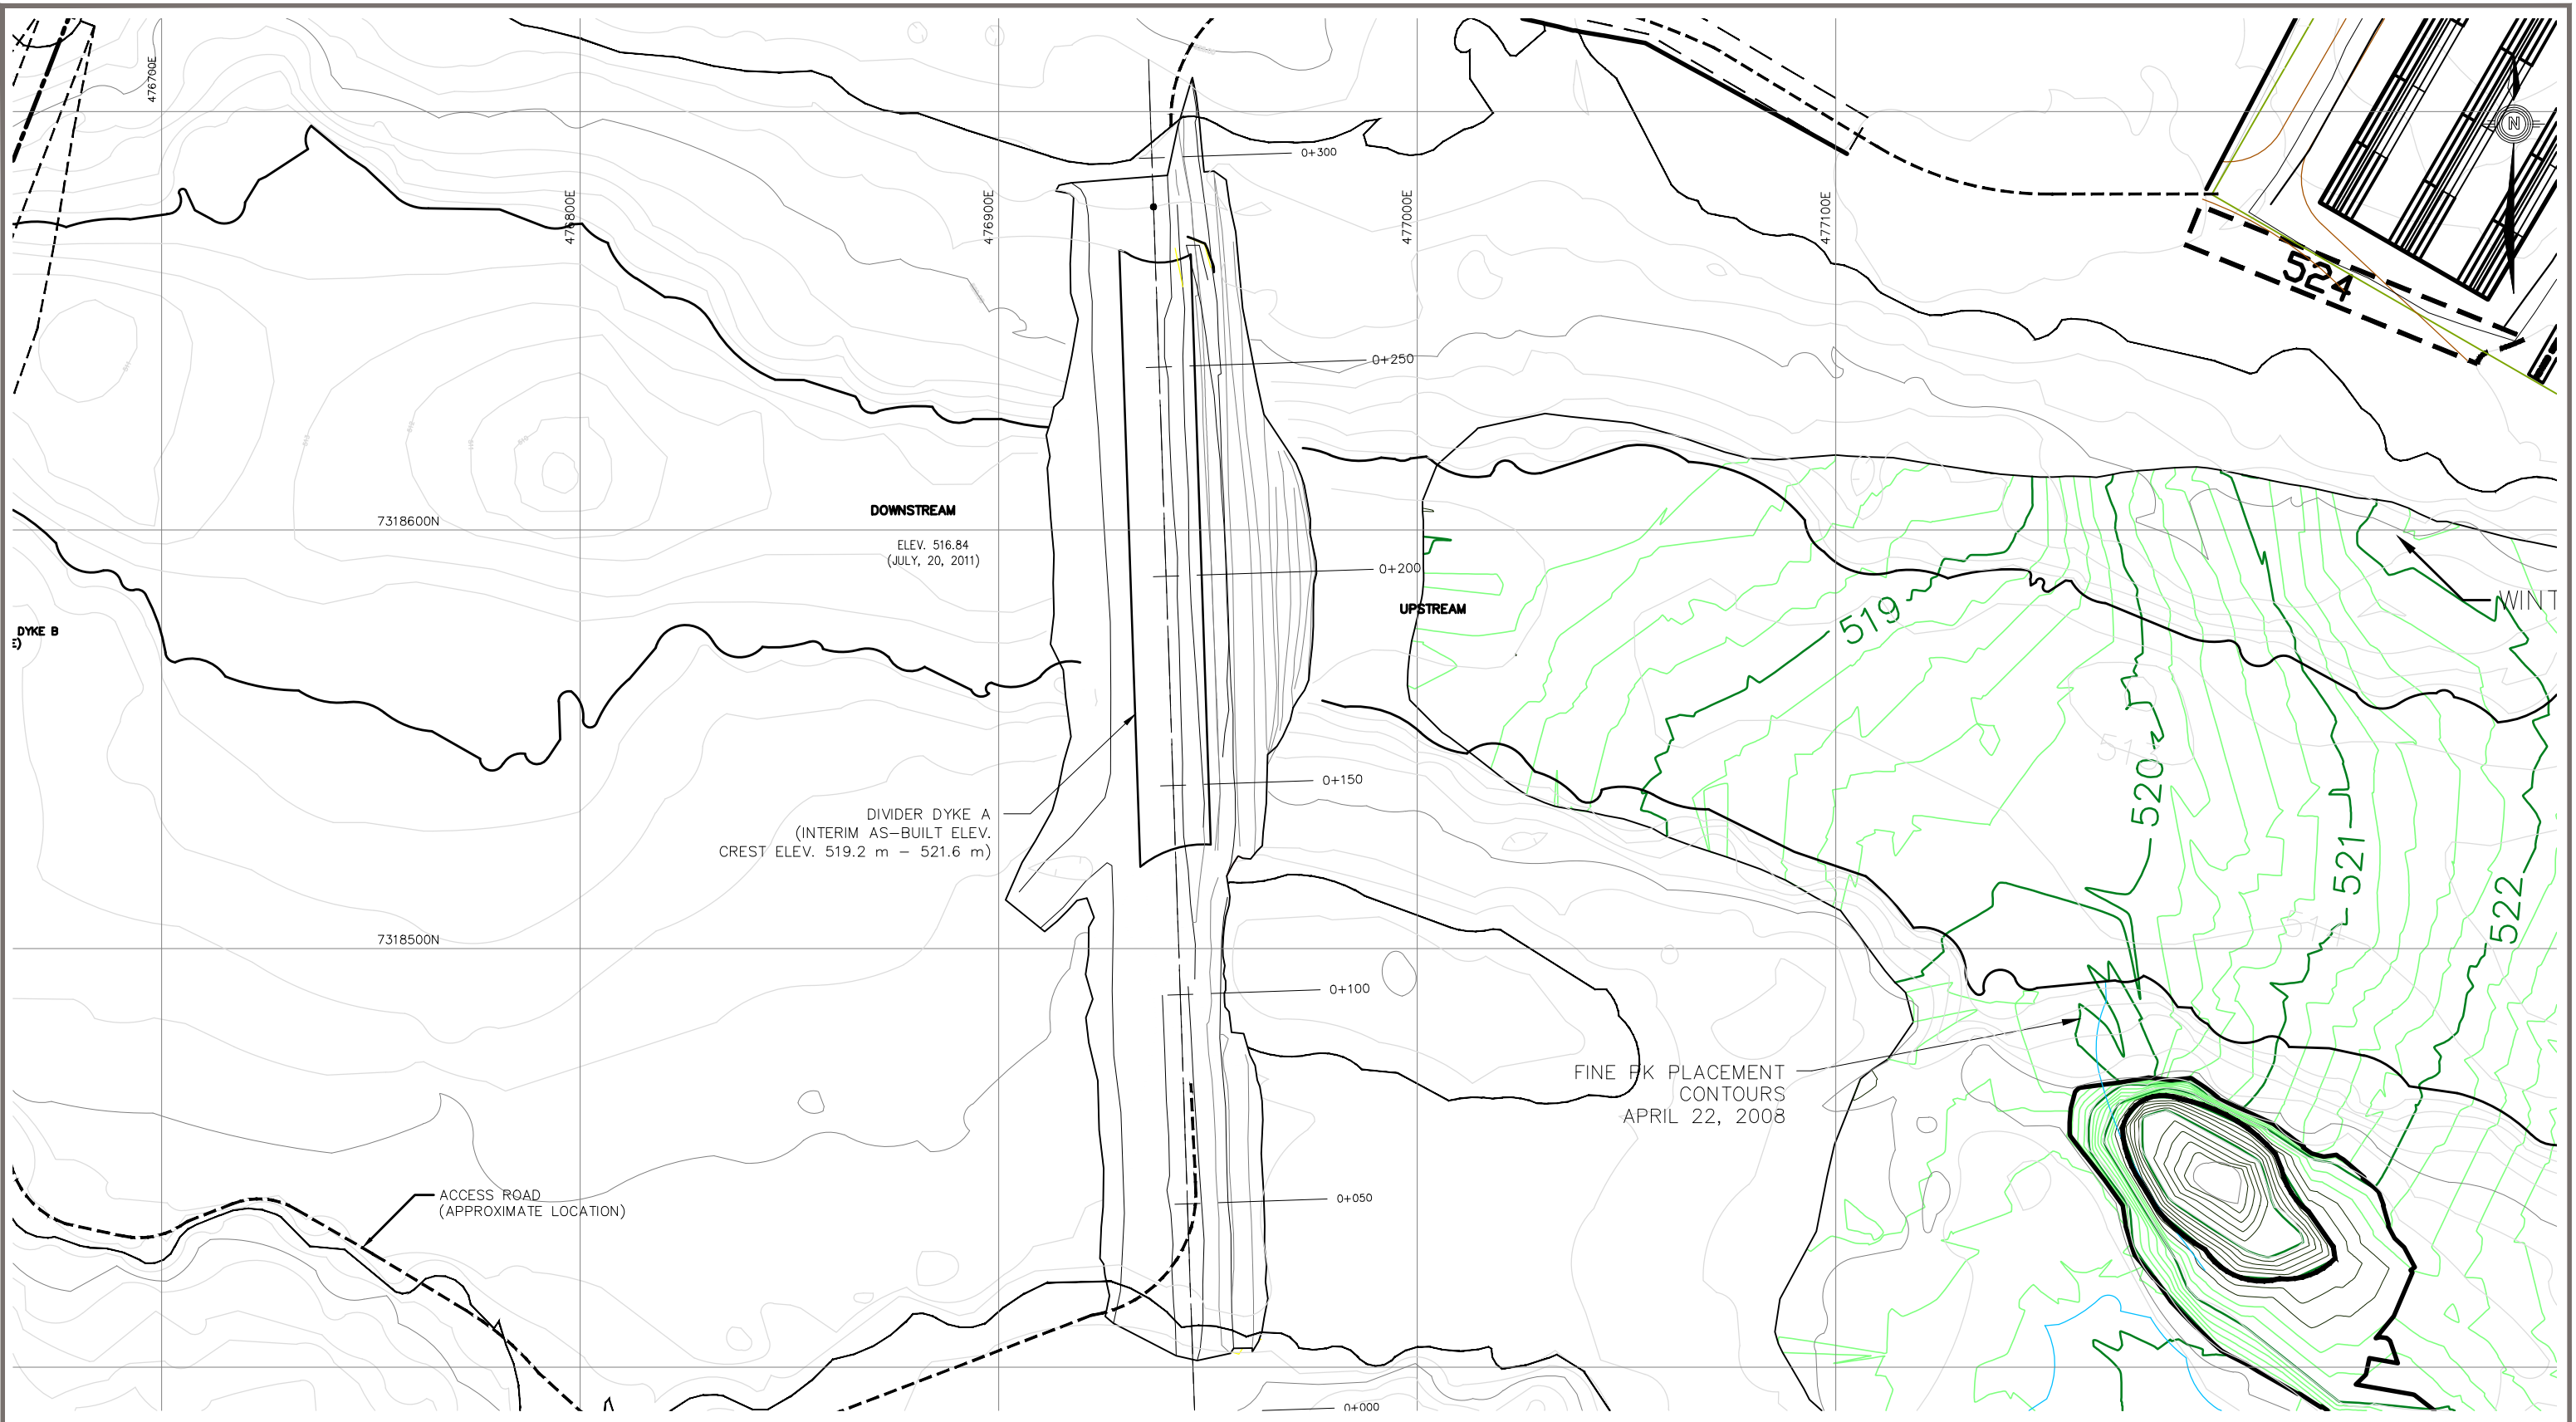
| 2011 ANNUAL GEOTECHNICAL INSPECTION JERICHO DIAMOND MINE, NU | | | | |
|---|---|---|---|---|
| PROJECT NO. E14101140 | DWN EP | CKD GDK | REV 0 | Figure C.1 |

NOTES
FIGURE BASED ON 2006 SURVEY.
DYKE WAS RAISED SINCE THIS SURVEY.

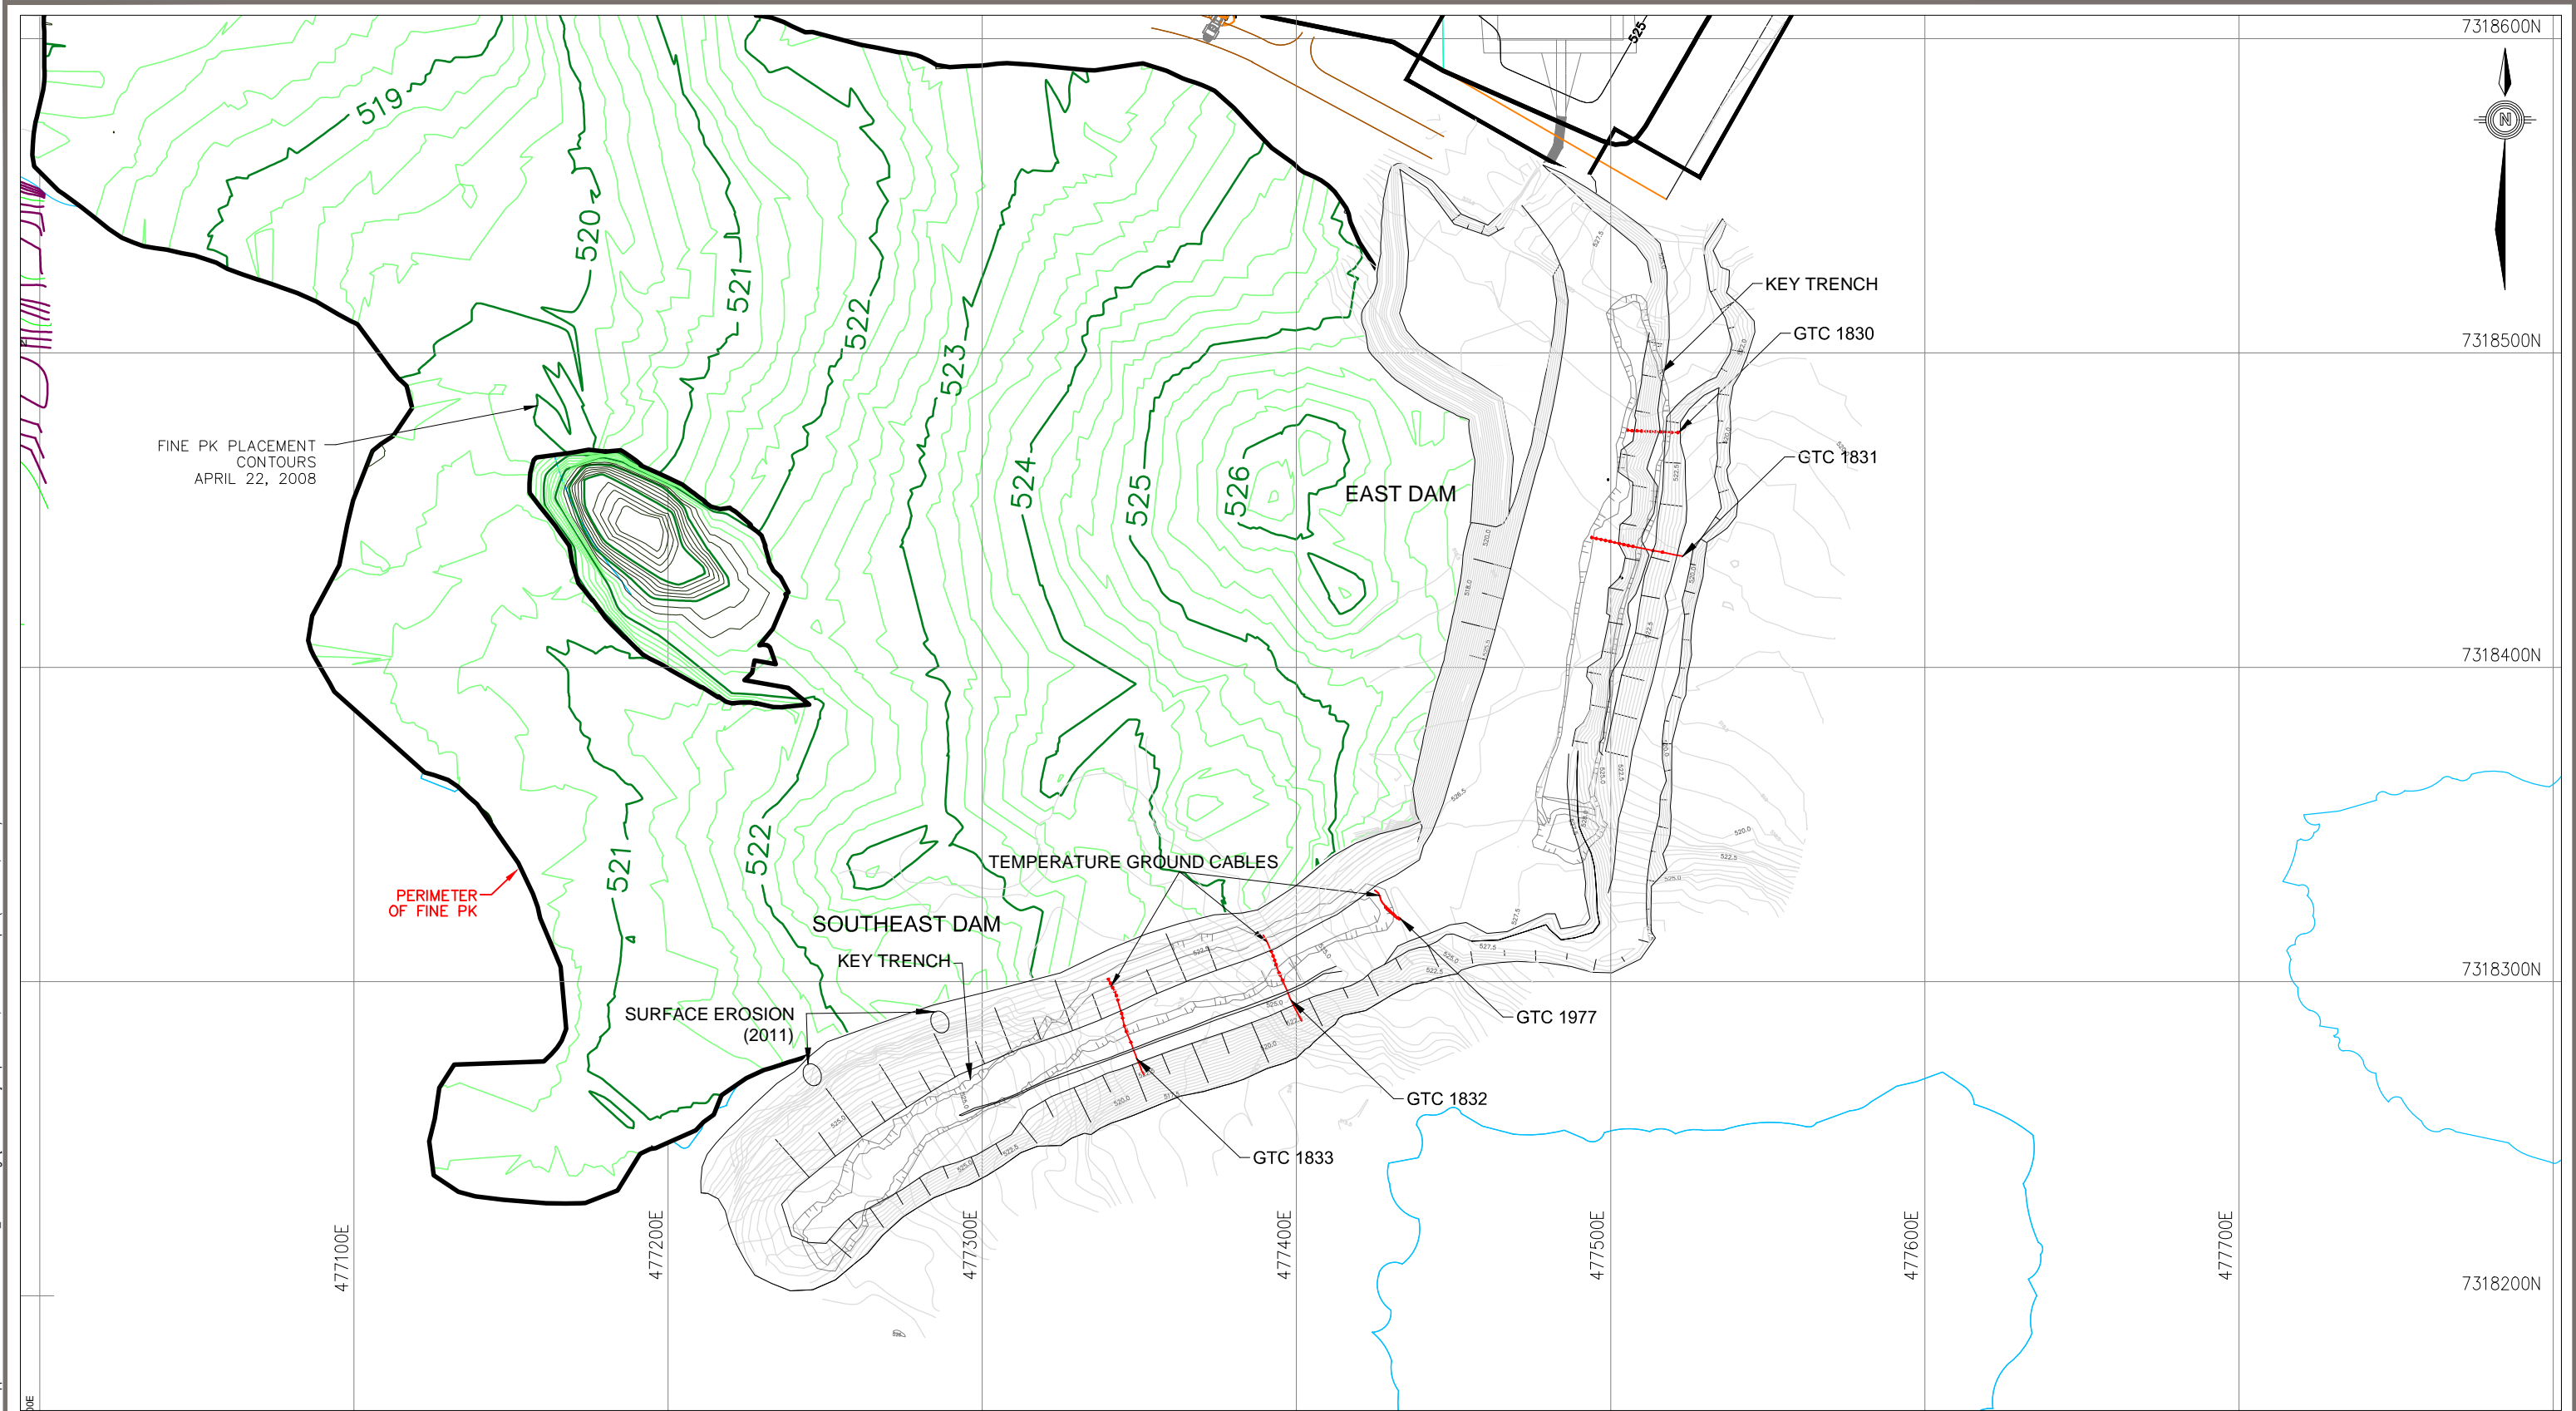
Y:\E14101140_Jericho\Annual Geotechnical Inspection\Appendix D - East Dam\E1410117_FIG D-1.dwg [FIGURE D.1] September 09, 2011 - 5:51:40 pm (BY: KOOP, GARY)

NOTES
GROUND TEMPERATURE CABLES (APPROXIMATE LOCATION).
CABLES AT BASE OF LINER IN KEY TRENCH.
FIGURE BASED ON 2007 RECORD DRAWINGS.
