## Geotechnical Inspection Summary

**Location:** Jericho Diamond Mine  
**Facility:** Southeast Dam  
**Observation Date:** July 15, 2011  
**Inspected by:** Gary Koop, P.Eng.  
 EBA, A Tetra Tech Company

2011 ANNUAL GEOTECHNICAL INSPECTION JERICHO DIAMOND MINE, NU				
SOUTHEAST DAM				
PROJECT NO. E14101140	DWN EP	CKD GDK	REV 0	Figure E.1
OFFICE EBA-EDM	DATE September, 2011

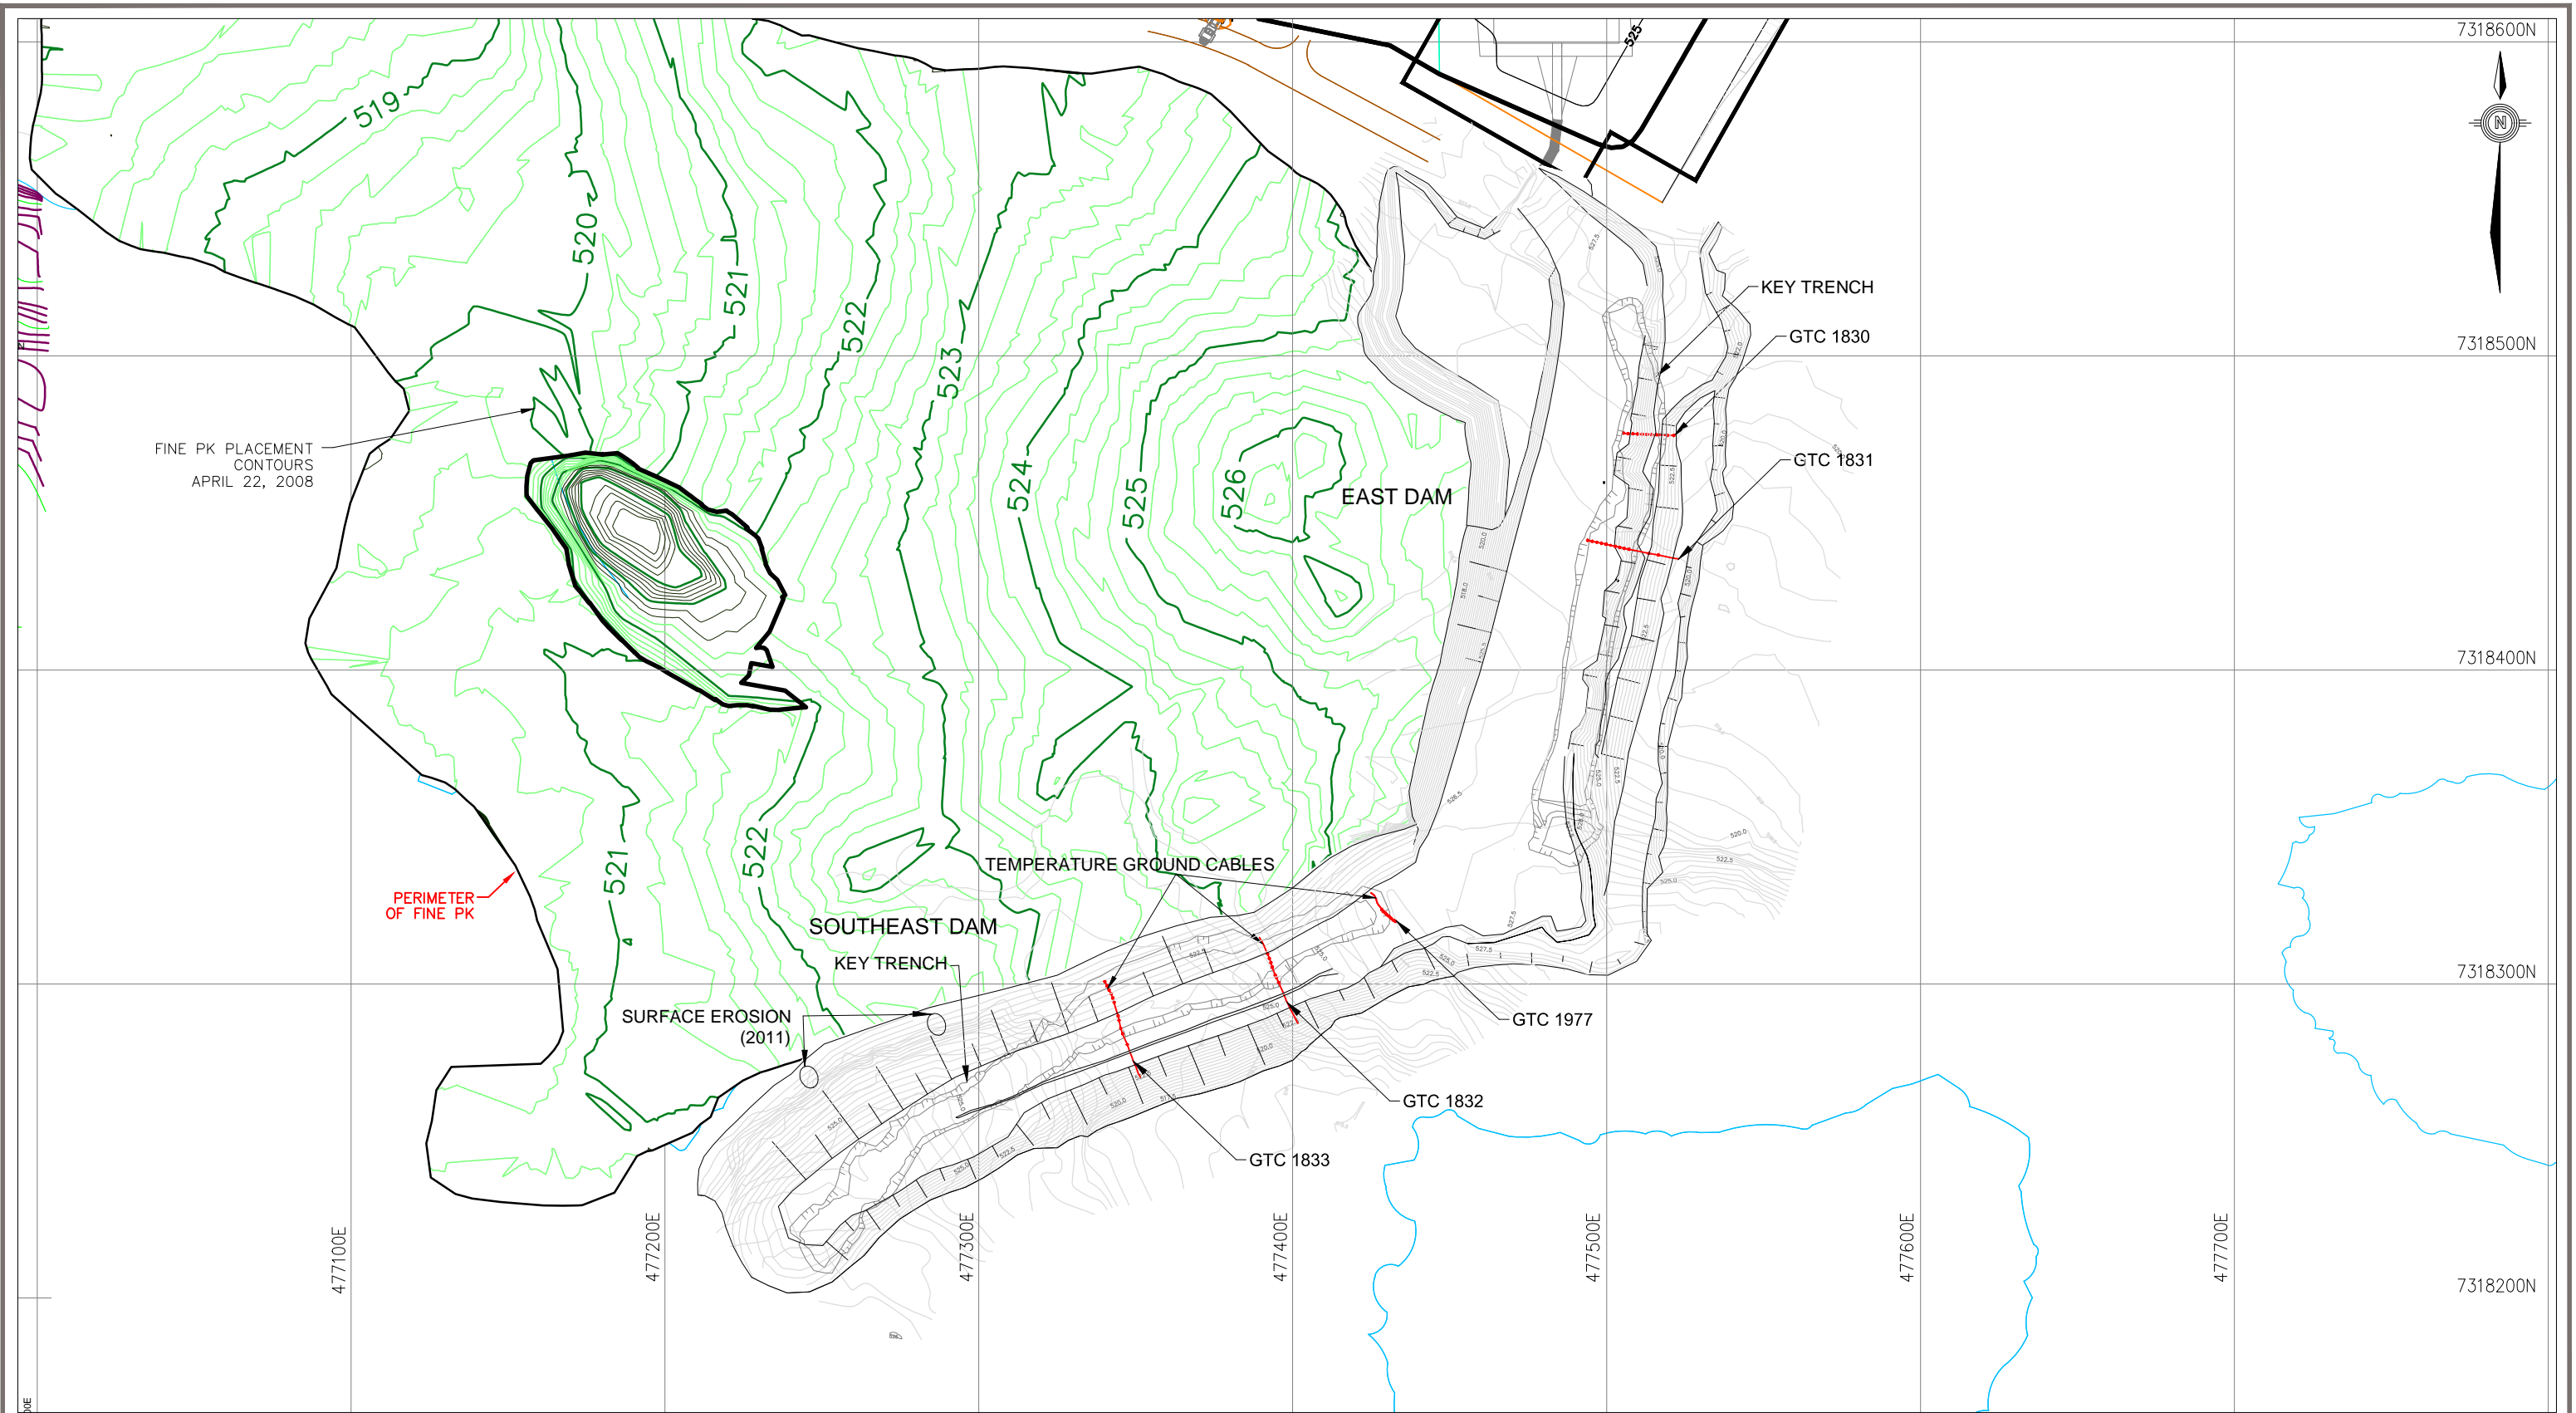
Y:\E14101140\_Jericho\Annual Geotechnical Inspection\Appendix E - Southeast Dam\E14101117\_FIG E-1.dwg [FIGURE E.1] September 09, 2011 - 5:58:39 pm (BY: KOOP, GARY)

**NOTES**  
GROUND TEMPERATURE CABLES (APPROXIMATE LOCATION).  
CABLES AT BASE OF LINER IN KEY TRENCH.  
FIGURE BASED ON 2007 RECORD DRAWINGS.
