2011 ANNUAL GEOTECHNICAL INSPECTION  
JERICHO DIAMOND MINE, NU

C1 DIVERSION

**Location:** Jericho Diamond Mine  
**Facility:** Tankfarm  
**Observation Date:** July 16, 2011  
**Inspected by:** Gary Koop, P.Eng.  
EBA, A Tetra Tech Company

TANK FARM

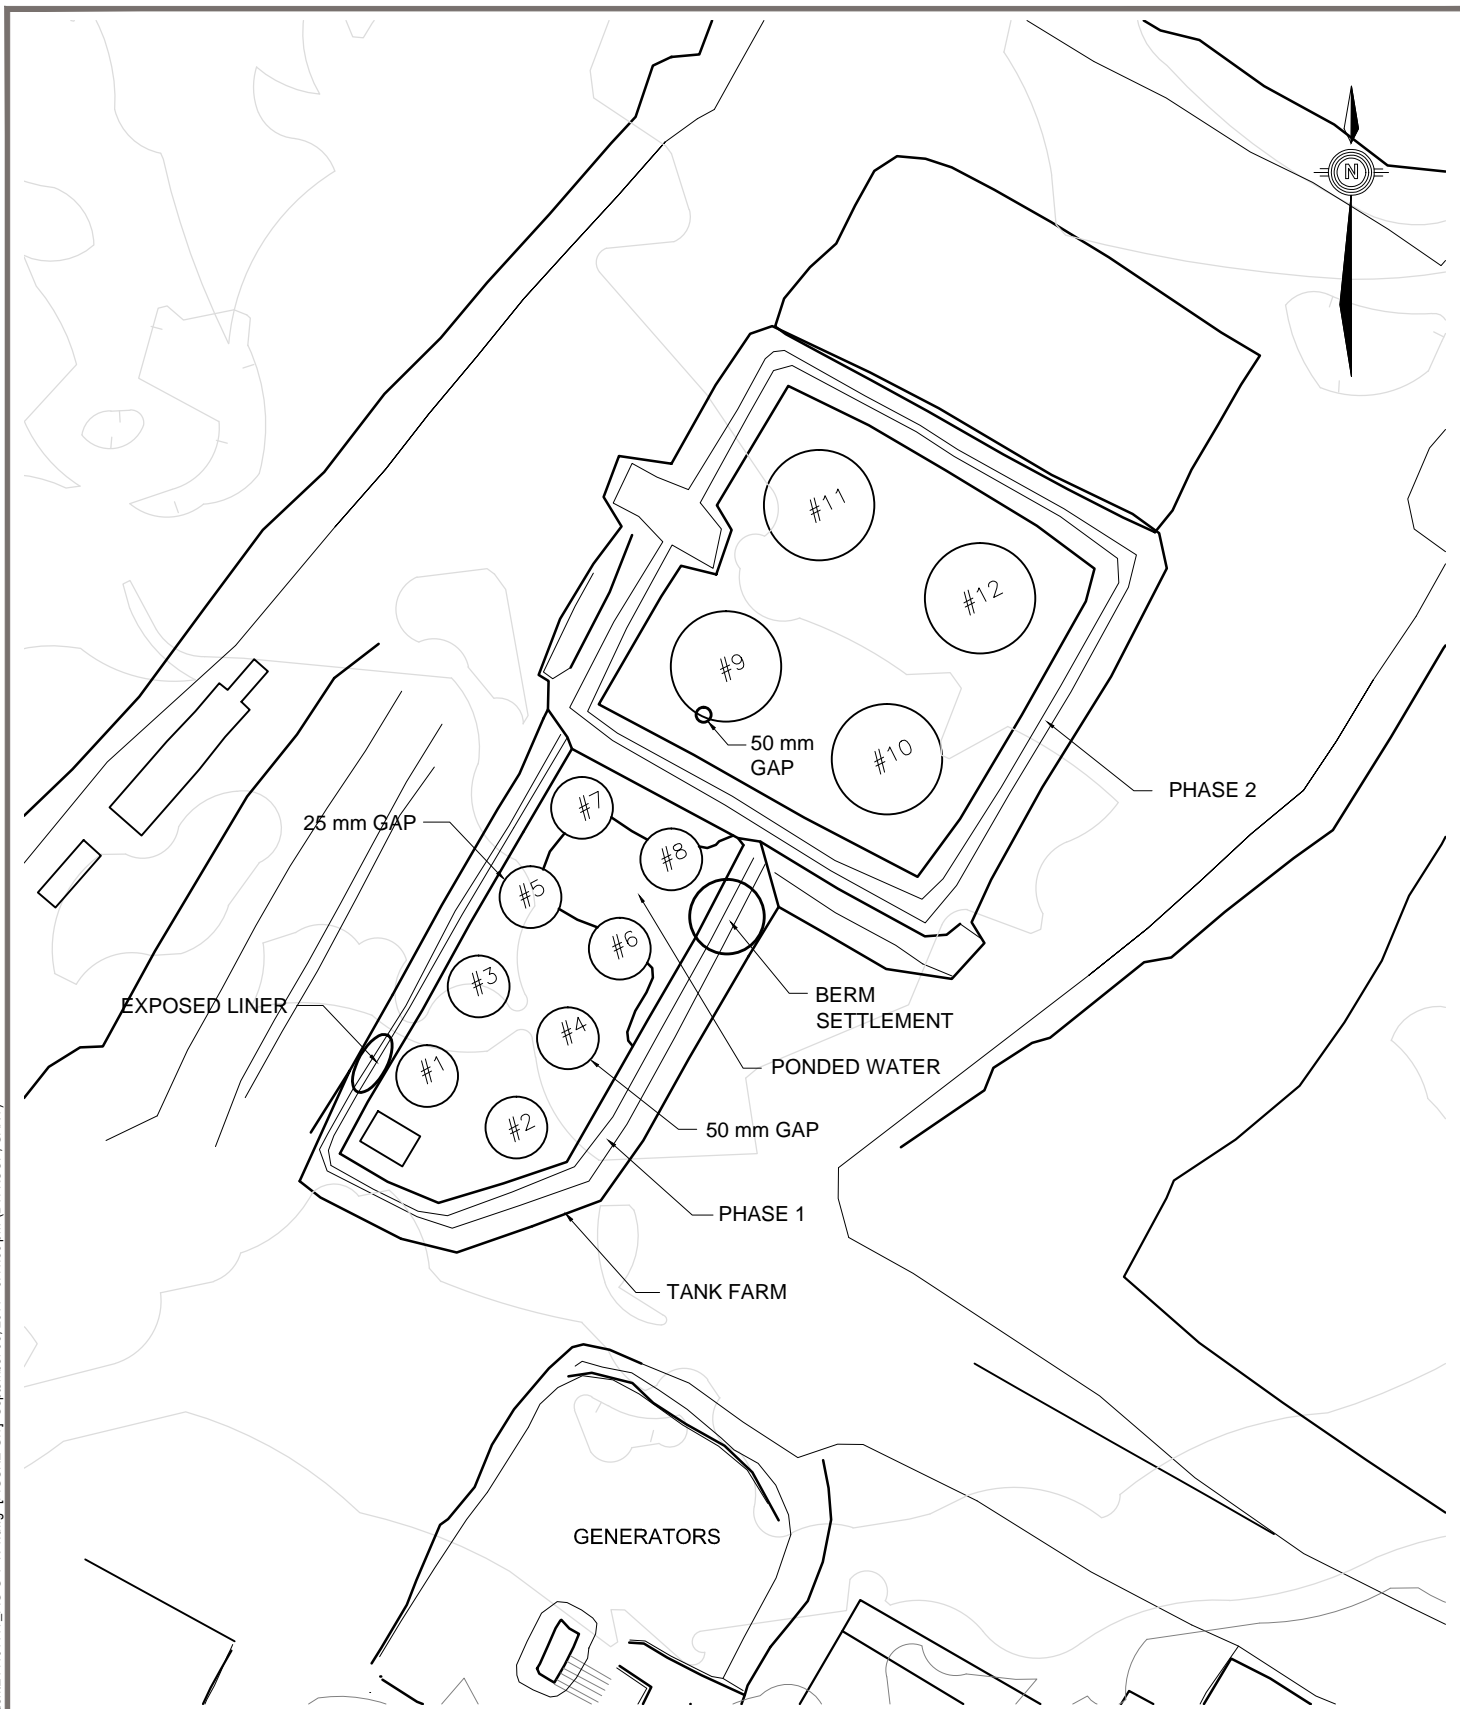
Figure G.1

| Features | Present (yes/no) | Dimensions | Extent | Description | Photographic Records |
|---|--|---|---|--|---|
| Settlement | Settlement within Phase 1 Tankfarm<br><br>Tanks List | Uneven surface throughout tank farm Gaps up to 50 mm high under several of the tanks. Tanks in Phase 1 tilting up to 1.5°. Previous monitoring indicated settlement during the first year, settlement appeared to slow down. Has not been monitored recently. Presently | Throughout the tankfarm and berm. | Settlement apparent under tanks. New flexible pipe connections were installed in 2007 to accommodate the settlement. | G.4 |

| | East Berm | no fuel in Phase 1 except for residual amount. | | Settlement in east berm appears to be greater than 0.3 m. | G.3 |
| Settlement | Settlement with Phase 2 Tankfarm | Gap under edge of Tank 9 - up to 35 mm. | Only noted on Tank 9 | Settlement has resulted in gap under edge of the tank. | G.6 |
| | Stained Soil | Numerous large stain areas | Sporadic, most at valve locations | Hydrocarbon stained soil on inside surface of tankfarm base | G.2 |
| | Ponded/Frozen Water | | Sporadic | Sections throughout Phase 1 | G.3 |

The deficiencies noted in the Tank Farm are similar to the previous inspection indicating that settlement has slowed or stopped at present. List angles of the tanks were measured by EBA but a survey of the tanks should be performed when possible.
