SHEAR DIAMONDS (NUNAVUT) CORP.

## 2011 ANNUAL SEEPAGE SURVEY REPORT JERICHO DIAMOND MINE, NUNAVUT

NOVEMBER 2011  
ISSUED FOR USE  
EBA FILE: E14101140

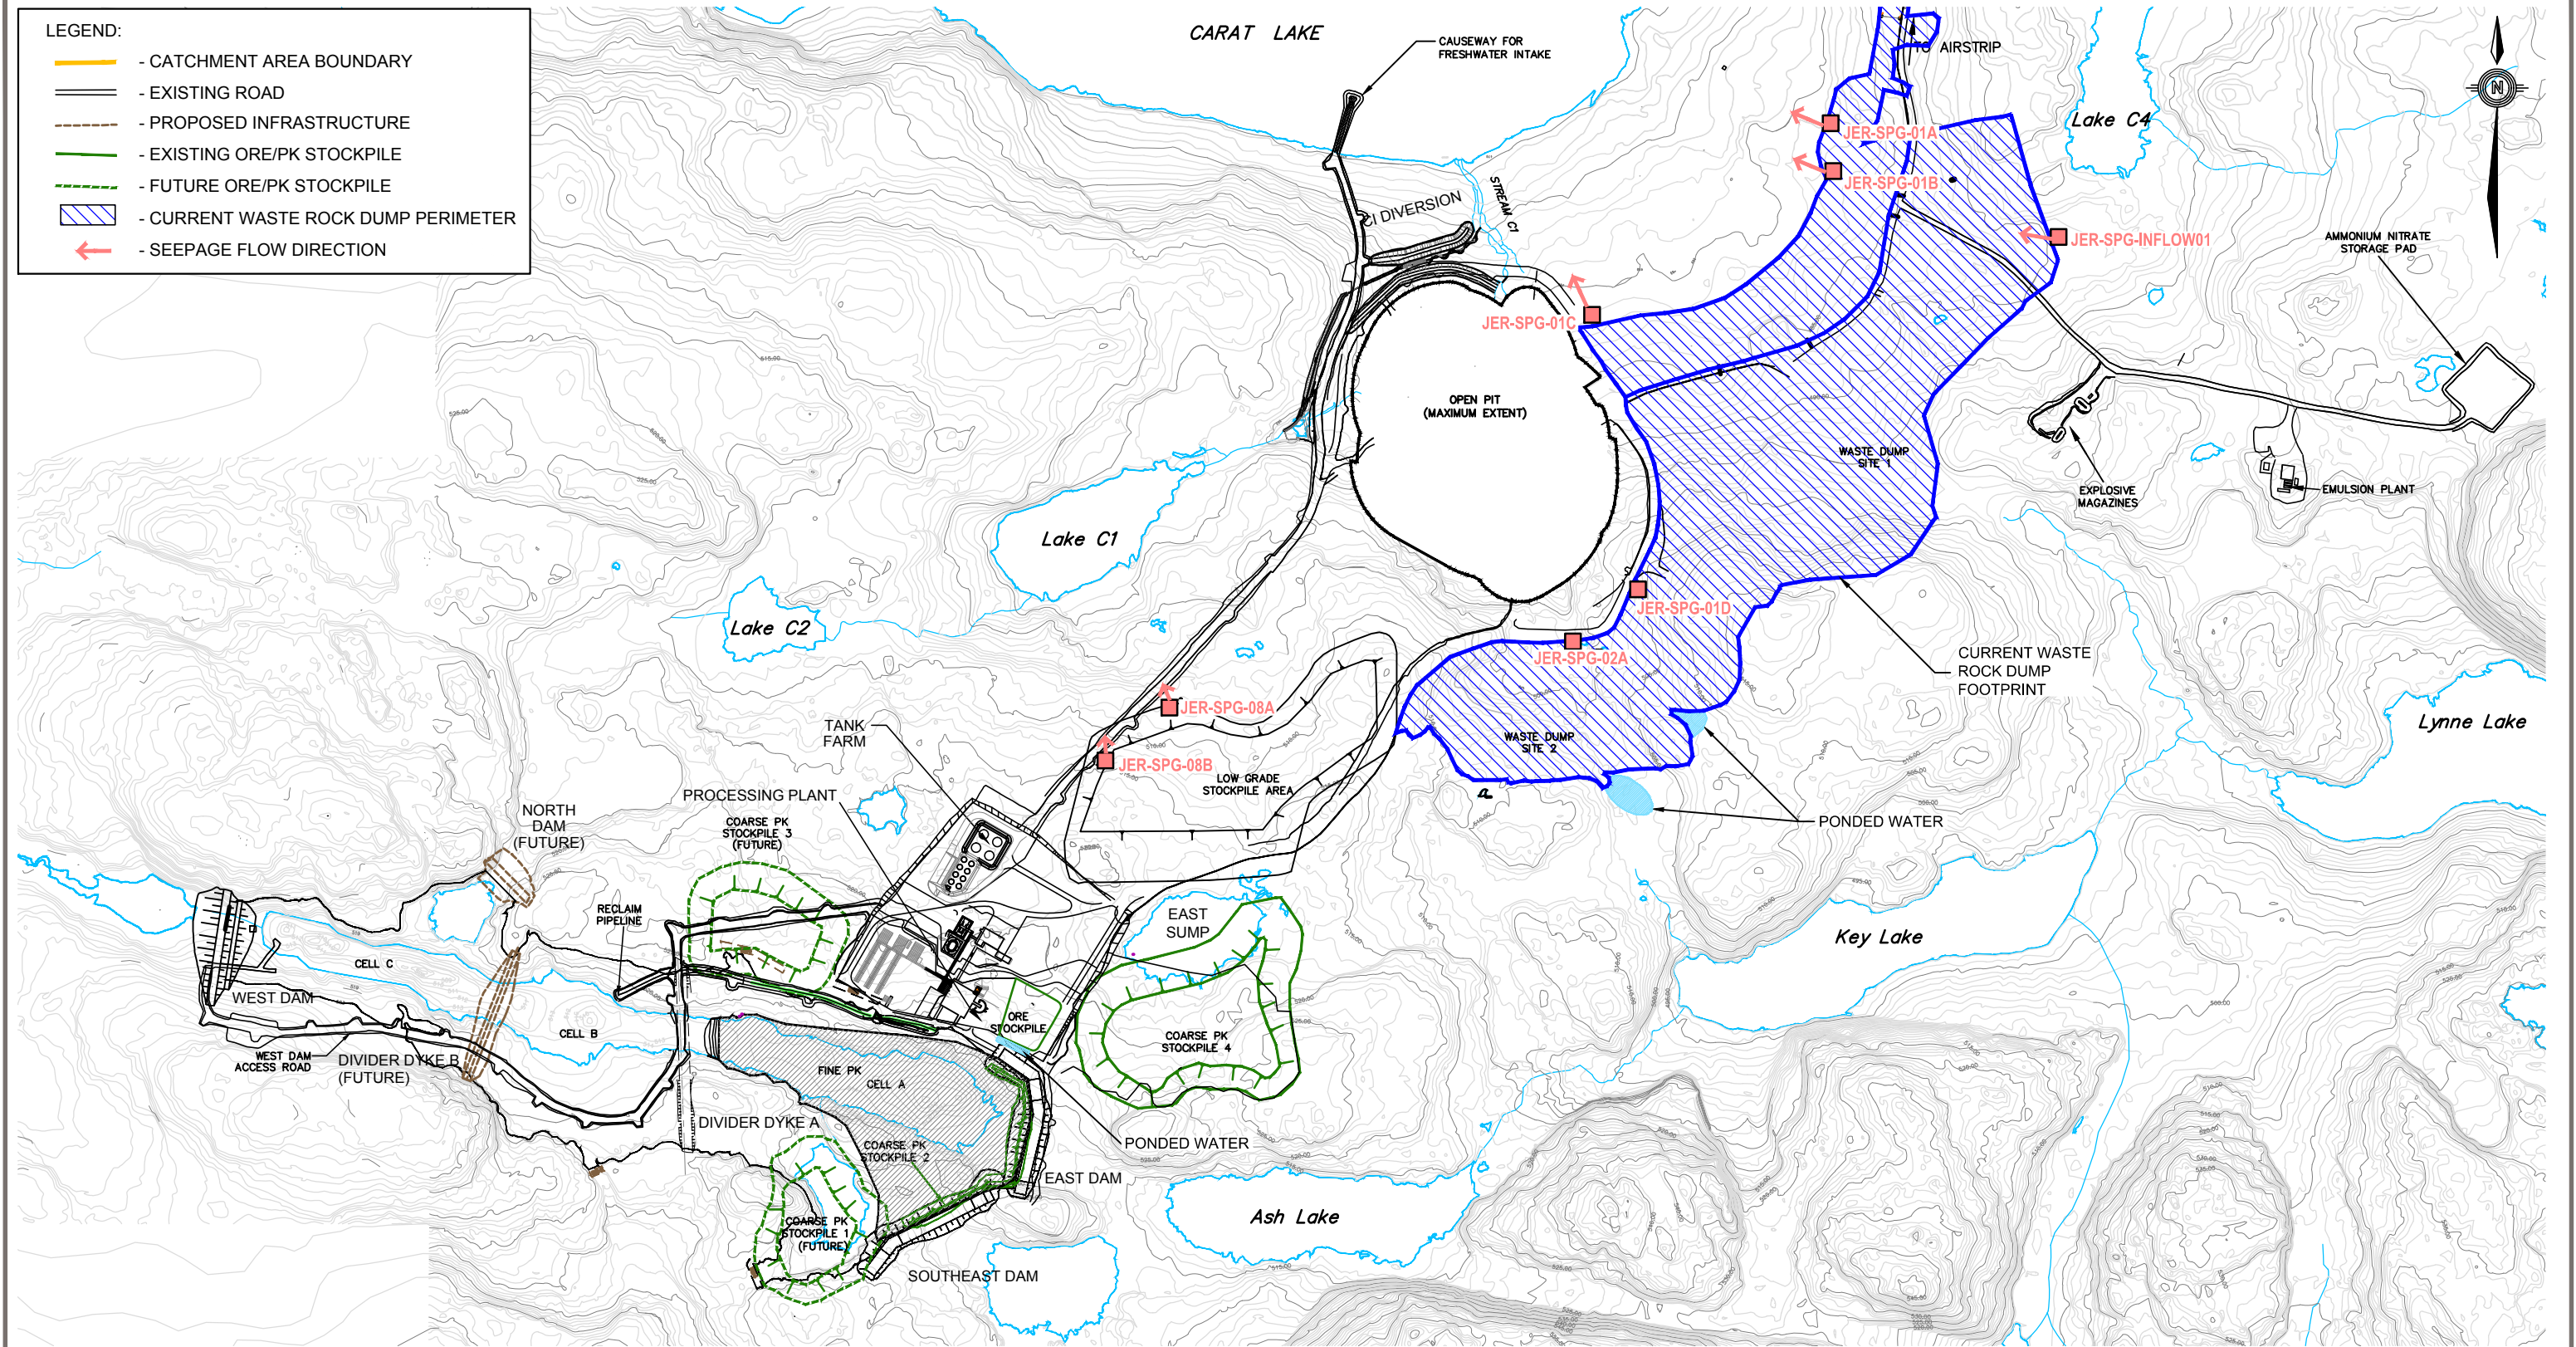
Figure 1 Catchment Areas and Sample Locations

The Waste Rock Dumps 1 and 2 spanned from the northeast to the southeast of the open pit. Based on the local topography and field observation, seeps that emerge from the waste rock dump generally flow northwest or west towards the pit or Carat Lake. During the survey, three active seeps (JER-SPG-01A, B, and C, see Photos 1 to 3) were identified at the northwest side of the Waste Rock Dump 1, which were flowing towards Carat Lake. Two smaller active seeps (JER-SPG-01D and 02A, see Photos 4 and 5) at the west side of the Waste Rock Dump 1 and the northwest side of the Waste Rock Dump 2 were flowing on, and eventually infiltrating into, the road between the waste rock dumps and the pit. The seepage water is anticipated to either feed into the pit sump or exit from the northwest side of the Waste Rock Dump 1 (approximate location of JER-SPG-01C). A small stream (JER-SPG-INFLOW01, see Photo 6) was also found to flow into Waste Rock Dump 1 from the Ditch C4 Catchment Area (See Figure 1).

In addition, six water pondings were observed along the perimeter of the waste rock dump, of which two relatively large water pondings had accumulated at the south and east side of Waste Rock Dump 2 (see Figure 1, and Photos 7 and 8). These two pondings were isolated at the time of the survey. Based on the observed moisture at the flow path between the ponding at the south side of Waste Rock Dump 2 and Key Lake, excessive water from this pond had flowed towards Key Lake in the past.

The low grade ore piles were placed on a waste rock pad. The approximate perimeter of the waste rock pad is shown in Figure 1. Based on the local topography and field observations, potential seeps emerging from the low grade ore piles and the waste rock pad would flow northwest or north towards Lake C1 or the open pit. During the survey, two active seeps (JER-SPG-08A and 08B, see Photos 9 and 10) were observed at the west side of the waste rock pad flowing towards Lake C1. Six small water pondings near the west and north side of the waste rock pad were also identified. No active seeps or ponded water were observed at the east or south side of the waste rock pad.

- Implementation of a more detailed seepage survey program in 2012 including:
  - Conducting seasonal seepage surveys starting at freshet to monitor the seasonal variation of the seepage quality and flow rate;
  - Establishing sampling stations in Carat Lake and Lake C1 near the seep inflows to verify the dispersion of the constituents from the seepage water;
  - Collecting water samples from the established stations on a seasonal basis; and
  - Identifying the sources and fates of the identified seeps
- Conducting surface water dispersion models in Carat Lake to predict the potential impact from the seeps during production and at closure; and
- Analyzing and pumping ponded water from the south and east side of Waste Rock Dump 2 to the PKCA (refer to Figure 1) to prevent overflowing into the receiving environment.
