**TAHERA RESPONSE TO INAC CONCERNS;  
INAC REVIEW OF TYPE A WATER LICENSE ANNUAL  
REPORT AND AUGUST 2008 INAC SITE INSPECTION**

*Tahera Diamond Corporation*

Compiled by: Mike Johnson  
Director of Operations

December 8, 2008

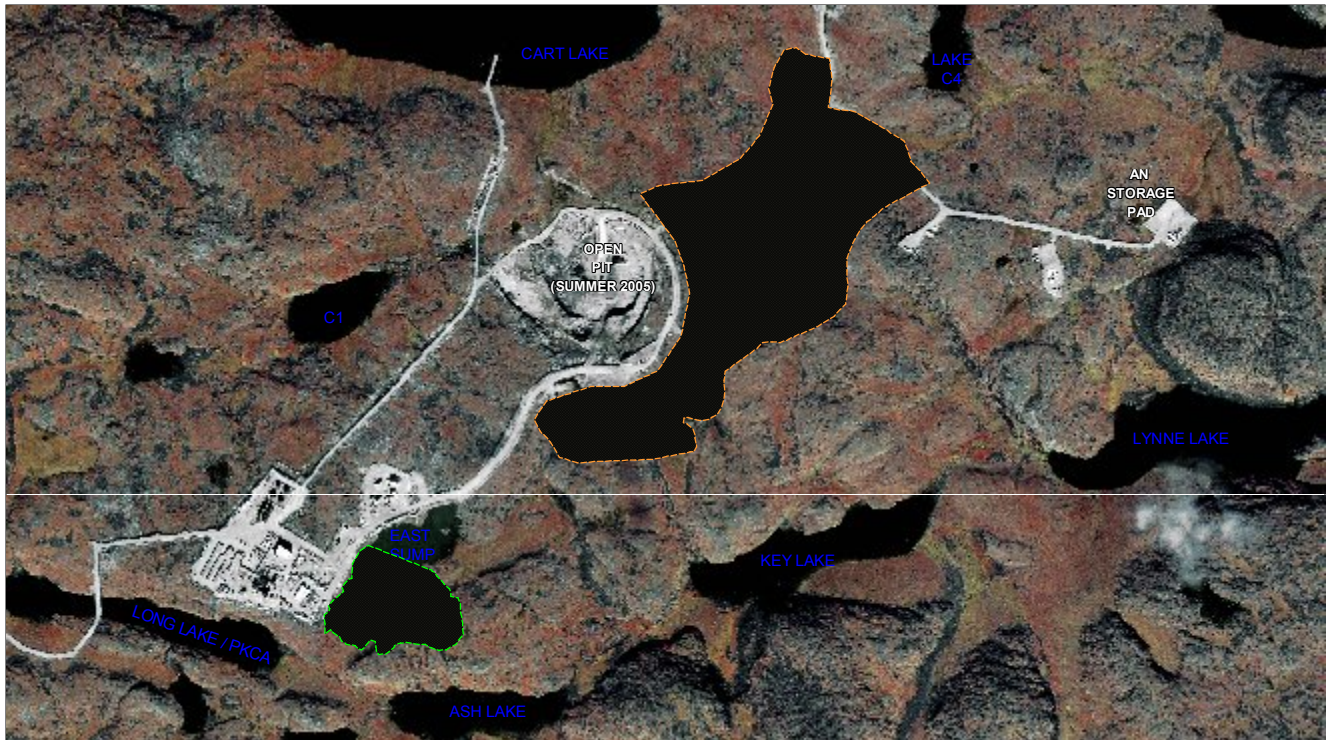
**Figure 1: Map of Project Area locating Lynne, Key and Ash Lakes, Waste Dump, Pit, Coarse PK and the Ammonium Nitrate Pad**

The ammonium nitrate ("AN") storage pad lies near the edge of the water shed of the Lynne / Key / Ash Lake system. Standing water around the AN pad may at times, depending on snow buildup and localized frozen ground, flow toward the Lynne Lake

system instead of the intended drainage into a local pond slightly northeast of the pad. (see figure 1) The AN pad was intended to be a lined / bermed storage pad, but Tahera had been allowed to operate without a lined pad until such time as one could be built. Currently the storage pad is not lined.

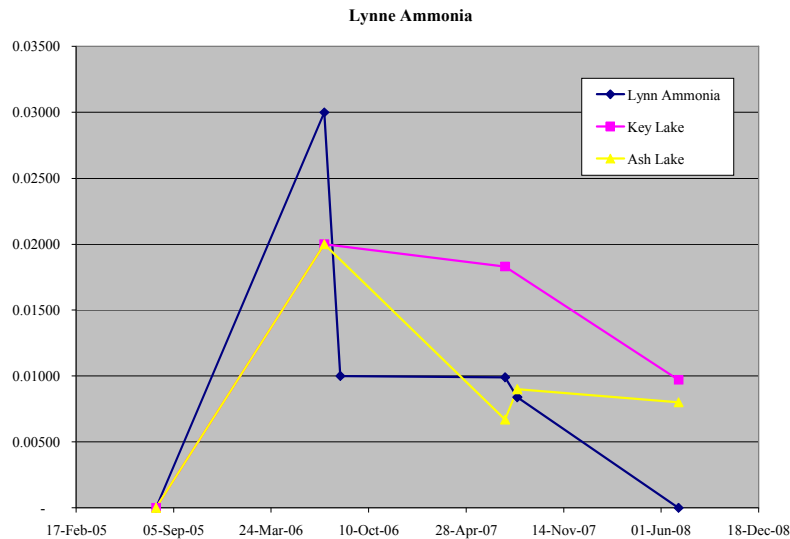
Secondly, the results of the sampling of these sites since the summer 2006 are showing improvement with reduced total ammonia levels. For Lynne Lake, the total ammonia levels have been falling since a “spike” in 2006 of 0.03 mg/L when 1 month later the levels had been reduced to 0.01mg/L. By July 2008 the total ammonia sample results for all three lakes were below the labs detection limit of 0.005 mg/L.

Figure 2, below, shows the trend of Lynne Lake total ammonia.

Nitrate levels show a similar reduction in concentration during this period. Nitrite levels are too low to be of any analytical value and are often below detection limit.

Tahera believes that the source of the slight elevations of ammonia in Lynne lake to be dust fallout from blasting, not run-off from the AN pad or the waste dumps. Experience at Ekati<sup>i</sup> indicates that AN contamination in the surface/seepage water is quickly

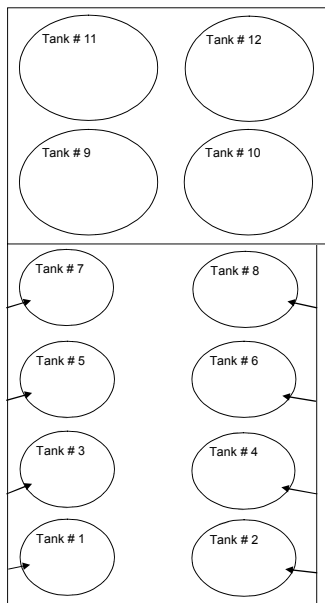
**Figure 2: Map of Main Tank Farm and Tank numbering**

The following map shows the Main Tank Farm storage including the tanks numbering designation and the current overall inventory (as of December 1, 2008), which is also summarized in a table as well.

Tanks 1 to 8 are part of the Phase 1 Tank Farm. Tanks 9-12 make up the Phase 2 Tank Farm.

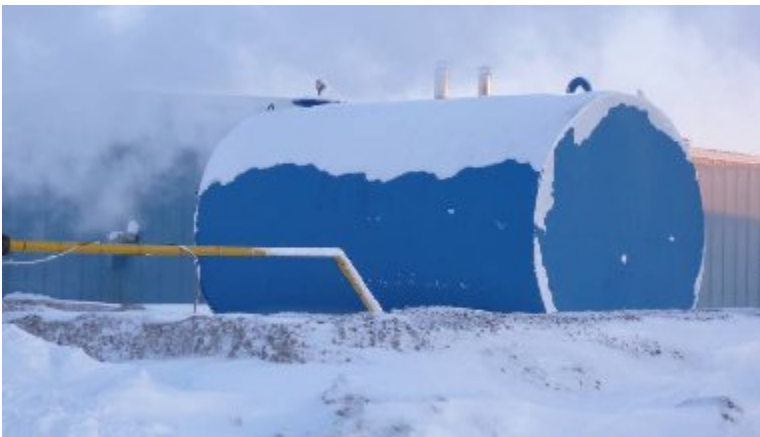
**Figure 5: Generator Day Tank and Berm**

The Generator Day Tank is a 62,000 litre tank that is hard lined to the main fuel transfer station. It is used to fill the generator tanks directly. Below is a picture of the tank and secondary containment berm.

It lies approximately 100m SE of the Main Tank Farm and is located several drawings in Appendix D.

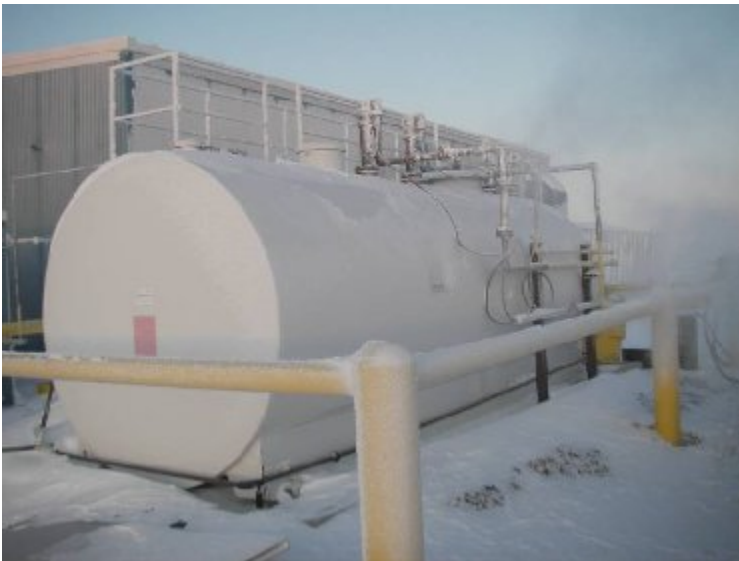
**Figure 7: Emulsion Plant Fuel Tank**

The emulsion plant has a 22,000 litre double walled tank mounted in a shallow concrete pad (see the photo below).

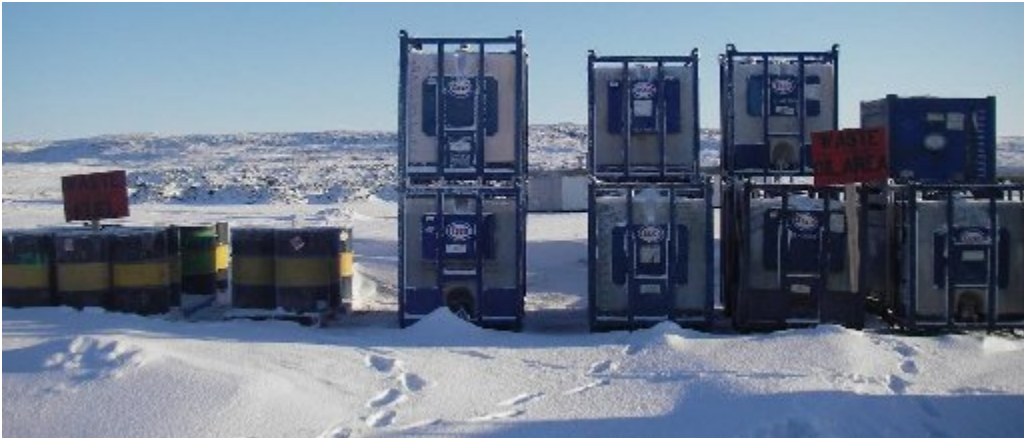
**Figure 18: WTA area Waste Oil and Waste Fuel in Drums and Cubes**

All material in the Waste Transfer Area has now been properly inventoried and labeled. The following pictures demonstrate the signage and organization.

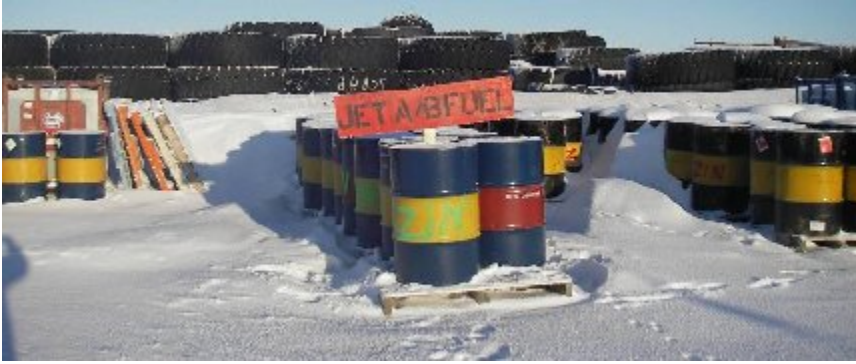
Figure 21: Organized and labelled Drums in WTA

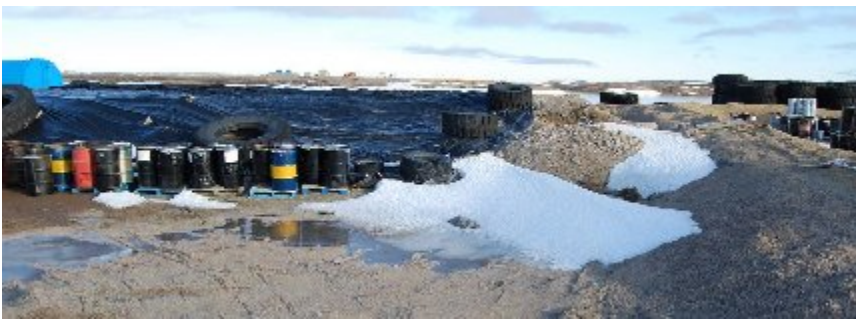
Figure 22: Bulk and drummed Hydrocarbon contaminated Soil

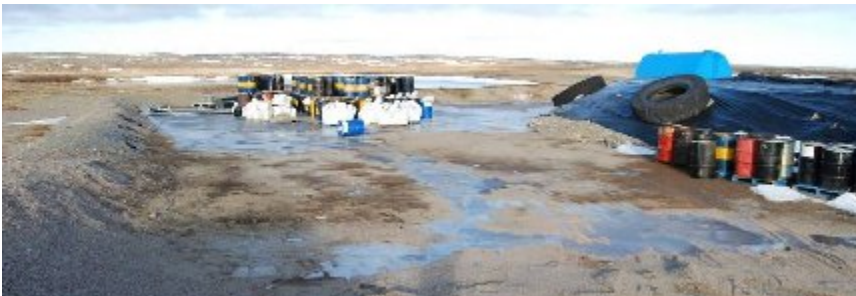
Figure 23: WTA Bulk, drummed and bagged Hydrocarbon contaminated Soil
