## 2AM-JER1119 Inspection July 4, 2012

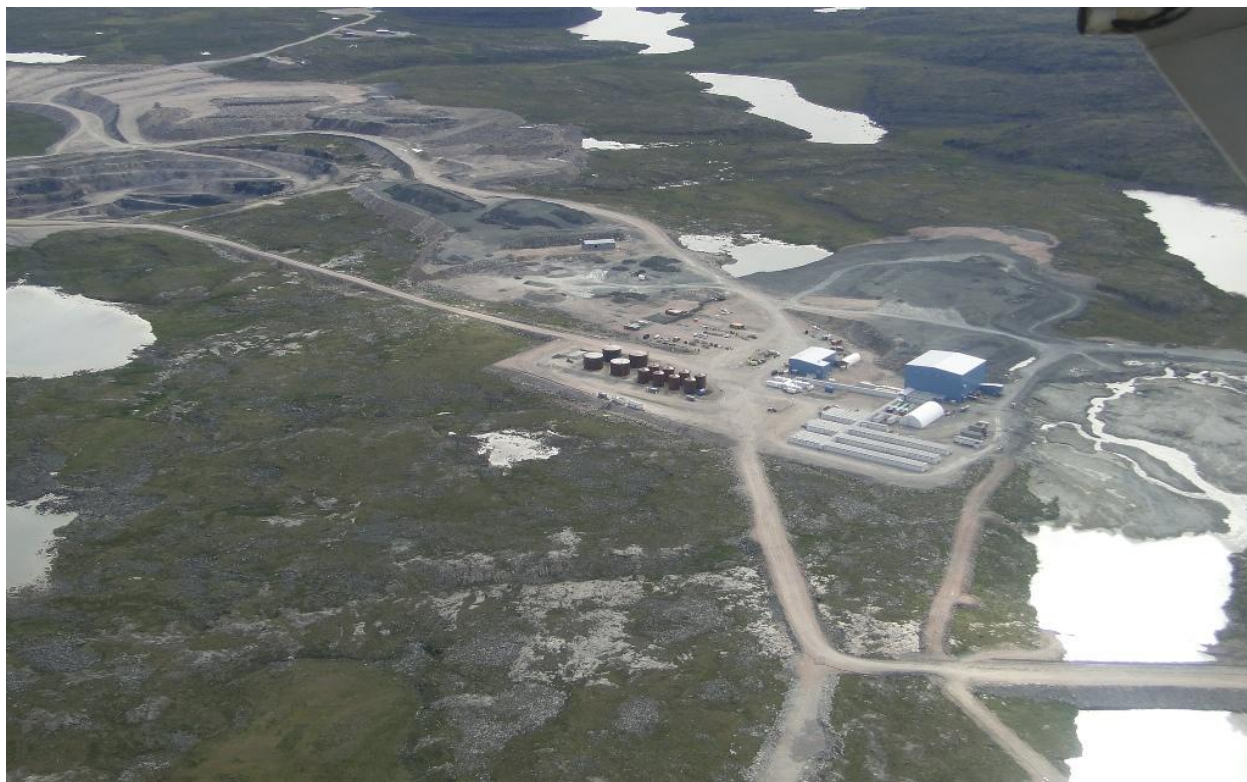
Figure 1. Jericho site

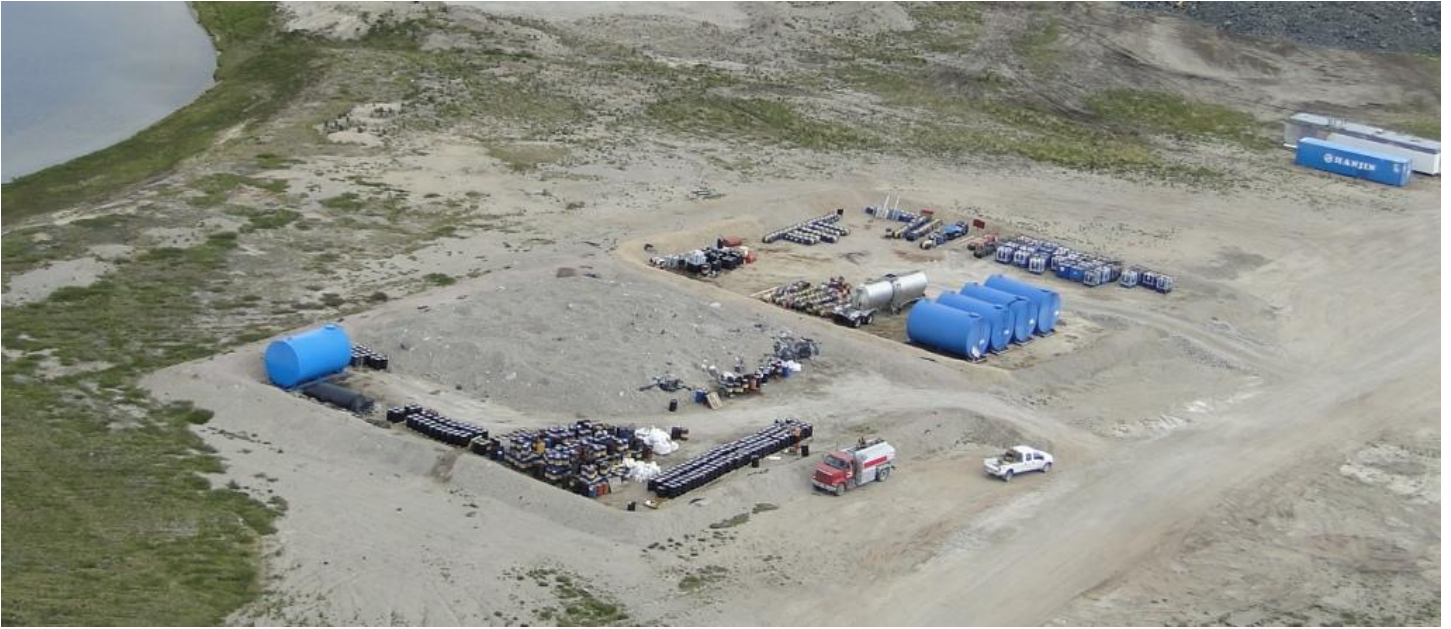
Figure 10. HWTA from above

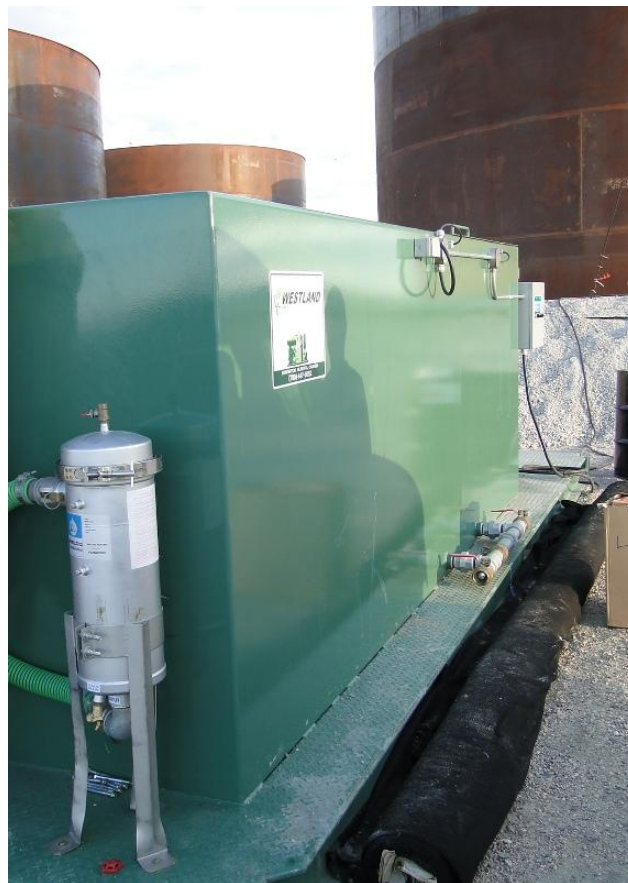
Figure 15. Shear has participated in the design of the Oztek Unit, a treatment unit for hydrocarbon-impacted water. They can now treat water on-site.

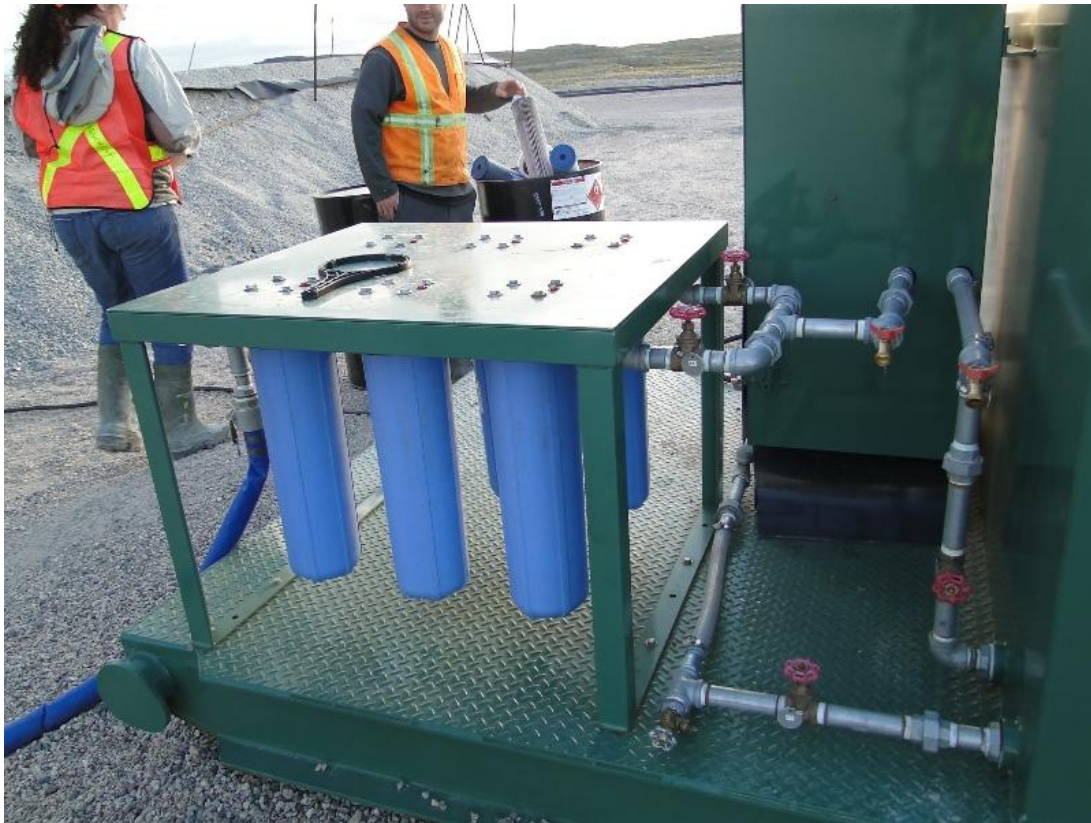
Figure 16. The Oztek uses a combination of filters and ozonation, and the only waste produced is a filter which can be incinerated.
