RE: Mitigation Monitoring Program and 'As Constructed' drawings for Fresh Water Intake Causeway in Carat Lake

Report of Mitigation Monitoring Program and ‘As Constructed’ drawings for Fresh Water Intake Causeway in Carat Lake

FIGURE 1 PLAN VIEW
PHOTOGRAPHIC VANTAGE
POINTS

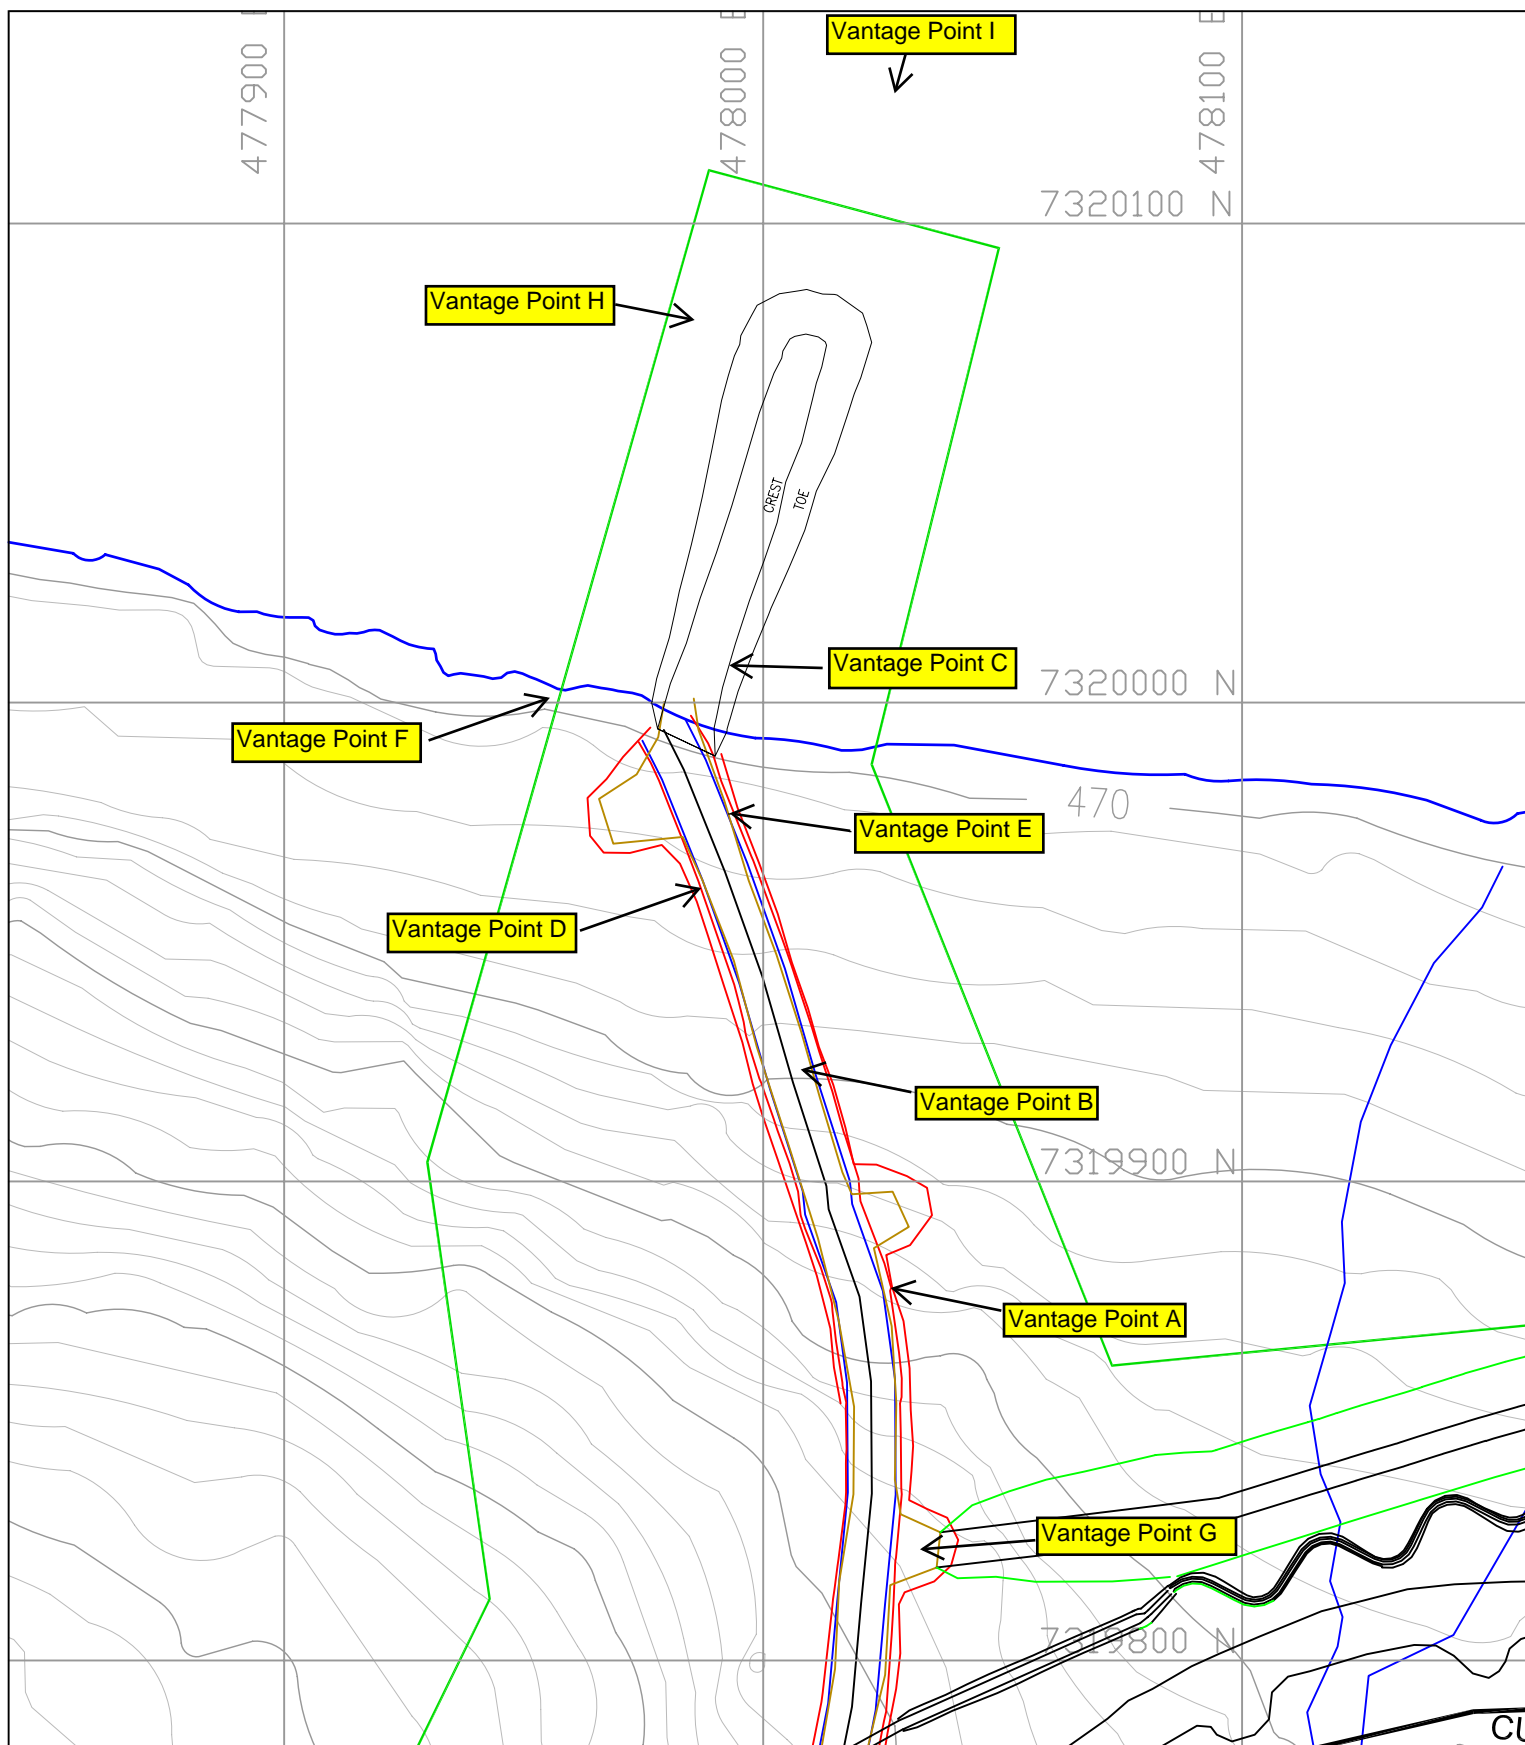
This section of the report details the phases of the construction and includes a photographic record of construction progress. Figure 1 is a plan view of the construction area showing the vantage points of pictures taken during the course of construction.

- Vantage Point A: Pictures 1, 6 and 16
- Vantage Point B: Pictures 2 and 9
- Vantage Point C: Picture 3
- Vantage Point D: Picture 4, 12 and 14
- Vantage Point E: Picture 5 and 15
- Vantage Point F: Picture 7

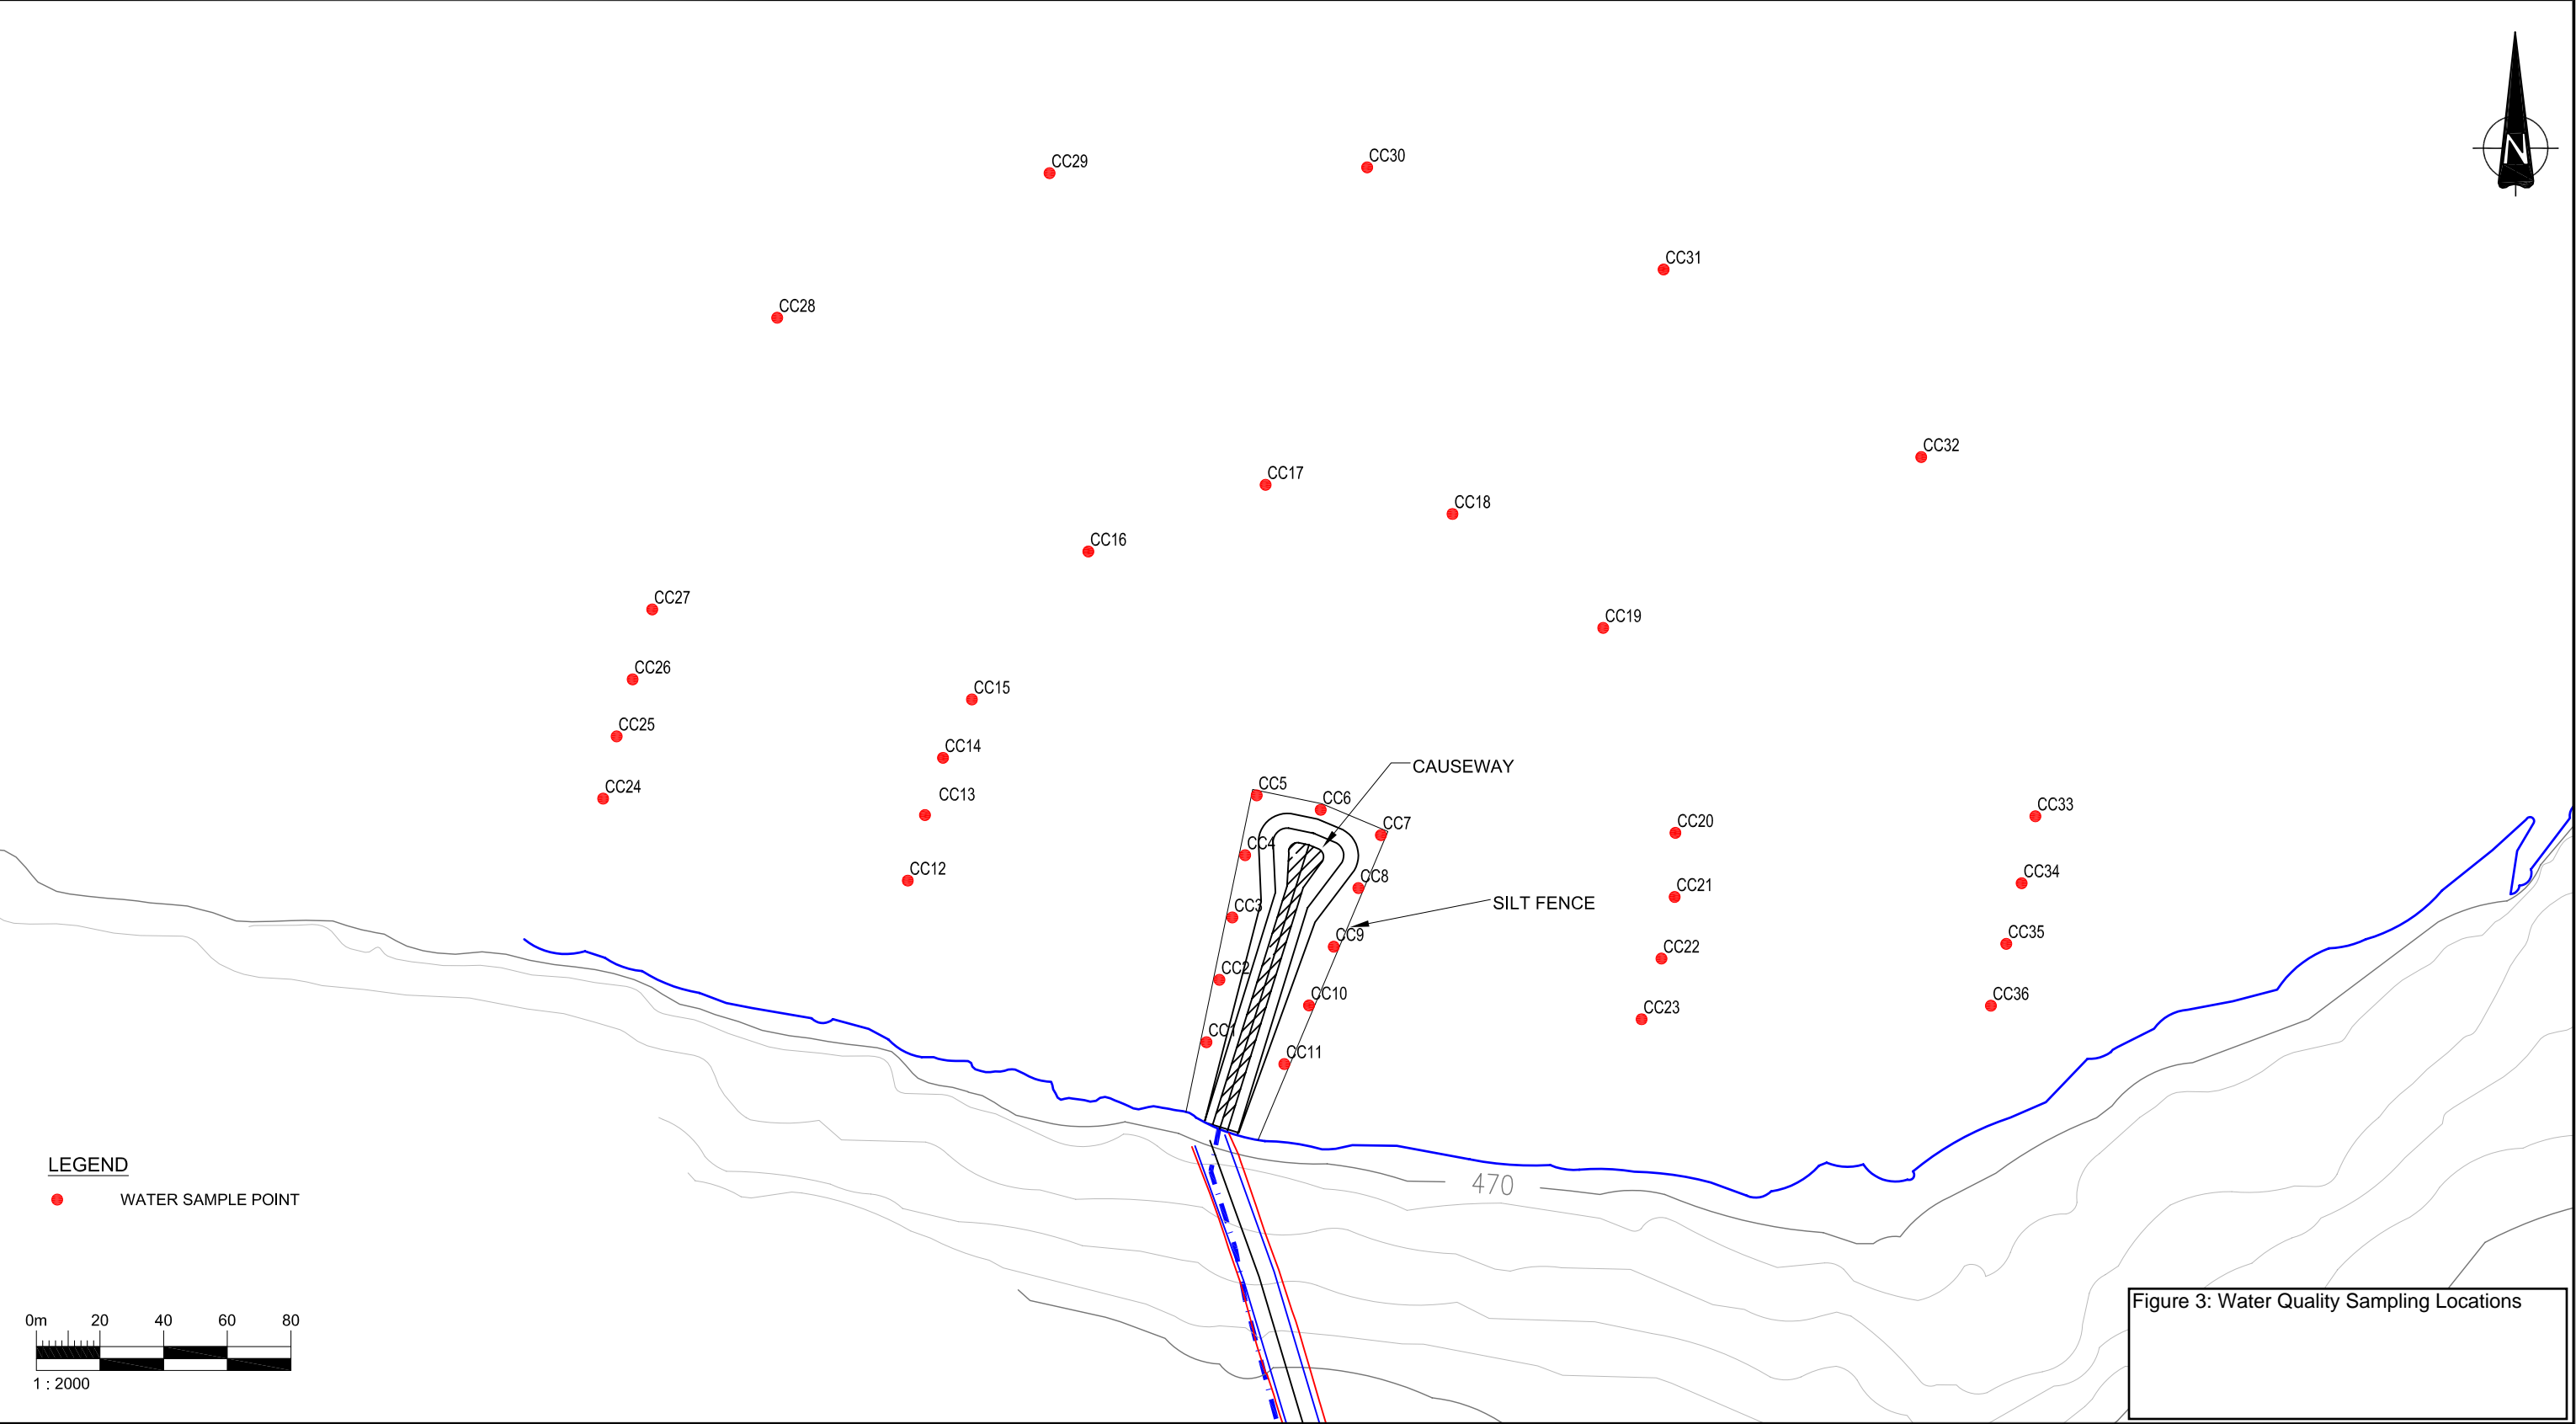
Figure 3: Water Quality Sampling Locations

Samples were collected at the 36 sampling points (Figure 3) at the end of the day August 5, 2005. During sample collection an area of slightly turbid water extended from the west side of the curtain where the curtain was pulled slightly below surface at the connection point between two segments of curtain. Water Quality results from the 5th were all near detection limit except for 5 samples inside the silt curtain on the east side that were slightly elevated.
