Tahera Diamond Corporation

NORTH DAM  
GEOTECHNICAL SITE INVESTIGATION  
JERICO DIAMOND MINE, NU

1100060.011

July 2007

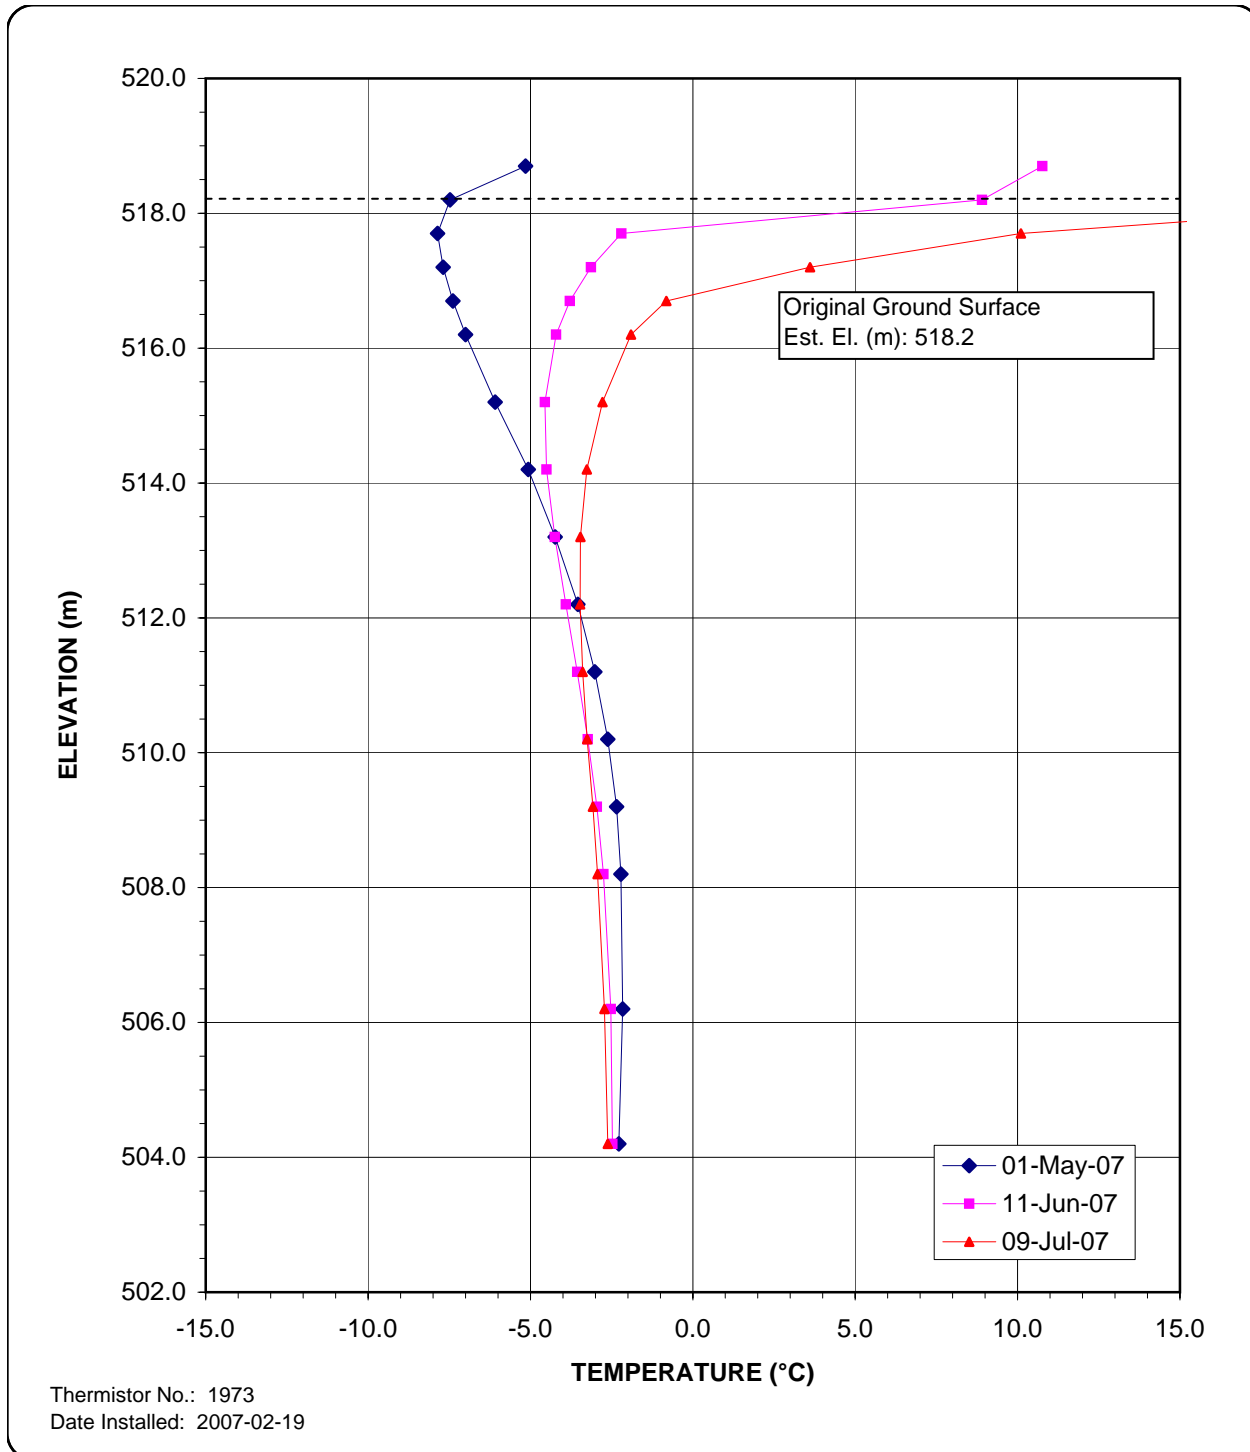
Figure 4  
Ground Temperature Profile  
Borehole ND-BH-02, GTC # 1973  
North Dam

A multibead ground temperature cable was installed in Borehole ND-BH-2 and single bead ground temperature cables were installed in Borehole ND-BH-1. The ground temperature readings from Borehole ND-BH-2 are presented in Figure 4. The readings indicated a ground temperature at depth in the order of  $-2.5^{\circ}\text{C}$ . Ground temperatures measured at Borehole ND-BH-1 are summarized in Table 5.

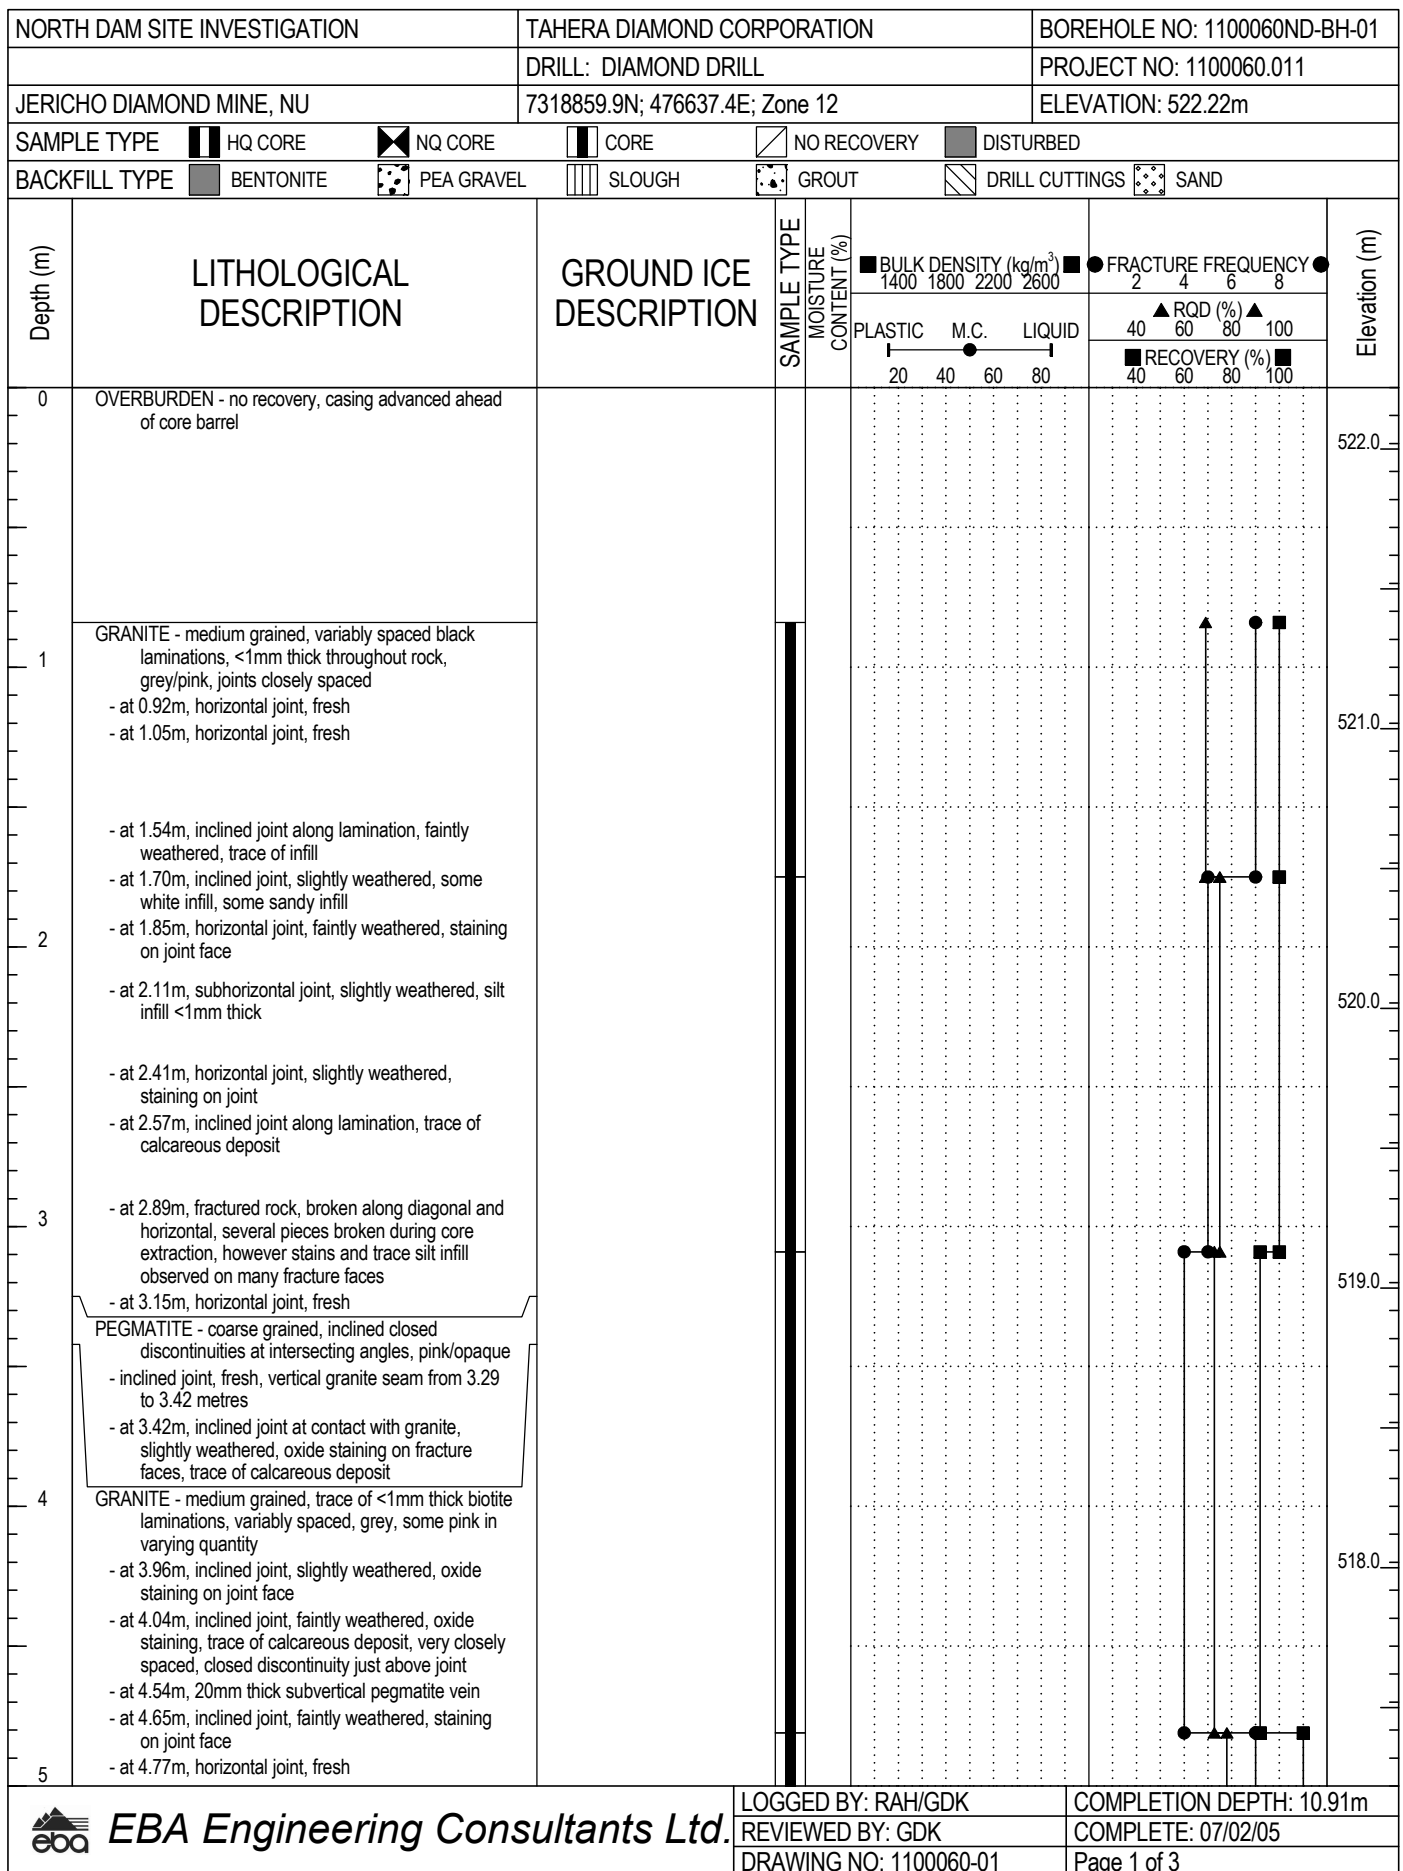
In Borehole ND-BH-1, fractured zones were encountered during drilling, which prevented filling of the borehole above a depth of 7.5 m below original ground.

Zones of fractured rock were encountered in Borehole ND-BH-1 at depths below 7.3 m. In total, four fractures zones were encountered, typically less than 300 mm in thickness. During drilling, all return water was lost when the first fractured zone was encountered at 7.3 m below original ground.

NORTH DAM SITE INVESTIGATION			TAHERA DIAMOND CORPORATION			BOREHOLE NO: 1100060ND-BH-01			
			DRILL: DIAMOND DRILL			PROJECT NO: 1100060.011			
JERICHO DIAMOND MINE, NU			7318859.9N; 476637.4E; Zone 12			ELEVATION: 522.22m			
SAMPLE TYPE			HQ CORE	NQ CORE	CORE	NO RECOVERY	DISTURBED		
BACKFILL TYPE			BENTONITE	PEA GRAVEL	SLOUGH	GROUT	DRILL CUTTINGS	SAND	
Depth (m)	LITHOLOGICAL DESCRIPTION	GROUND ICE DESCRIPTION	SAMPLE TYPE	MOISTURE CONTENT (%)	BULK DENSITY (kg/m <sup>3</sup> )		FRACTURE FREQUENCY		Elevation (m)
					PLASTIC	M.C.	LIQUID	RECOVERY (%)	
5	<ul style="list-style-type: none"><li>- at 5.20m, horizontal and inclined joint, slightly weathered, oxide staining, trace of silt infill</li><li>- at 5.27m, horizontal joint, slightly weathered, trace of silt infill</li><li>- at 5.29m, horizontal joint, faintly weathered, staining on portion of joint face</li><li>- at 5.35m, horizontal joint, faintly weathered, 2mm thick vertical pegmatite vein observed on joint face</li><li>- at 5.44m, horizontal joint, fresh, may be mechanical</li><li>- at 5.62m, horizontal joint, faintly weathered, trace of staining</li><li>- at 5.81m, horizontal joint, faintly weathered, trace of staining, inclined closed joint for 30mm</li><li>- at 5.85m, horizontal joint, faintly weathered, trace of staining</li><li>- at 5.92m, horizontal joint, fresh, may be mechanical break</li><li>- at 6.13m, horizontal and inclined joint, faintly weathered, trace of oxide staining</li><li>- from 6.32 to 6.66m, fractured zone, oxide staining on fragments, silty infill on some fragments</li><li>- at approximately 6.5m, lose all return water</li><li>- at 7.09m, pegmatite vein, coarse grained, inclined orientation, pink opaque, 50mm long</li><li>- from 7.34 to 7.52m, fractured zone</li><li>- from 7.76 to 8.06m, fractured zone, particle as small as 70mm, trace of staining on some pieces, trace of infill</li><li>- at 8.30m, 70mm thick subvertical closed joint</li><li>- at 8.37m, subhorizontal joint, slightly weathered, calcareous infill in portion of fracture face</li><li>- at 8.44m, inclined joint, fresh</li><li>- from 8.57 to 8.77m, fracture zone, 30mm pieces, rough surface, faintly weathered</li><li>- at 8.76m, vertical joint, faintly weathered, 190mm long</li><li>- from 8.91 to 9.01m, fracture zone</li><li>- at 9.11m, subhorizontal joint, some discolouration on face</li><li>- at 9.21m, horizontal joint, fresh</li><li>- at 9.61m, horizontal joint, fresh</li><li>- at 9.76m, subhorizontal joint, slightly weathered, trace of white calcareous deposit, dark discolouration on joint</li></ul>							517.0

10	- at 9.92m, horizontal joint, fresh - from 9.96 to 10.11m, fracture zone, multiple inclined vertical joints, oxide staining on fracture faces  - from 10.40 to 10.70m, fracture zone						512.0
11	END OF BOREHOLE (10.91 metres) Three single bead thermistors installed at 2.4, 5.6 and 8.7m below OG.						511.0
12							510.0
13							509.0
14							508.0
15

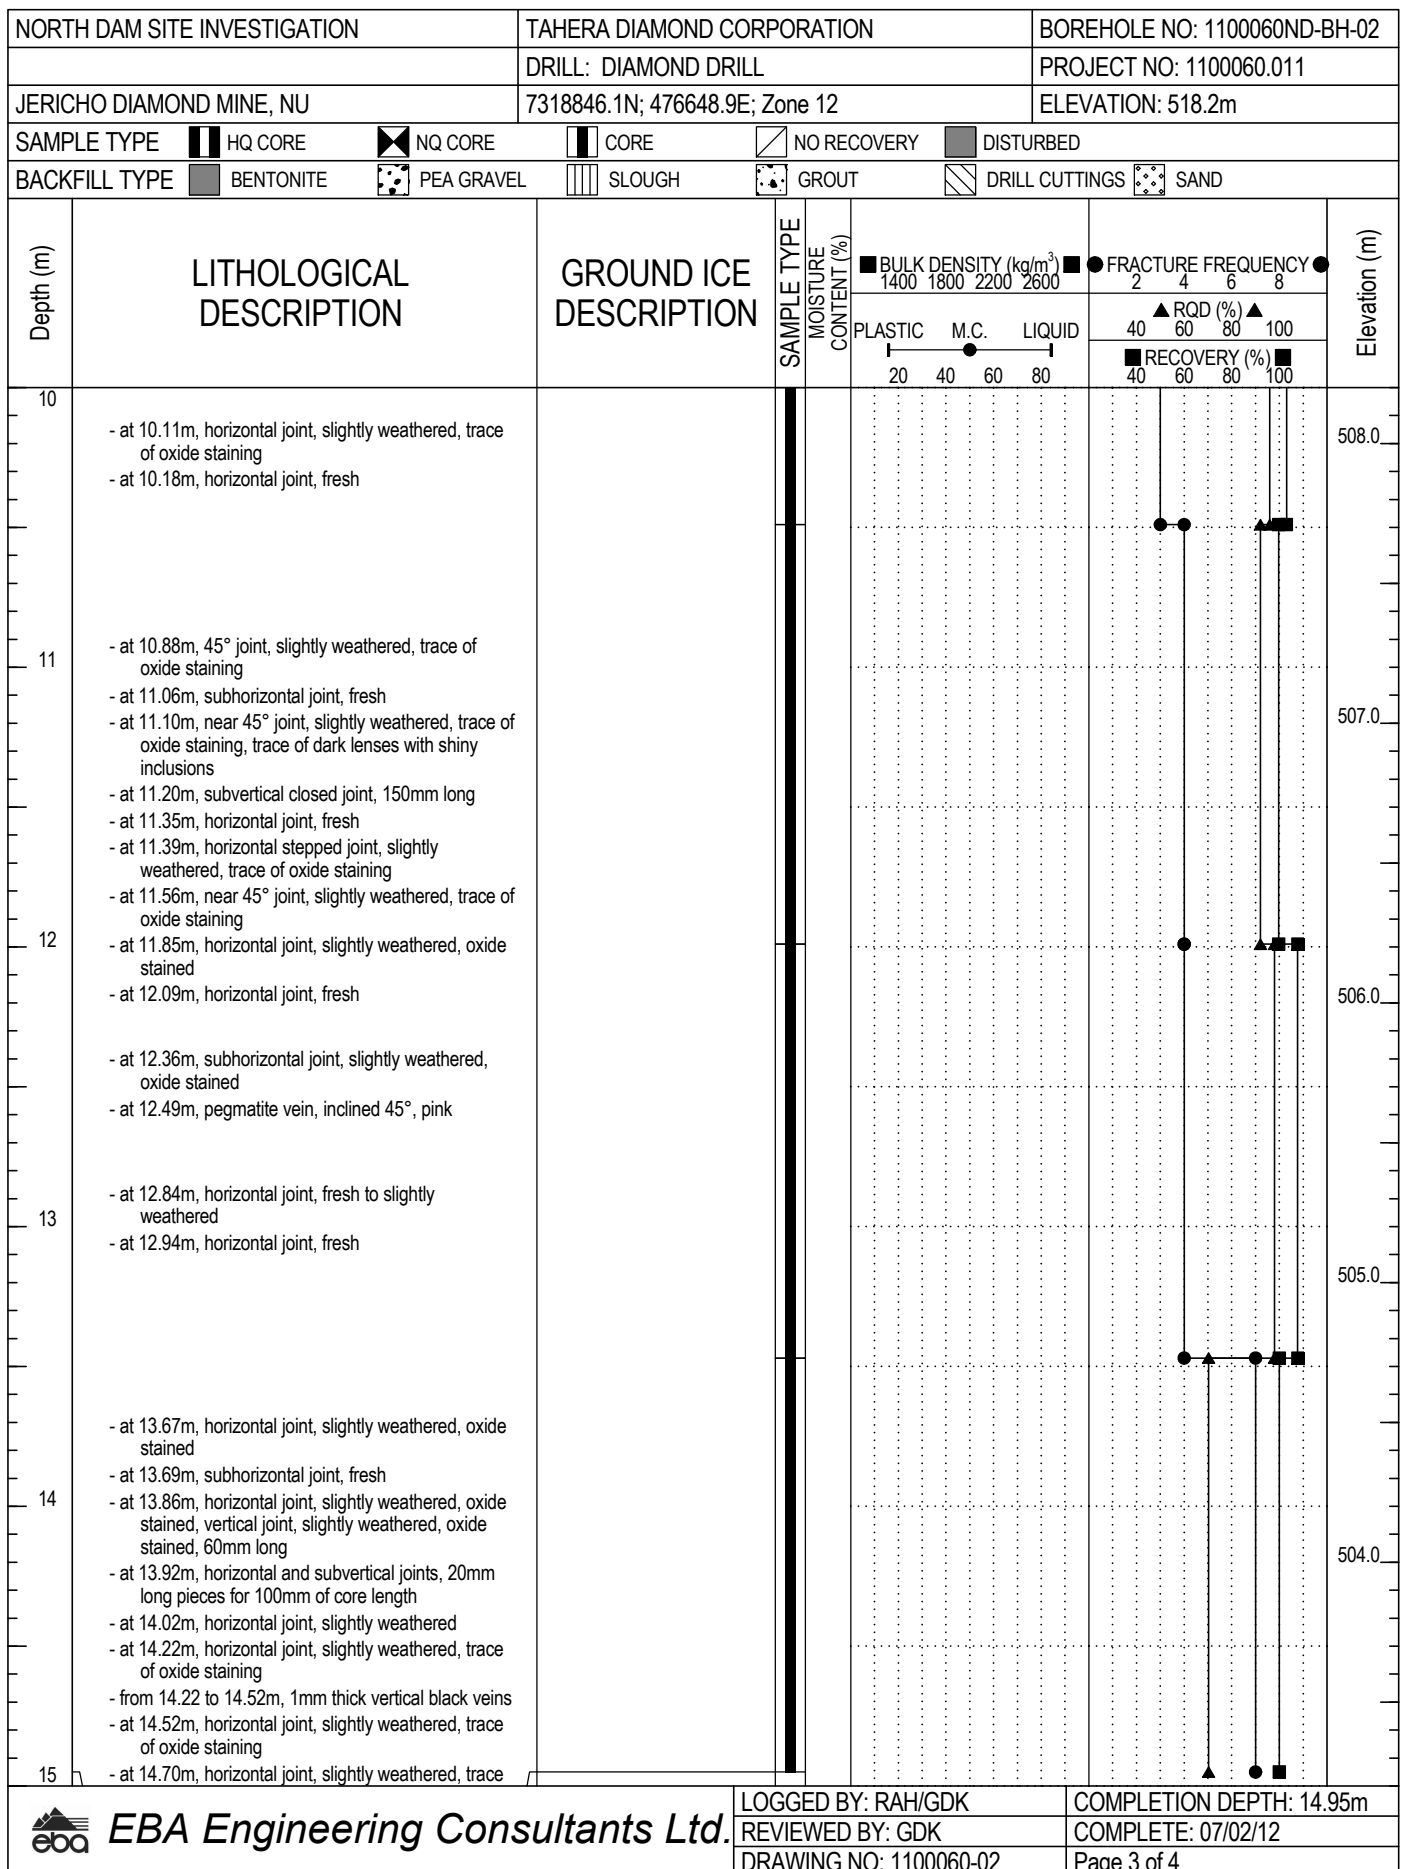
NORTH DAM SITE INVESTIGATION		TAHERA DIAMOND CORPORATION		BOREHOLE NO: 1100060ND-BH-02			
		DRILL: DIAMOND DRILL		PROJECT NO: 1100060.011			
JERICHO DIAMOND MINE, NU		7318846.1N; 476648.9E; Zone 12		ELEVATION: 518.2m			
SAMPLE TYPE		<input type="checkbox"/> HQ CORE <input checked="" type="checkbox"/> NQ CORE <input type="checkbox"/> CORE <input type="checkbox"/> NO RECOVERY <input type="checkbox"/> DISTURBED					
BACKFILL TYPE		<input type="checkbox"/> BENTONITE <input type="checkbox"/> PEA GRAVEL <input type="checkbox"/> SLOUGH <input type="checkbox"/> GROUT <input type="checkbox"/> DRILL CUTTINGS <input type="checkbox"/> SAND					
Depth (m)	LITHOLOGICAL DESCRIPTION	GROUND ICE DESCRIPTION	SAMPLE TYPE	MOISTURE CONTENT (%)	<input type="checkbox"/> BULK DENSITY (kg/m <sup>3</sup> ) 1400 1800 2200 2600	<input type="checkbox"/> FRACTURE FREQUENCY 2 4 6 8	Elevation (m)
					PLASTIC    M.C.    LIQUID 20 40 60 80	<input type="checkbox"/> RQD (%) 40 60 80 100

15	of oxides END OF BOREHOLE (14.95 metres) Ground thermistor cable installed.						503.0
16							502.0
17							501.0
18							500.0
19							499.0
20

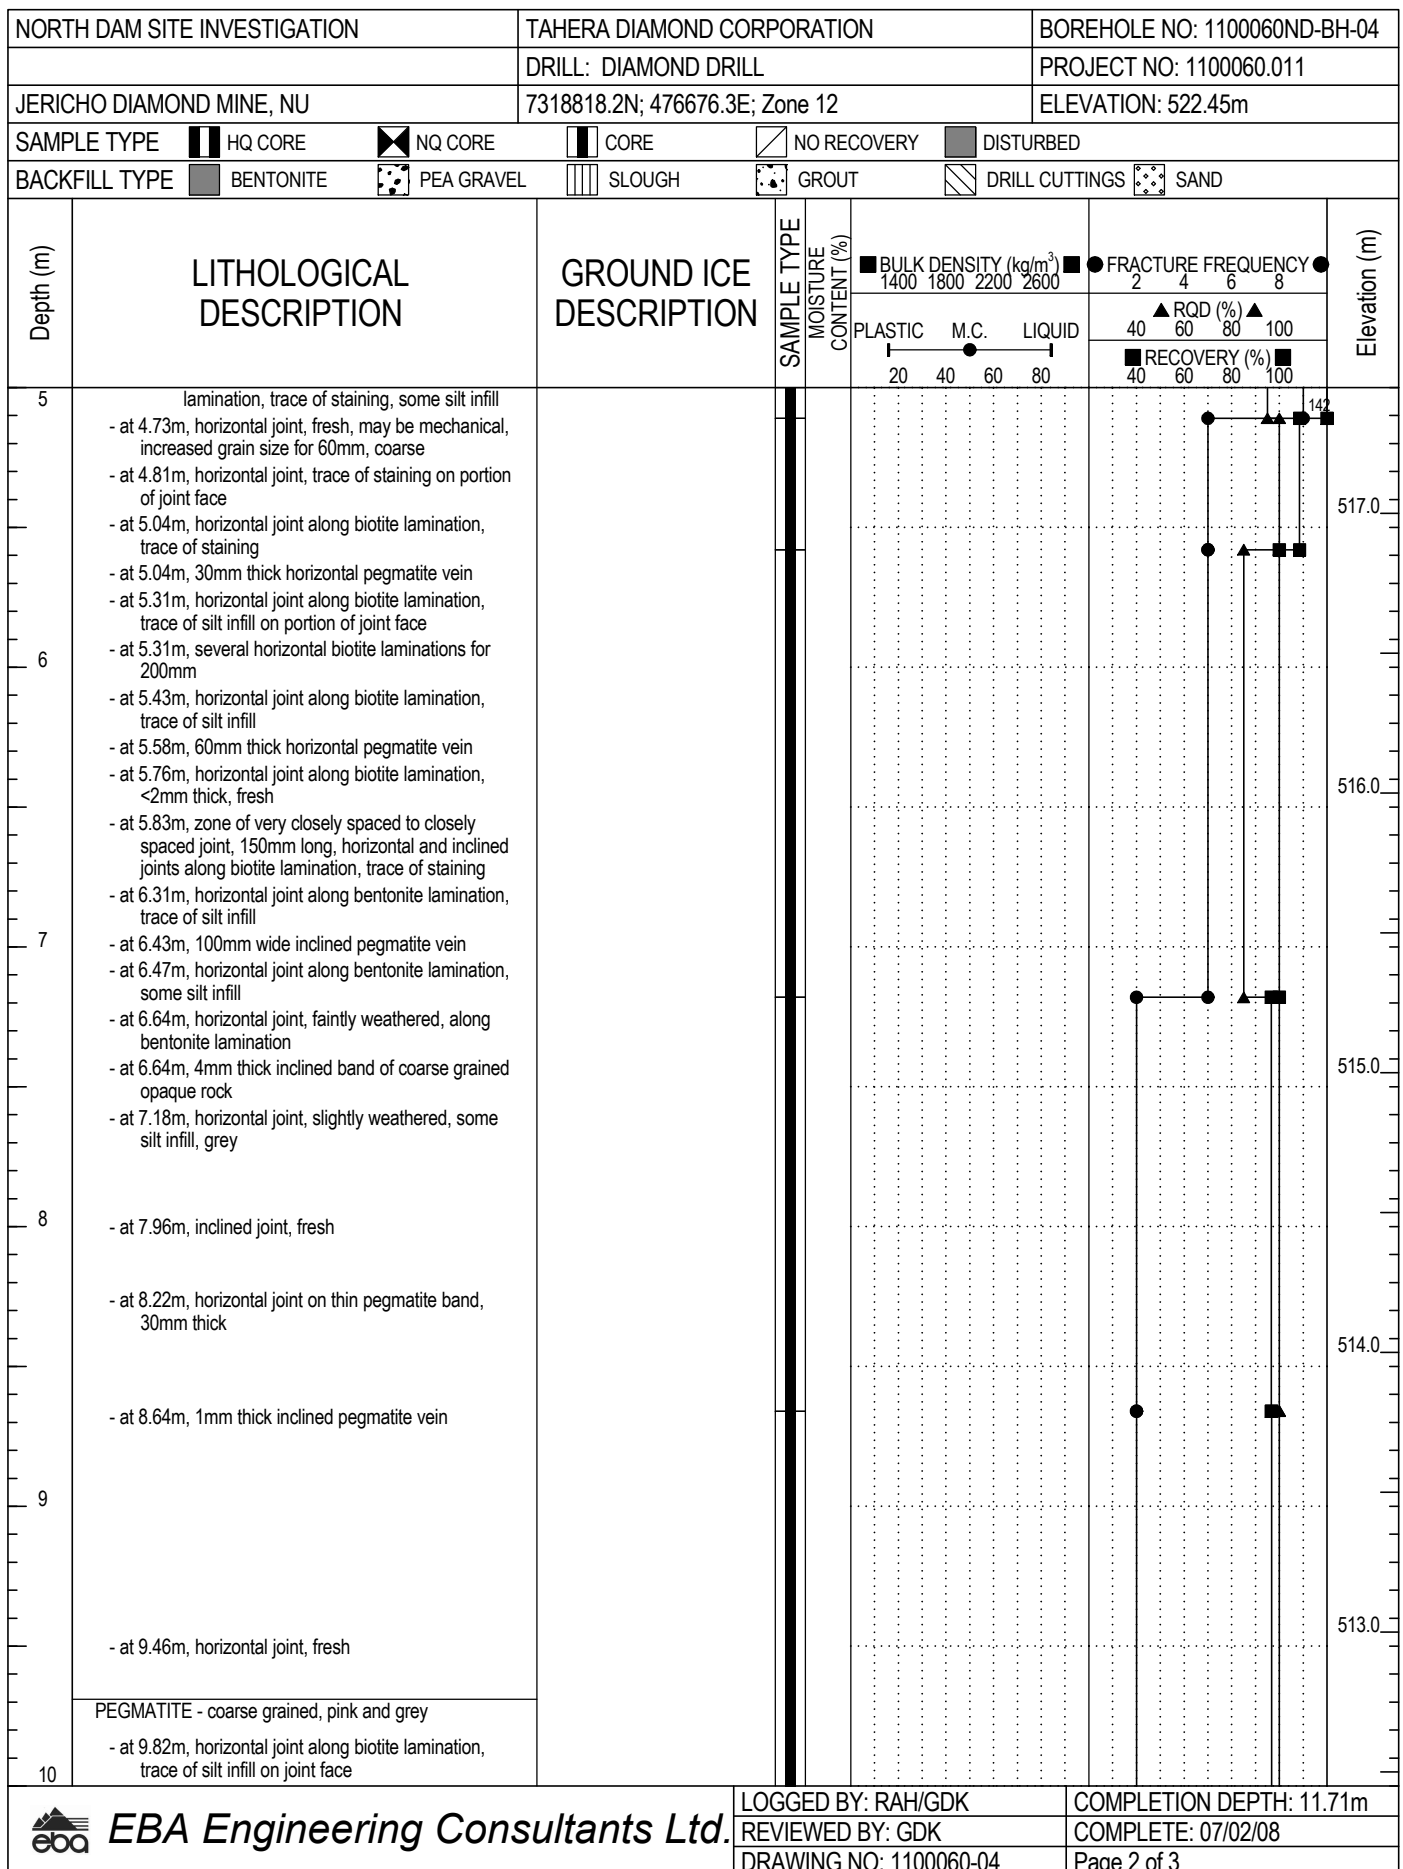
NORTH DAM SITE INVESTIGATION		TAHERA DIAMOND CORPORATION		BOREHOLE NO: 1100060ND-BH-04			
		DRILL: DIAMOND DRILL		PROJECT NO: 1100060.011			
JERICHO DIAMOND MINE, NU		7318818.2N; 476676.3E; Zone 12		ELEVATION: 522.45m			
SAMPLE TYPE		<input checked="" type="checkbox"/> HQ CORE <input checked="" type="checkbox"/> NQ CORE <input type="checkbox"/> CORE <input type="checkbox"/> NO RECOVERY <input type="checkbox"/> DISTURBED					
BACKFILL TYPE		<input type="checkbox"/> BENTONITE <input type="checkbox"/> PEA GRAVEL <input type="checkbox"/> SLOUGH <input type="checkbox"/> GROUT <input type="checkbox"/> DRILL CUTTINGS <input type="checkbox"/> SAND					
Depth (m)	LITHOLOGICAL DESCRIPTION	GROUND ICE DESCRIPTION	SAMPLE TYPE	MOISTURE CONTENT (%)	BULK DENSITY (kg/m <sup>3</sup> ) 1400 1800 2200 2600 PLASTIC    M.C.    LIQUID 20 40 60 80	FRACTURE FREQUENCY 2 4 6 8 RQD (%)    40 60 80 100 RECOVERY (%)    40 60 80 100	Elevation (m)

10	GRANITE - medium to coarse grained, joints very closely spaced, pink  - at 10.68m, horizontal joint, slightly weathered, dull grey/green deposit on joint face - at 10.74m, horizontal joint, slightly weathered, trace of oxide staining and calcareous infill/deposit on part of joint face - at 10.74m, broken rock for 30mm - at 10.77m, horizontal joint, faintly weathered, trace of silt infill - at 11.30m, horizontal joint, fresh - at 11.50m, vertical fracture, faintly weathered to run end, likely due to extraction						512.0
11							511.0
12	END OF BOREHOLE (11.71 metres)						510.0
13							509.0
14							508.0
15
