2012 Annual Geotechnical Inspection – Lupin Mine Tailings Containment Area, Nunavut

Lupin Mines Incorporated

SRK Consulting (Canada) Inc.
1CL008.000
November 2012

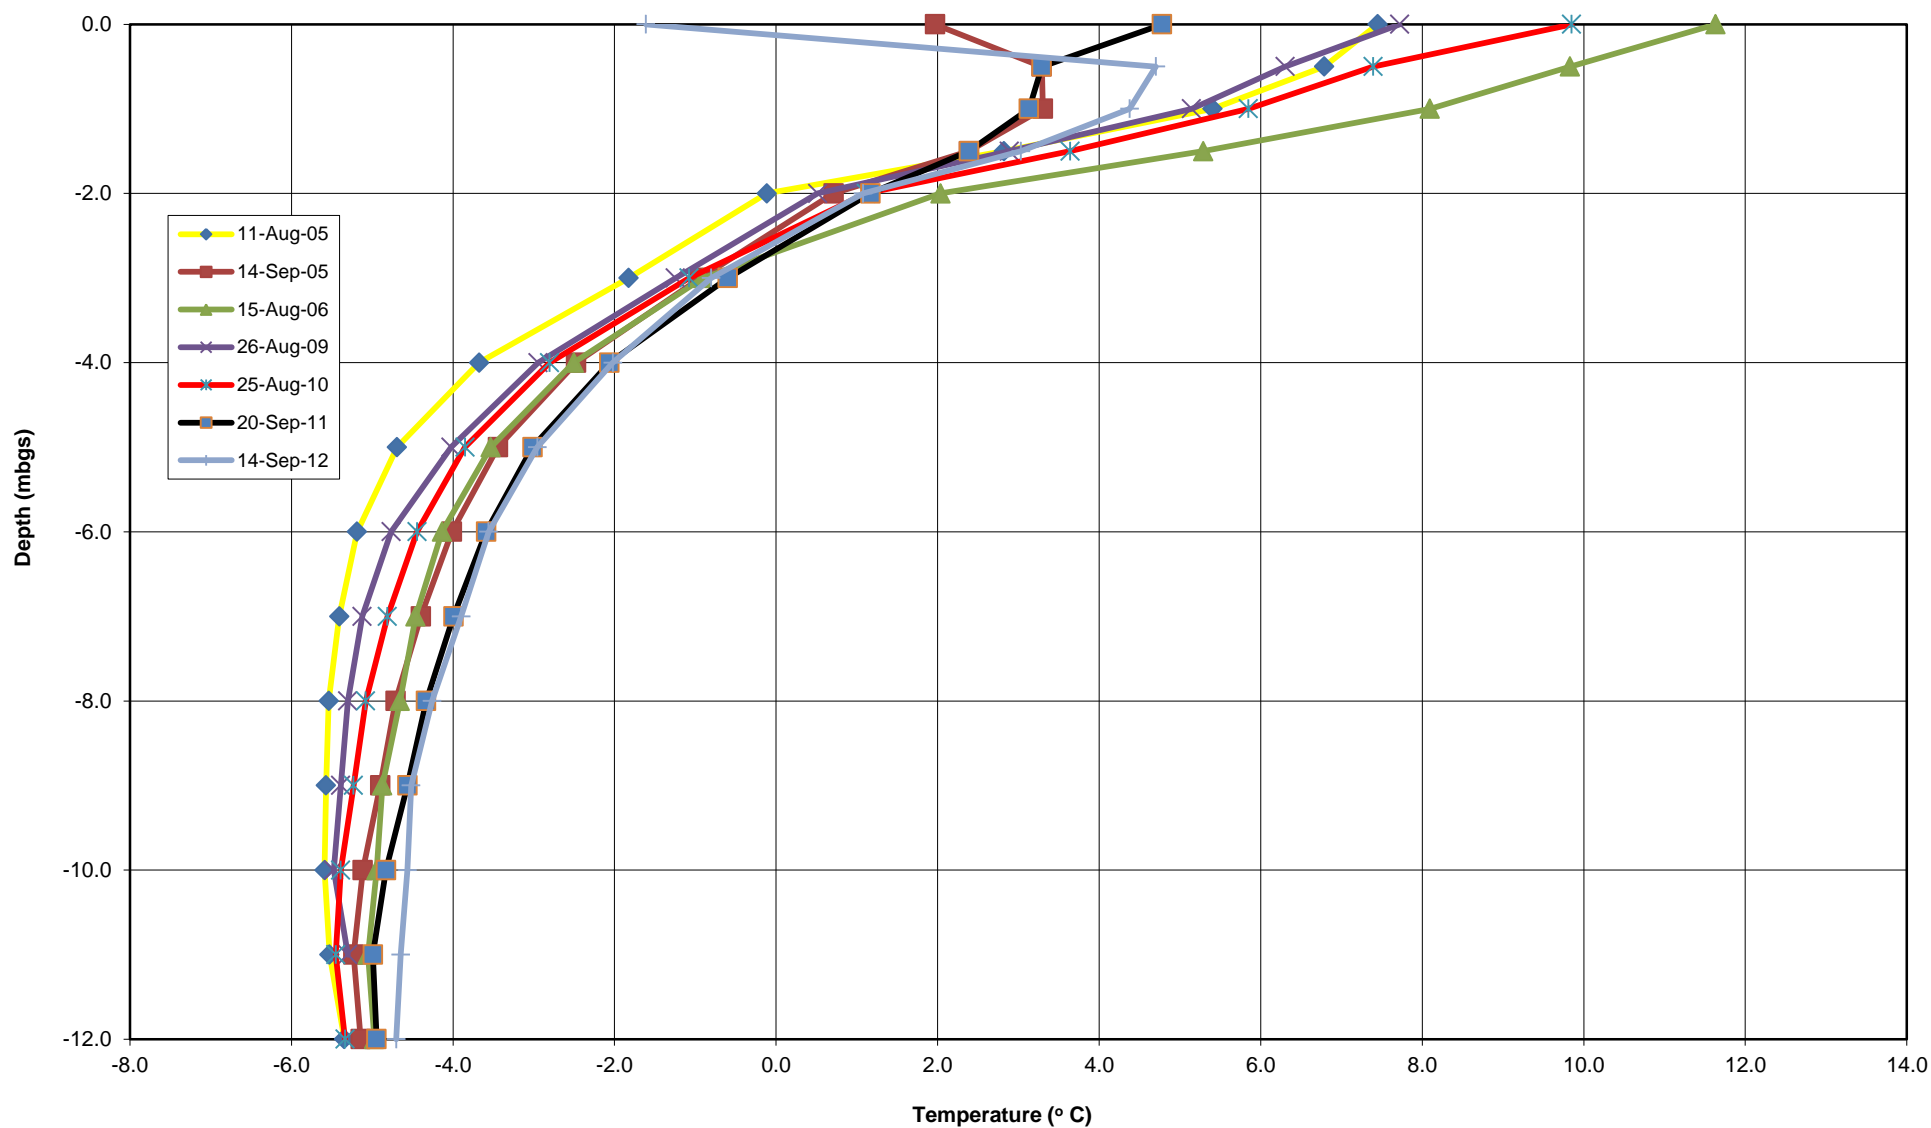
Figure:
3.1

In the TCA, all five of the thermistors are less than 20 m deep. Based on the data since 2005, taking into account annual climatic variations, there is no trend showing permafrost degradation. The largest variation occurs in Dam 1A, of 3°C in the given data set, at approximately 5 m below dam crest. This variation occurs below -3°C; and the -1°C gradient occurs at approximately 3 m below the surface. This concurs with the regional active zone. These records indicate the frozen core in the dam is performing satisfactorily and the general trends support that permafrost is not degrading. Figure 3.1 to Figure 3.5 show the thermistor data read during summer periods from 2005 to present.

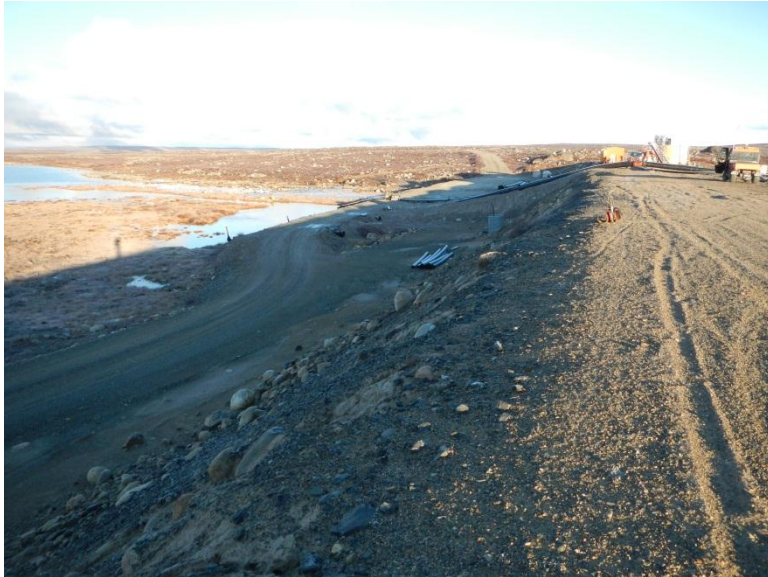
DS Slope of Dam 1A

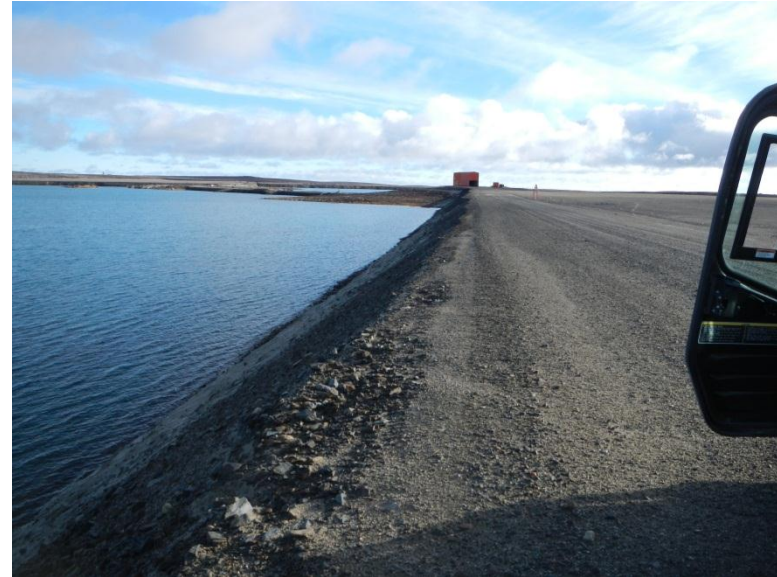
DS Slope of Dam K

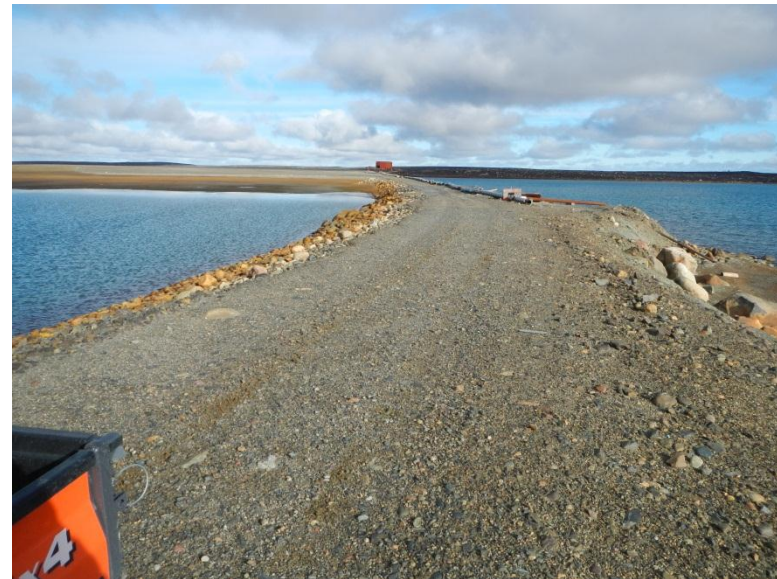
During the inspection, a substantial erosion breach was observed at the south end of Dam L. It is assumed that the erosion was caused by the freshet where the water from the uncovered portion of Cell 3 breached into Cell 4. From physical observation and conversation with site staff, it appears that the Cell 3 water level has not been managed in recent years. This raised water level breached the lowest point in Dam L and discharged into Cell 4. Section 4 of this report provides recommendations to deal with the breached section in Dam L.
