KINROSS Gold Corporation

PROJECT ANNUAL INSPECTION OF PERIMETER TAILINGS DAMS				
TITLE				
DAM 4 INSPECTION PHOTOS				
PROJECT No.		DWG. No.	REV.	
0256-009-02		10	0

BGC Engineering Inc. AN APPLIED EARTH SCIENCES COMPANY

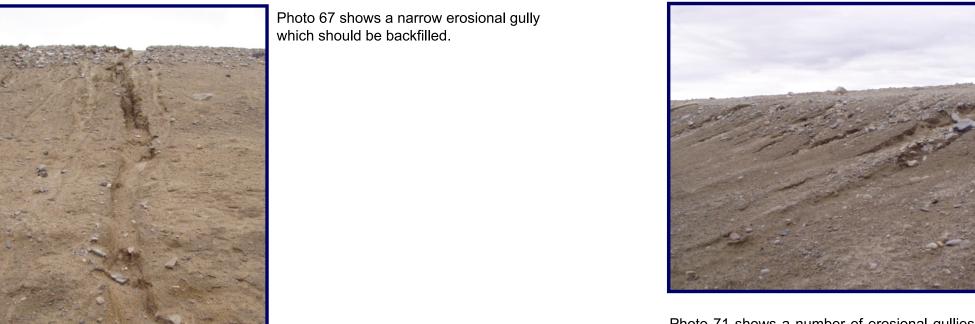
Photo 71 shows a number of erosional gullies right at the west abutment on the downstream side. These should be backfilled to prevent any additional erosion.
