Canada – Lupin Mine NWB Water License No: 2AM-LUP0914

2010 Annual Report to the Nunavut Water Board

2010 Annual Geotechnical Inspection
Perimeter Dams Tailings
Containment Area
Lupin Mine, Nunavut

2010 GEOTECHNICAL INSPECTION
PERIMETER TAILINGS DAMS

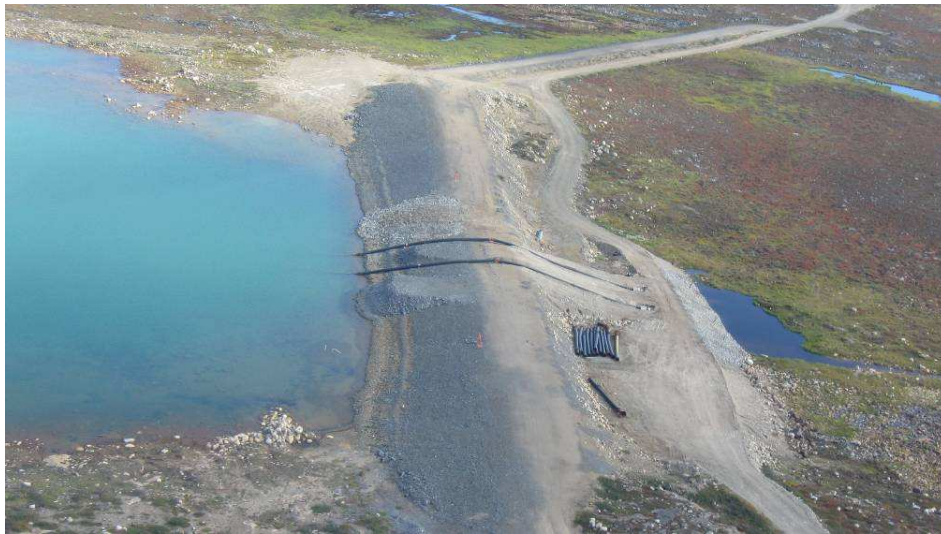
Dam 1A Overview

LOCATION:	West side of Pond 2.
FUNCTION:	Major perimeter closure for water retention; siphon pipes for water decant system on the crest of the dam. Pond level presently being lowered using siphons
LENGTH:	250 +/- m
MAX HEIGHT:	8 m +/- above d/s tundra.
AS-BUILT CREST ELEVATION:	486.27 m
CURRENT CREST ELEVATION:	486.1 – 486.4 m
POND ELEV.:	481.8 m
FREEBOARD :	4.3 m
CREST WIDTH AND CONDITION:	7 to 8 m; surfaced with esker material, but not traveled because of the siphons. No significant cracking evident; condition remains good.
RIPRAP:	Run of Mine rockfill; broadly graded; good condition.
BACKSLOPE:	<p>Approx. 1.5H; 1V; variably armored with cobbles and boulders. Of the 5 siphon pipes in place last year, only 2 remain in service. The most northerly 3 siphon pipes have been completely removed while the 2 most southerly siphon piles have been left in-place below the access road. In the area of the two remaining siphon pipes, the pipe supports along the stream slope have been removed and the slope flattened with granular fill to support the siphon pipes. This slope flattening was carried out over a length of approximately 26 m. Slope flattening was not carried out in the area of the three abandoned siphon pipes.</p> <p>Two ,1 m long cracks noted near the downstream crest, likely due to shallow sloughing as a result of the formation of widespread shallow erosion gullies along downstream slope. Erosion is most predominant south of the remaining 2 siphon pipes.</p>

SEEPAGE:	No evidence of seepage.
INSTRUMENTATION:	Thermistor D1A-00-1 is located in the crest, just south of the mid-point of the dam. However, this thermistor was not operational.
MAINTENANCE RECOMMENDATIONS:	Maintenance is recommended to repair erosion along areas of the downstream slope.
CONCLUSIONS:	The dam is appears to be in a stable condition. Maintenance of downstream erosion is recommended.

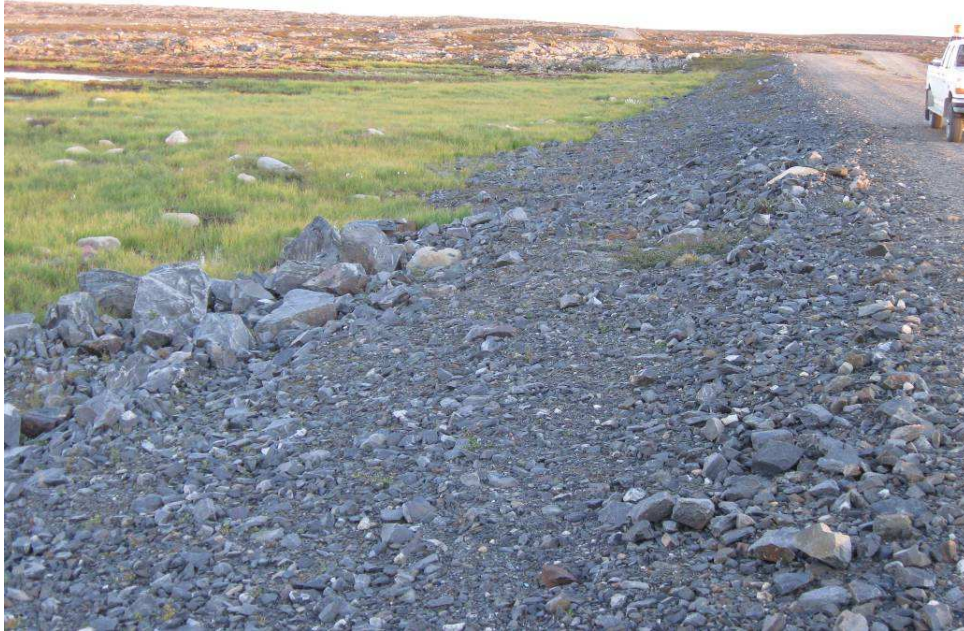
Dam 1B: Upstream

LOCATION:	West side of Pond 2.
FUNCTION:	Major perimeter closure for water retention; pond level is below dam base elevation thus currently functioning only as a road embankment.
LENGTH:	250 +/- m
MAX HEIGHT:	2.5 +/- m above d/s tundra.
AS-BUILT CREST ELEVATION:	485.83 m
CURRENT CREST ELEVATION:	485.4 – 485.6 m
POND ELEV.:	481.8 m
FREEBOARD :	3.6 m
CREST WIDTH AND CONDITION:	5 to 6 m wide; surfaced with esker material. Downstream berm provides roadway for access around the perimeter of the TCA. Crest condition is good.
RIPRAP:	Run of Mine rockfill; variable sizes in good condition overall.
BACKSLOPE: toe-of-	Approx. 1.5H; 1V with minor runoff erosion rills and gullies and a slope roadway berm. No cracking observed..
SEEPAGE:	No seepage observed
INSTRUMENTATION:	None.
MAINTENANCE RECOMMENDATIONS:	Maintenance of downstream surface erosion should be considered.
CONCLUSIONS:	The dam appears to be in a stable condition. Maintenance of downstream erosion is recommended.

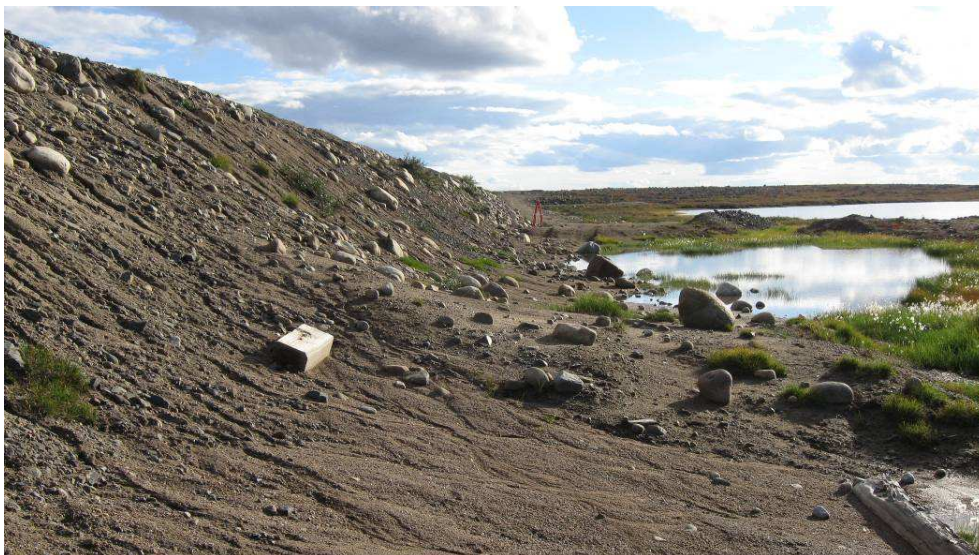
Dam 2: Downstream Slope

One small area of light seepage was noted along the downstream toe. At the time of this inspection, the seepage water was free of sediment and piping conditions were not evident. It is possible the seepage conditions may become worse over time and with an increase in level of Pond 2. It is possible that some of the water ponding on the downstream side of the dam

originates from seepage through the dam and/or under the dam, through the foundation soils. Seepage may also be related to recent precipitation that may have infiltrated the downstream portion of the dam. A sample of the seepage water should be collected to assess if the source can be Pond 2.

The geotechnical conditions at Dam 2 should be investigated to determine the in situ fill conditions and to measure pore water levels in the dam. In addition, an additional thermistor string may be considered at the seepage location to review the depth of frozen ground. Once conditions at the site are determined, remediation of the downstream slope should be undertaken. Remediation options may involve construction of suitable granular filter zones and / or construction of a suitable impermeable barrier to significantly reduce seepage losses. Widening of the base of the dam to attract the aggradation of permafrost conditions into the deep foundation of the dam may also be considered as a design alternative.

The investigation and design and approvals work should be undertaken in 2011. With suitable monitoring and some temporary remediation efforts, construction of the slope improvements may be scheduled for 2012. In the interim, the water ponded downstream of the dam should be sampled to ensure environmental compliance and may require containment and pump back over the dam. The water level in Pond 2, should be lowered as much as possible to reduce seepage gradients until such time as the seepage conditions are understood and/or corrective measures can be implemented. The seepage conditions at Dam 2 should be monitored and the mine should be prepared to implement immediate temporary repair to the dam should conditions deteriorate.

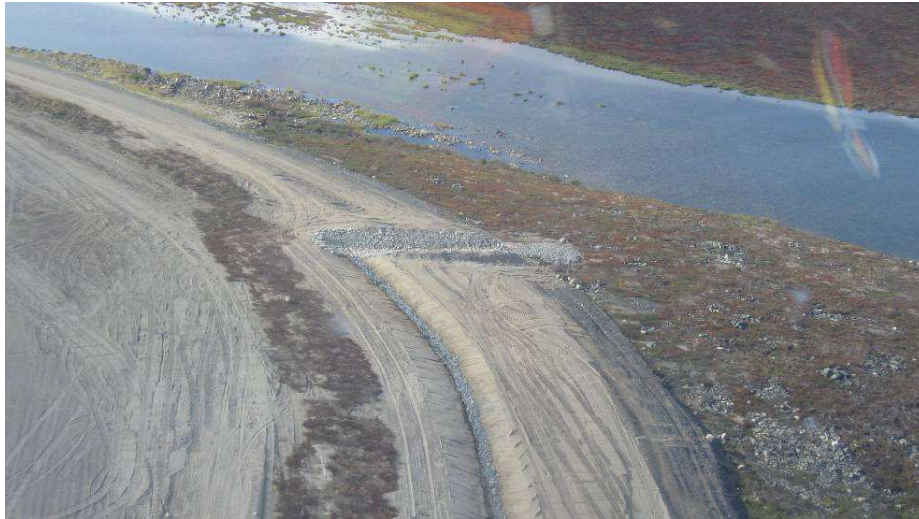
Dam 3: Overview

LOCATION:	East end of now-covered tailings storage area, east of Cells 1 and 2.
FUNCTION:	Minor perimeter closure for tailings retention; Boomerange Lake downstream of the dam. The dam retains tailings covered with an esker material cap
LENGTH:	600 +/- m
MAX HEIGHT:	2.5 +/- m above d/s tundra.
AS-BUILT CREST ELEVATION:	488.4 m
CREST WIDTH AND CONDITION:	Approx. 8 m; surfaced with esker material. In 2010, a new upstream ditch outlet spillway was constructed across the dam to replace the existing spillway which did not appear to have sufficient capacity. While the new spillway has a significant increase in capacity over the original spillway, the new spillway was constructed smaller than specified and as such may have less capacity than designed for. In addition, a portion of the upstream ditch has been reconstructed between the old and new spillway locations has been lined with riprap (without geotextile) over a length of approx. 100 m. The existing ditch upstream of the reconstructed section has experienced some erosion and deposition of sediment. Between the old and new spillway locations, the crest of the dam has been recovered with esker material in a loose condition.

RIPRAP:	Not applicable: Inside slope buried with cover comprised of esker sand and gravel.
BACKSLOPE:	Variable in inclination; locally meets the shoreline of Boomerang Lake. Some minor erosion rills and sloughing were noted.
SEEPAGE:	None observed.
MAINTENANCE RECOMMENDATIONS:	The loosely placed esker material along the crest should be compacted to improve resistance to erosion. The existing ditch southeast of the regraded section should be cleaned out to remove accumulated material. The newly regarded portion of the upstream ditch should be inspected for future signs of erosion. The new spillway performance should be monitored for signs of erosion and/or inadequate capacity.
CONCLUSIONS:	The dam appears to be in a stable condition. Maintenance and inspection as recommended above should be carried out.

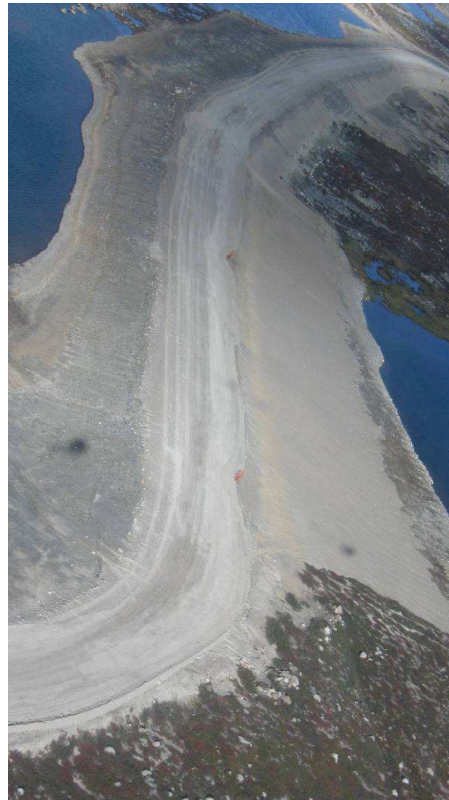
Dam 4: Overview

Measures to address a seepage issues noted last year along Dam 4 (in the area of the downstream coffer dam) have been carried out. This involved in filling the area between the downstream toe and coffer dam, thus flattening the downstream slope. However, the fill material appears to have been placed in a loose manner. As a minimum, surface compaction of the newly placed fill should be considered to improve erodability of the new fill surface.

Dam appears to be in a stable condition. Maintenance of extensive downstream erosion should be carried out to prevent further deterioration of the dam.

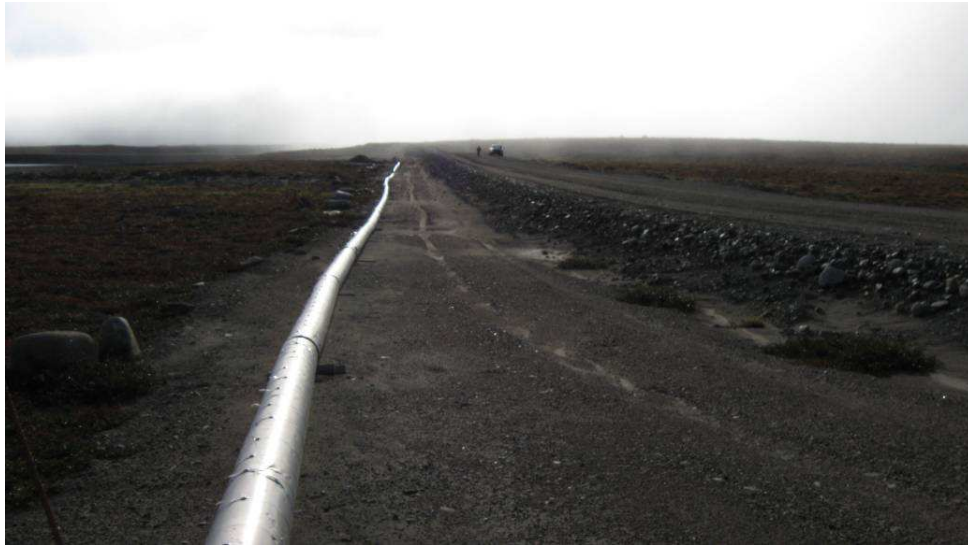
Dam 5: Upstream

LOCATION:	Southeast corner of Cell 3, just northwest of Dam 4.
FUNCTION:	Minor perimeter closure intended for future tails and water retention; currently functioning as a road embankment.
LENGTH:	250 +/- m
MAX HEIGHT:	1.5 +/- m above d/s tundra.
AS-BUILT CREST ELEVATION:	491.54 m
CREST WIDTH AND CONDITION:	Approximately 8 m wide and esker surfaced so that the dam may also function as roadway. Crest is in generally good condition.
RIPRAP:	Approximate slope of 3H:1V and in good condition.
BACKSLOPE:	About 1.5 to 2H:1V with till and esker sand. 2 small cracks noted along downstream shoulder along east half of dam (indication of possible shallow sloughing). A few small 150 mm deep erosion gullies have formed along downstream slope.
SEEPAGE:	No seepage observed. No water head being retained by the majority of structure.
MAINTENANCE RECOMMENDATIONS:	Downstream erosion should be maintained.
CONCLUSIONS:	The dam appears to be in a stable condition. Maintenance of downstream erosion recommended.

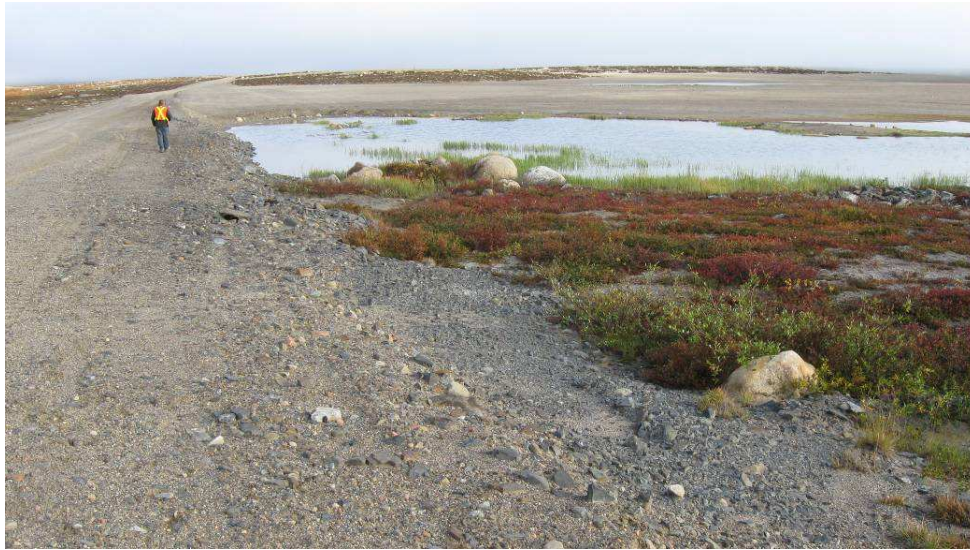
Dam 6: Upstream

LOCATION:	West side of Cell 3 retaining tailings.
FUNCTION:	Minor perimeter closure. Retaining some tailing beach and ponded water on the northern portion of the dam.
LENGTH:	300 +/- m
MAX HEIGHT:	2.5 +/- m above d/s tundra.
AS-BUILT CREST ELEVATION:	490.25 m previously
CREST WIDTH AND CONDITION:	Approximately 10 m wide and esker surfaced to function as a roadway. Crest in good condition.
RIPRAP:	Not applicable for most of dam. Upstream side tailings have been covered with esker sand and gravel. Riprap along upstream slope in area of small upstream pond.
BACKSLOPE:	About 2H:1V with till and esker sand; extensive erosion gullies have now formed along downstream slope (up to 0.5 m deep).
SEEPAGE:	No seepage observed.
MAINTENANCE RECOMMENDATIONS:	Backfilling of ponded area may be considered (as previously recommended). Maintenance of downstream erosion is recommended.
CONCLUSIONS:	The dam appears to be in a stable condition. Maintenance of downstream erosion is recommended.

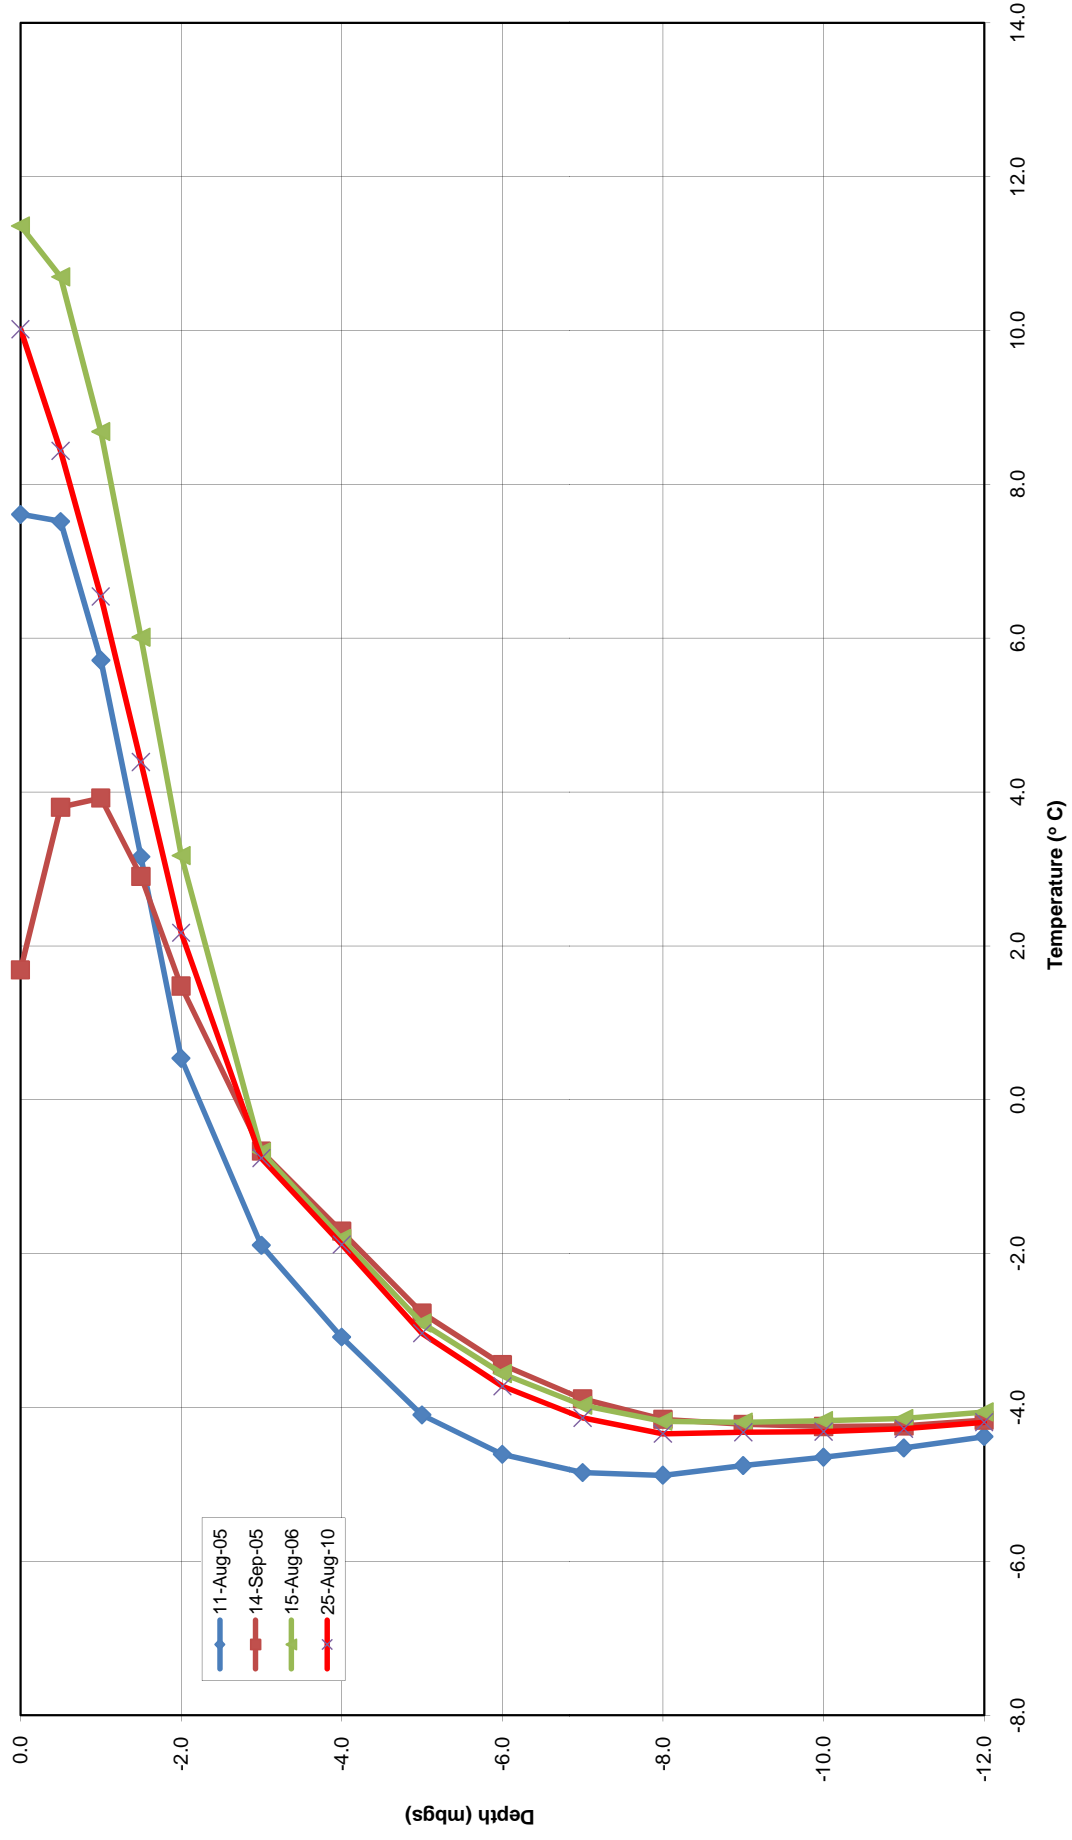
Thermistor D4-3 - Installed October 25, 1995
(Vertical Thermistor installed on the crest of Dam 4, West End, Just East of TD4-4)

A review of the thermistor data available indicates the dams continue to maintain frozen conditions below the active zone, located approximately 2 m below grade. Many of the thermistor strings are now damaged and/or not readable. It is recommended that the thermistor monitoring program be reviewed and updated. Damaged thermistors should be replaced and additional thermistor strings may be warranted.
