WATER LICENCE INSPECTION FORM

| Lupin Mines Inc. | | Karyn Lewis | |
| 2AM-LUP0914(expired)(amended) | | | |
| 14/07/2015 | | Eva Paul | |

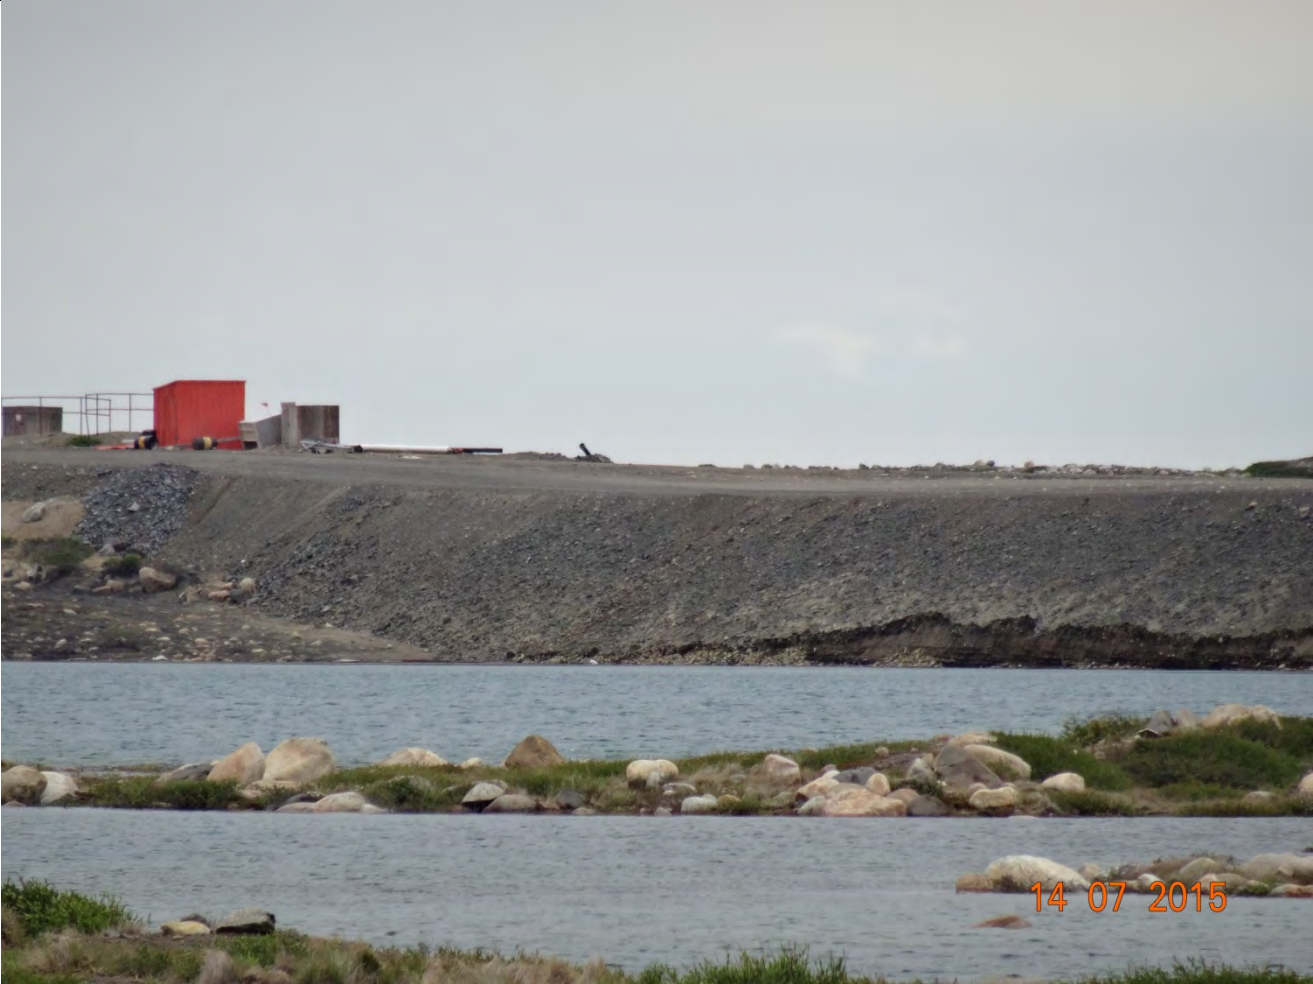
Photo #DSC03073

Description: View of eroded internal TCA dam.

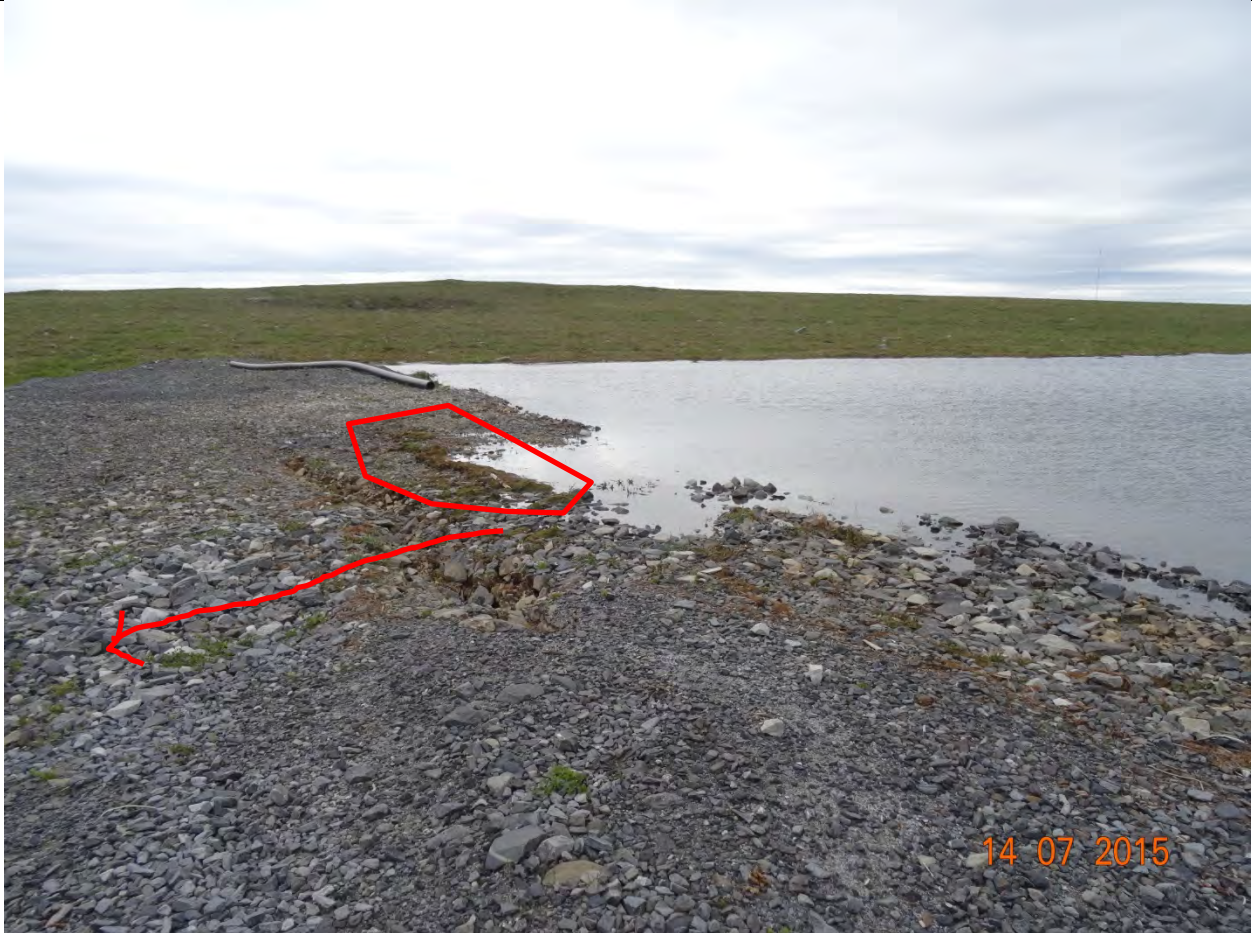
| Photo # DSC03122 | N65°45'28.96" W111°12'55.92" |

**Description:** Compromised section of Lower Sewage Dam. Effluent was trickling over this section at the time of the inspection in the direction of the arrow. It is suspected that the flow was greater prior to the inspection. Contents of LSL are pushed onto the berm (circled area).
