ECHO BAY MINES LTD.

2000 GEOTECHNICAL INSPECTION OF PERIMETER TAILINGS DAMS

LUPIN MINE NUNAVUT

PROJECT NO.: 0256-001-01
DATE: OCTOBER 3, 2000

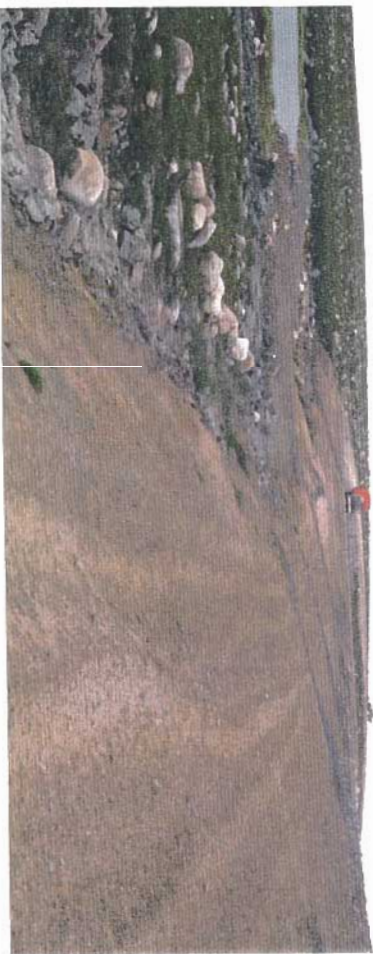
Two shot panoramic of some of the disturbances on the upstream side riprap of Dam #4. This disturbance has been noted in previous inspections.
