**RE: Echo Bay Mines Ltd., Lupin Gold Mine, Contwoyto Lake, NT.; Water Licence
NWB1LUP0008; 2001 Annual Geotechnical Inspection**

2001 GEOTECHNICAL INSPECTION OF PERIMETER TAILINGS DAMS

LUPIN MINE NUNAVUT

PROJECT NO.: 0256-003-02
DATE: SEPTEMBER 26, 2001

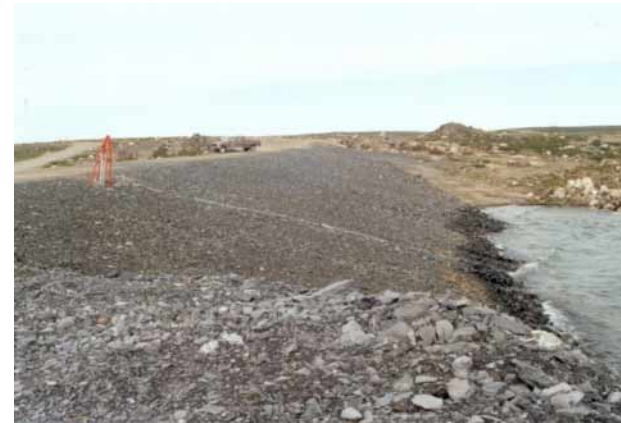
View of the overall slope situated on the riprap side of the dam.

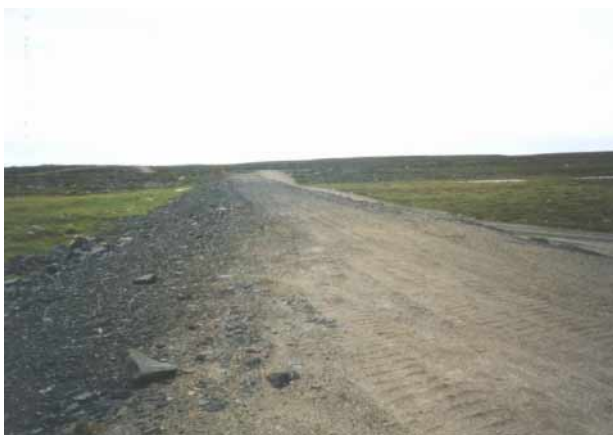
View of the crest on the upstream side of this dam. The crest is somewhat well travelled with the tire marks still visible. As previously noted, the upstream side is somewhat undulating.

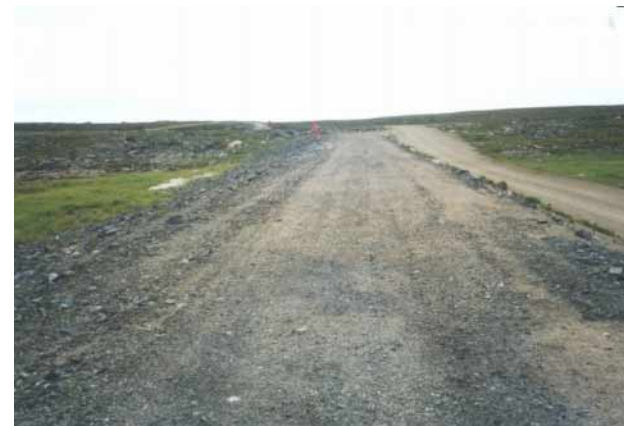
Shows another view of the crest of the Dam 1B. It should be noted that the dam does not retain any water.

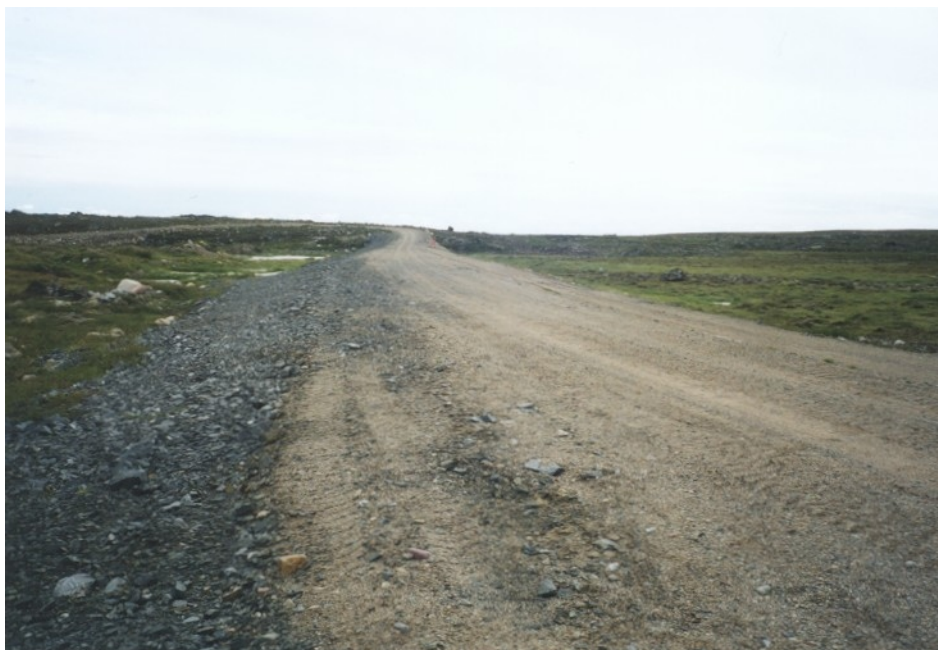
View of the upstream side and crest of Dam 1C looking towards the south. The crest is relatively well travelled as is the small access road on the downstream side.

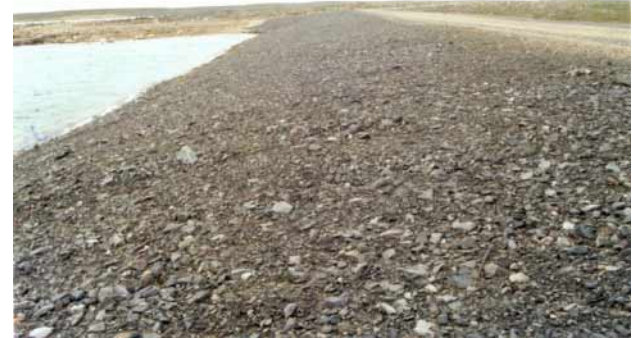
Another view of the riprap on the upstream side of the dam.

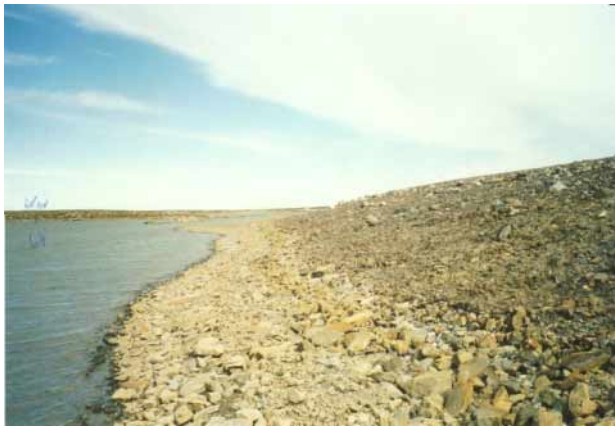
View taken from the waterline on the upstream side of the dam. This distance from waterline to the crest is approximately 3 metres.

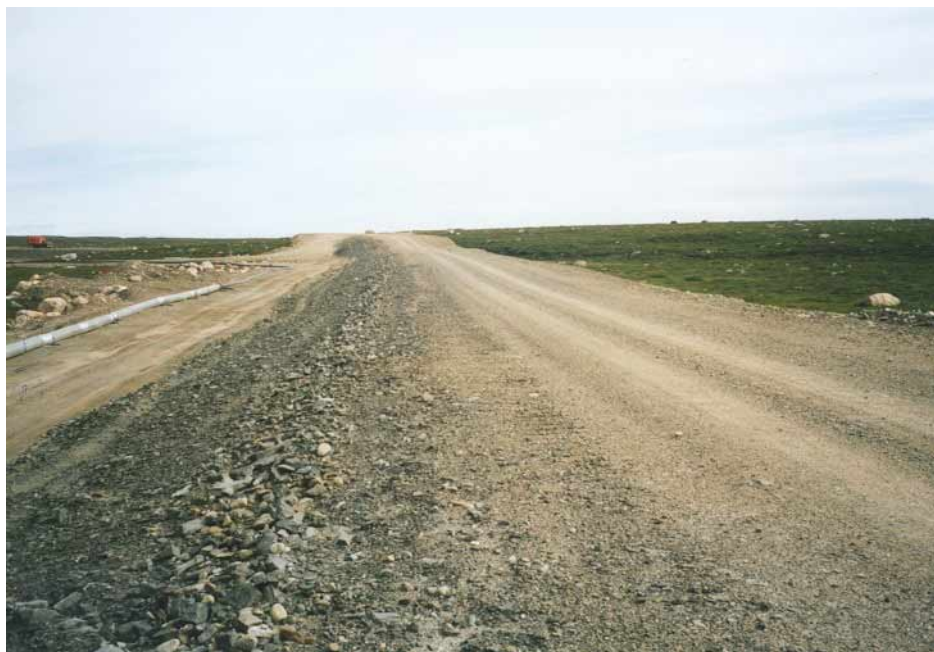
View of the crest and upstream side of this dam. As can be seen, the crest is relatively well travelled and there are no signs of cracking or deformation within the dam embankment.

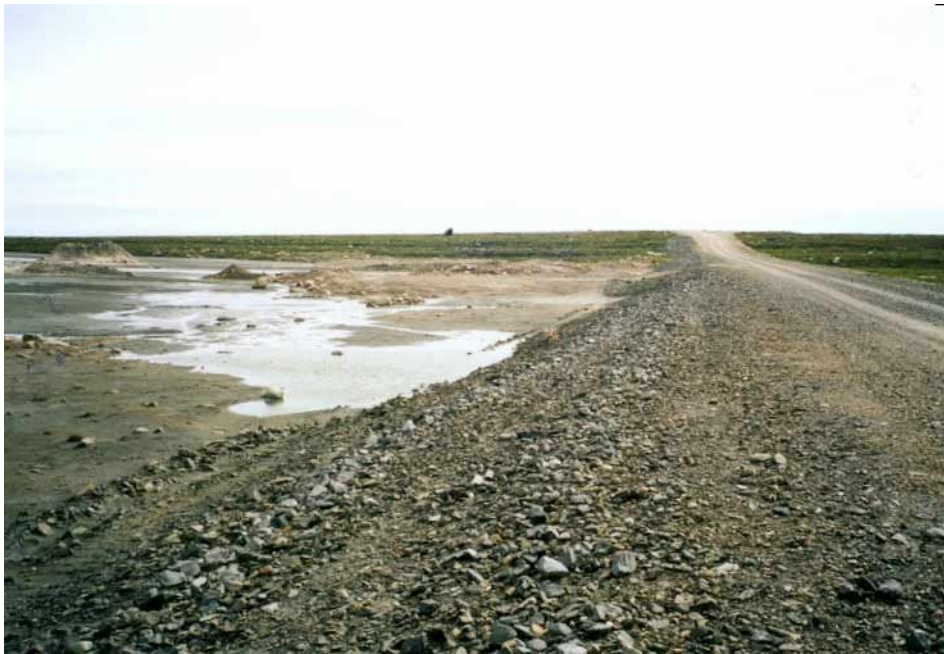
Shows a view of the upstream side of the dam up to its southern abutment.
