**RE: Kinross Gold Corporation, Lupin Mine, Contwoyto Lake, NU.
Water License NWB1LUP0008
2006 Annual Geotechnical Report**

2006 GEOTECHNICAL INSPECTION PERIMETER TAILINGS DAMS

LUPIN MINE NUNAVUT

PROJECT NO.: 0256-012-01
DATE: OCTOBER 10, 2006

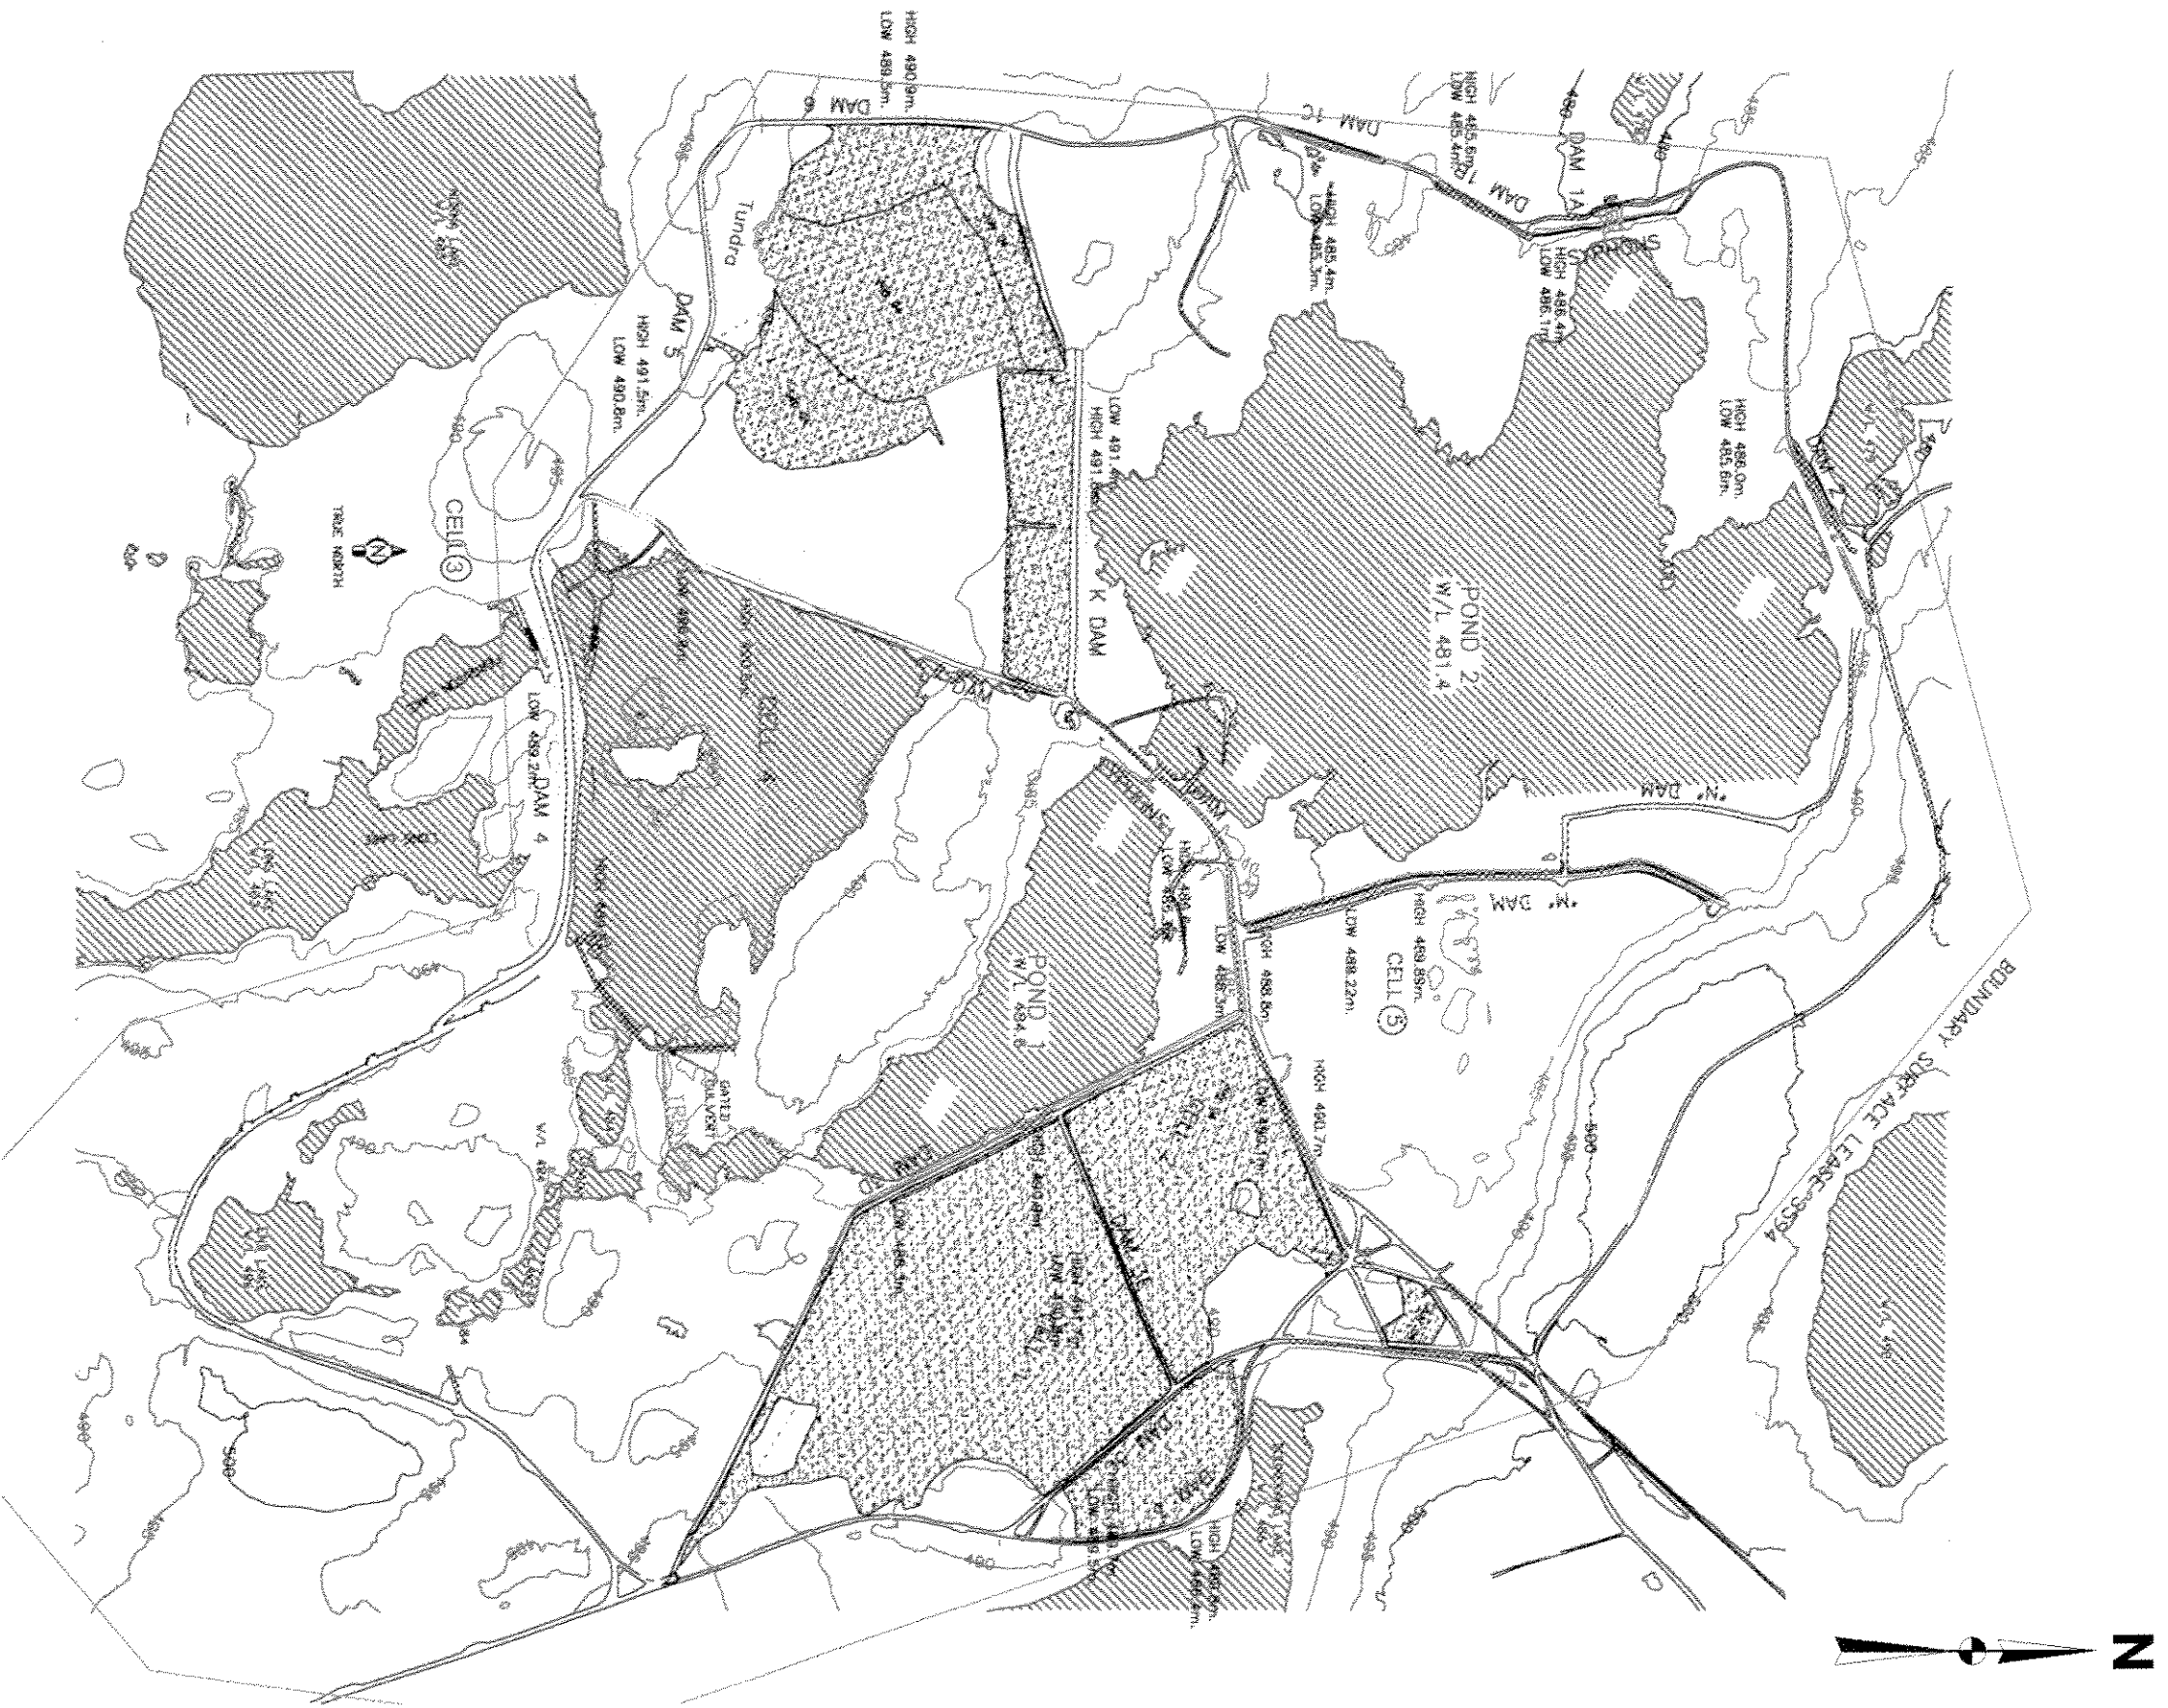
PROJECT: ANNUAL INSPECTION OF PERIMETER TAILINGS DAMS
TITLE: TAILINGS CONTAINMENT AREA
PROJECT No. 0256-012-01
FIGURE No. 2
REV 0

As illustrated on Figure 2, tailings storage at Lupin Mine utilises a number of low embankments which are arranged to provide five cells for solids accumulation, some supernatant water storage within these cells, supernatant runoff storage accumulation (Pond 1) and an adjacent area (Pond 2) for transport water conditioning and staged release. In that none of the tailings water is recycled to the mill, aged water is typically transferred from Pond 2 to the environment once every second year (usually beginning mid-July). Following this discharge, tailings water is transferred from Pond 1 to Pond 2 for subsequent ageing. During the transfer, water treatment chemicals are added, if required. In a typical year, compliant water within Pond 2 is discharged to the environment via the siphons over Dam 1A. When storage capacity is created in Pond 2, Pond 1 water is transferred in using the siphons over J-Dam.

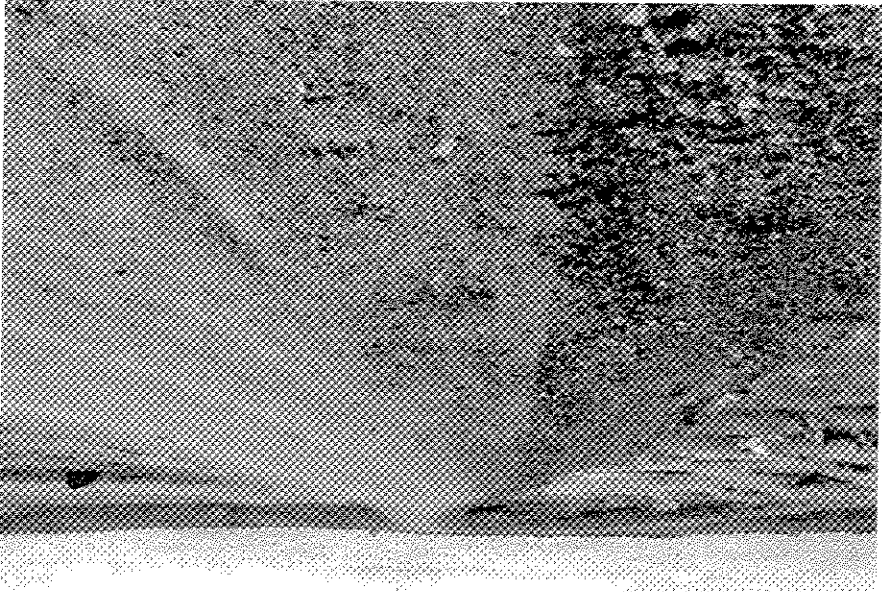
View of the crest and the upstream side looking towards it south abutment. This dam has no retained head pond and only a few small isolated ponds of water are retained by this dam.
