2009 Annual Geotechnical Inspection Perimeter Dams Tailing Containment Area Lupin Mine, Nunavut

December 1, 2009

Ref. No. 09-161

**Re: 2009 Annual Geotechnical Inspection
Perimeter Dams Tailings Containment Area
Lupin Mine, Nunavut**

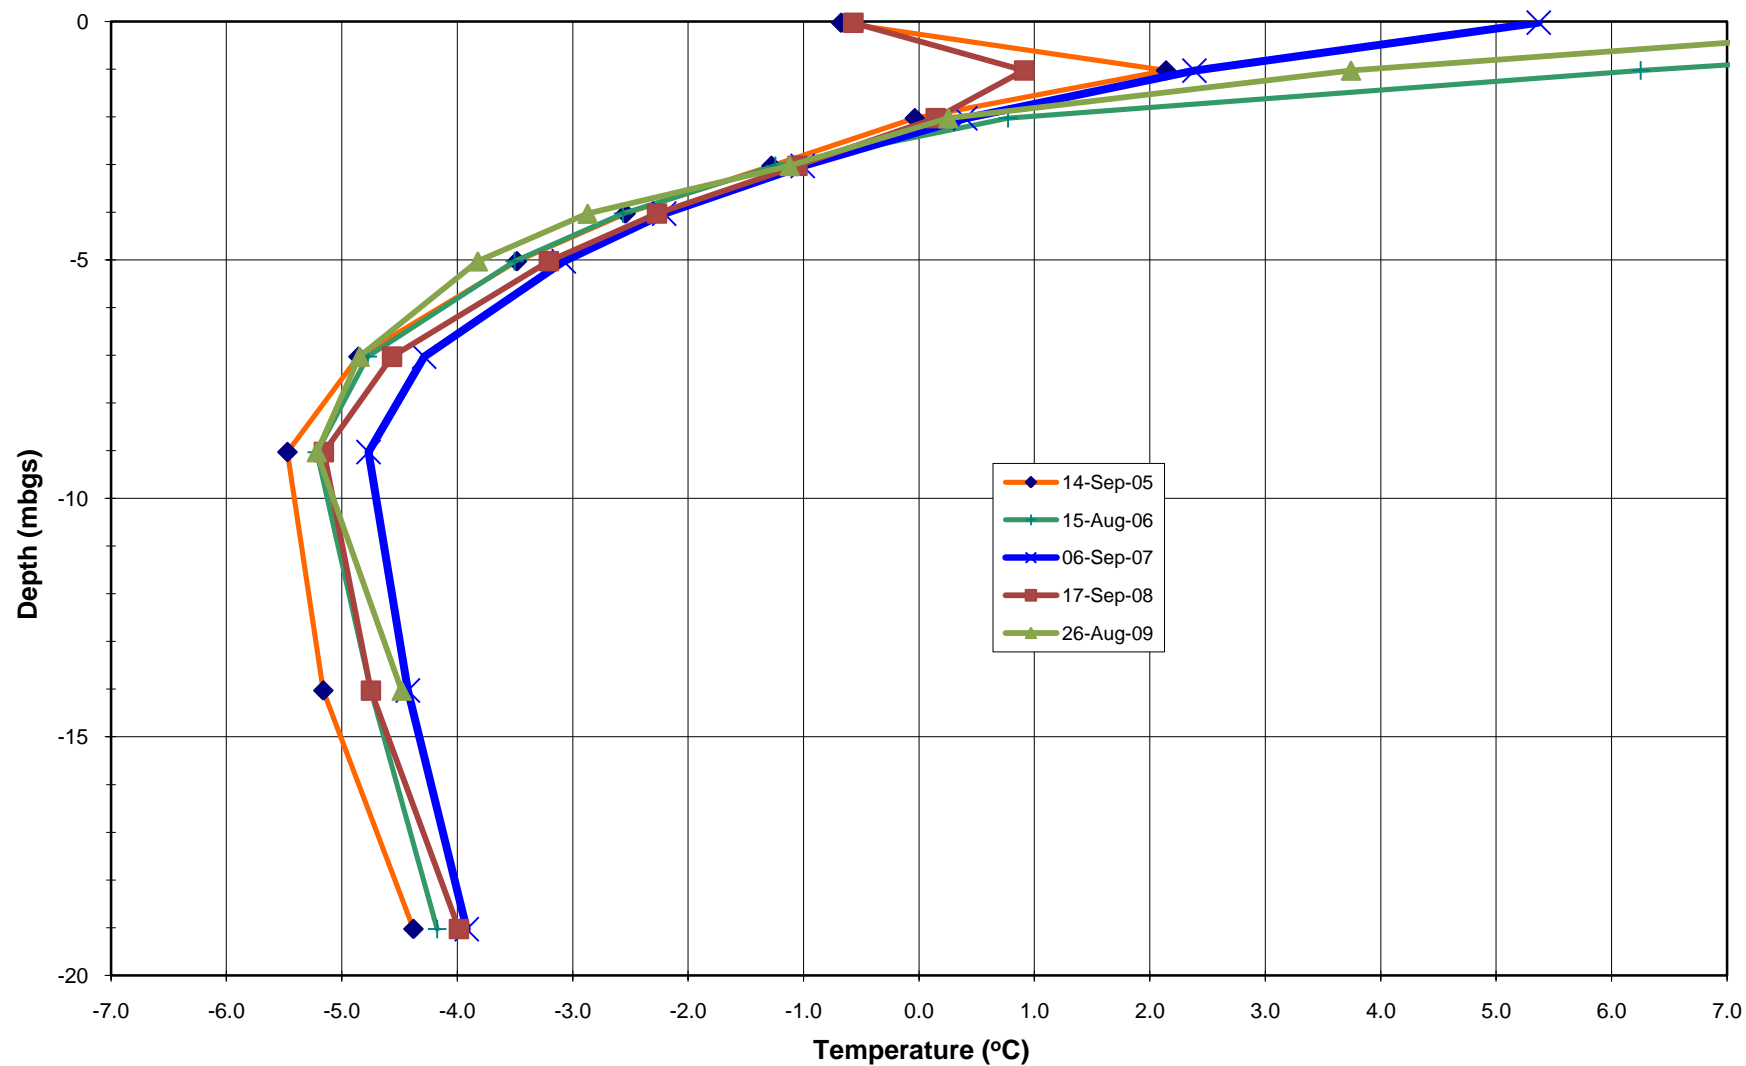
**Thermistor D1A-00-01 - Installed November 9, 2000
(Vertical Thermistor installed on the crest of Dam 1A, south of Syphons)**

A review of the thermistor data indicates the dams continue to maintain frozen conditions below the active zone, located approximately 2 m below grade.
