2015 Annual Geotechnical Inspection – Lupin Mine Tailings Containment Area, Nunavut

Lupin Mines Incorporated

SRK Consulting (Canada) Inc.
1CL008.002
October 2015

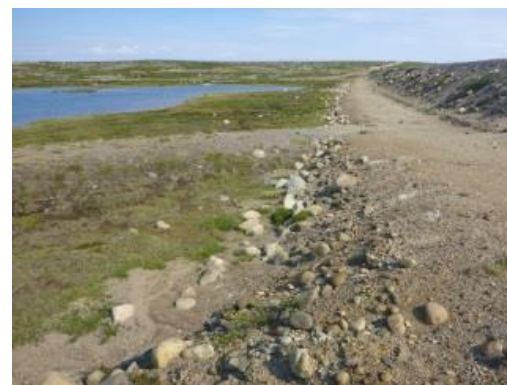
The previous annual inspection found seepage in the western buttress toe of Dam 4 into Ferguson Lake and the northern buttress toe of Dam 2 into a pond created by a cofferdam adjacent to Dam 2 Lake. Seepage at Dam 4 has not been observed since the 2011 inspection. Seepage at the toe of Dam 2 was observed in 2015, at similar flowrates since 2012. In 2015, this seepage was contained by the cofferdam downstream of north abutment and pumped back into Pond 2 when it pooled.

Photo 3: Looking southwest on Dam 2 near the northern abutment.

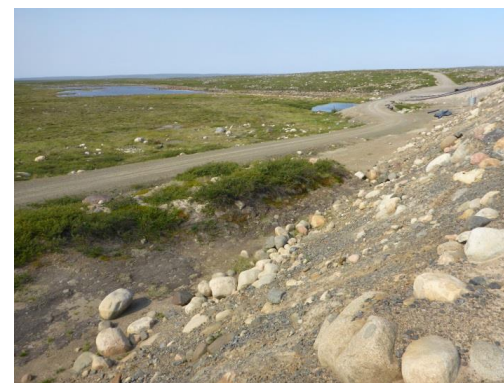
Photo 6: Looking north from the southern abutment of Dam 1A

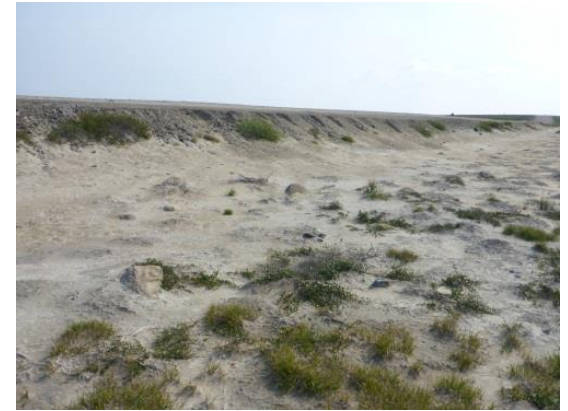
Photo 15: Looking north at the downstream face of Dam 6 from the southern abutment

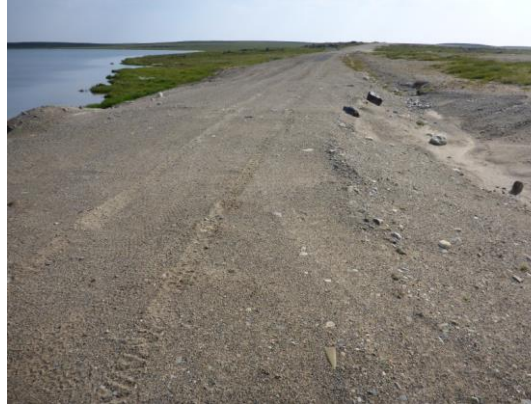
The storm ditch built within the top 2 m of Dam 3 has suffered some erosion damages from the 2014 freshet. It is believed that ponding in sections of the ditch is the main cause of the erosion damage. Because of the poor grading, the closure cover runoff water pooled, froze, and created an ice dam; which in turn forced the freshet water to overtop the ditch, over a small portion of Dam 3. Repair was completed on the damaged area in 2015 by constructing an armored channel along the alignment of the erosion, to let the drainage bypass the ponding section.

Photo 23: Looking east at the storm channel on Dam 3.

Dam 3	N/A (no water is impounded by this dam)	Erosion has once again damaged the dam crest due to the poor storm ditch grading. Mitigation included converting the erosion gully into an armored storm ditch to provide proper drainage.	Repairs were completed on the eroded section by LMI after the inspection. Monitoring should be carried out to check that the new ditch is performing as intended.	Minor surface erosion. Despite repairs to the storm ditch, it does not yet have a free-draining grade.	Repairs were completed on the eroded section after the inspection by LMI. Consider to re-grade ditch to minimize ponding and monitor during freshet to prevent ice blockages.
Dam 4	~2 m	Surface erosion with a number of erosion gullies. Exposed geogrid observed near the eastern downstream toe of the dam.	Repair the deep erosion gullies, re grade surface and backfill and depressions monitor the exposed geogrid for further erosion and potential water seepage.	Surface erosion with a number of deep erosion gullies. Exposed geogrid or similar synthetic reinforcements observed near the eastern downstream toe of the dam.	Repair the deep erosion gullies and maintain the surface. Monitor the exposed geogrid for further erosion and potential water seepage.

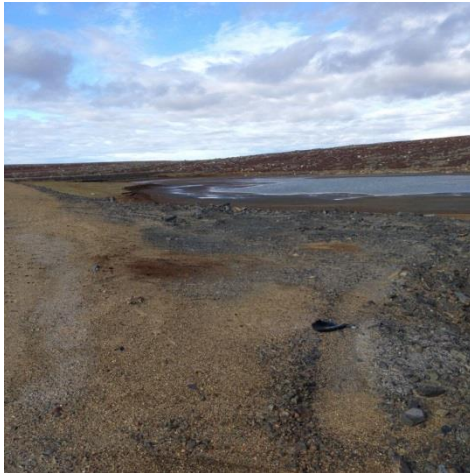
Eight significant tension cracks were observed on Dam M. Visual comparison between 2012 and 2015 photographs showed the existing cracks are widening and lengthening. Potentially, the failed portions of the dam could breach and allow the supernatant water and tailings to flow from Cell 5 into Pond 2. Because of the severity of the cracks and potential breach, LMI was advised that all vehicle traffic should avoid this section for safety reasons. A risk assessment was completed by SRK in 2012 to evaluate the potential impact on water quality and the environment in the event of a breach. The results of the assessment indicated that there would be minimal impact to the environment due to the presence of the perimeter dam containment (SRK 2012b). However, a breach in Dam M would be a concern for worker safety, site infrastructure access, future operations, and ongoing care and maintenance activities. Section 4.1 provides recommendations to address the potential risks in the event of a full breach.

Photo 34: Looking east at the upstream face of Dam M and dewatered Cell 5, near the western abutment.

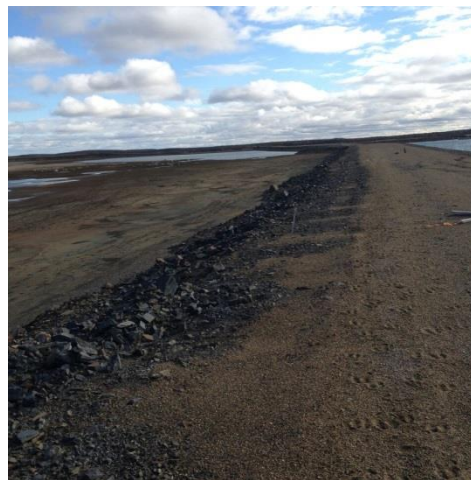
Photo 35: Looking west at the upstream face of Dam M and dewatered Cell 5, near the middle of the dam.

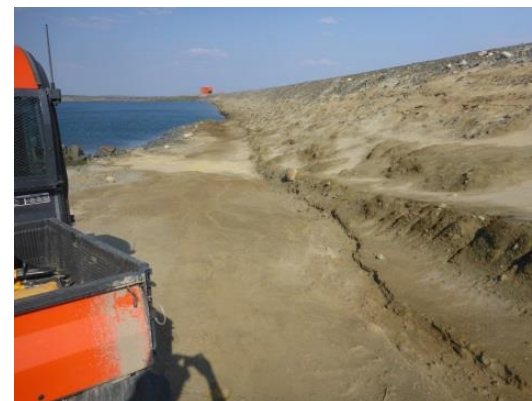
Dam K has historically experienced erosion (undercutting) at the toe of the slope due to wave action on the adjacent water in Pond 2. Minor tension cracks and a few erosion gullies were observed in the dam crest. Recent observations made by an SRK engineer during an inspection on October 7 indicate that there is in fact riprap armoring along the northern toe of Dam K. This riprap armoring was submerged during previous inspections and was only exposed recently as Pond 2 was lowered. Animal burrows were observed in the eroded gullies. It is unknown what type of animal made these burrows.

Photo 42: Looking west at Dam K with pond 2 at the left at the eastern abutment.

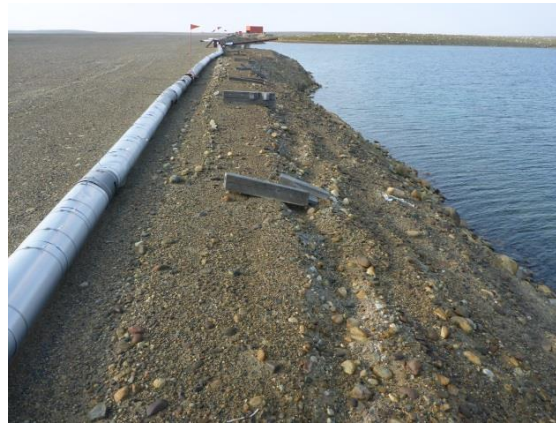
During the 2012 inspection, an erosion breach was observed at the south end of Dam L. The erosion damage was repaired this year. The Dam L slope facing Cell 3 is observed to have considerable erosion near the toe.

Photo 44: Looking north at the crest and dam face with Cell 4 to the right.
