2015 Waste Management Facilities Geotechnical Inspection

Lupin Mines Incorporated

SRK Consulting (Canada) Inc.
1CL008.002
October 2015

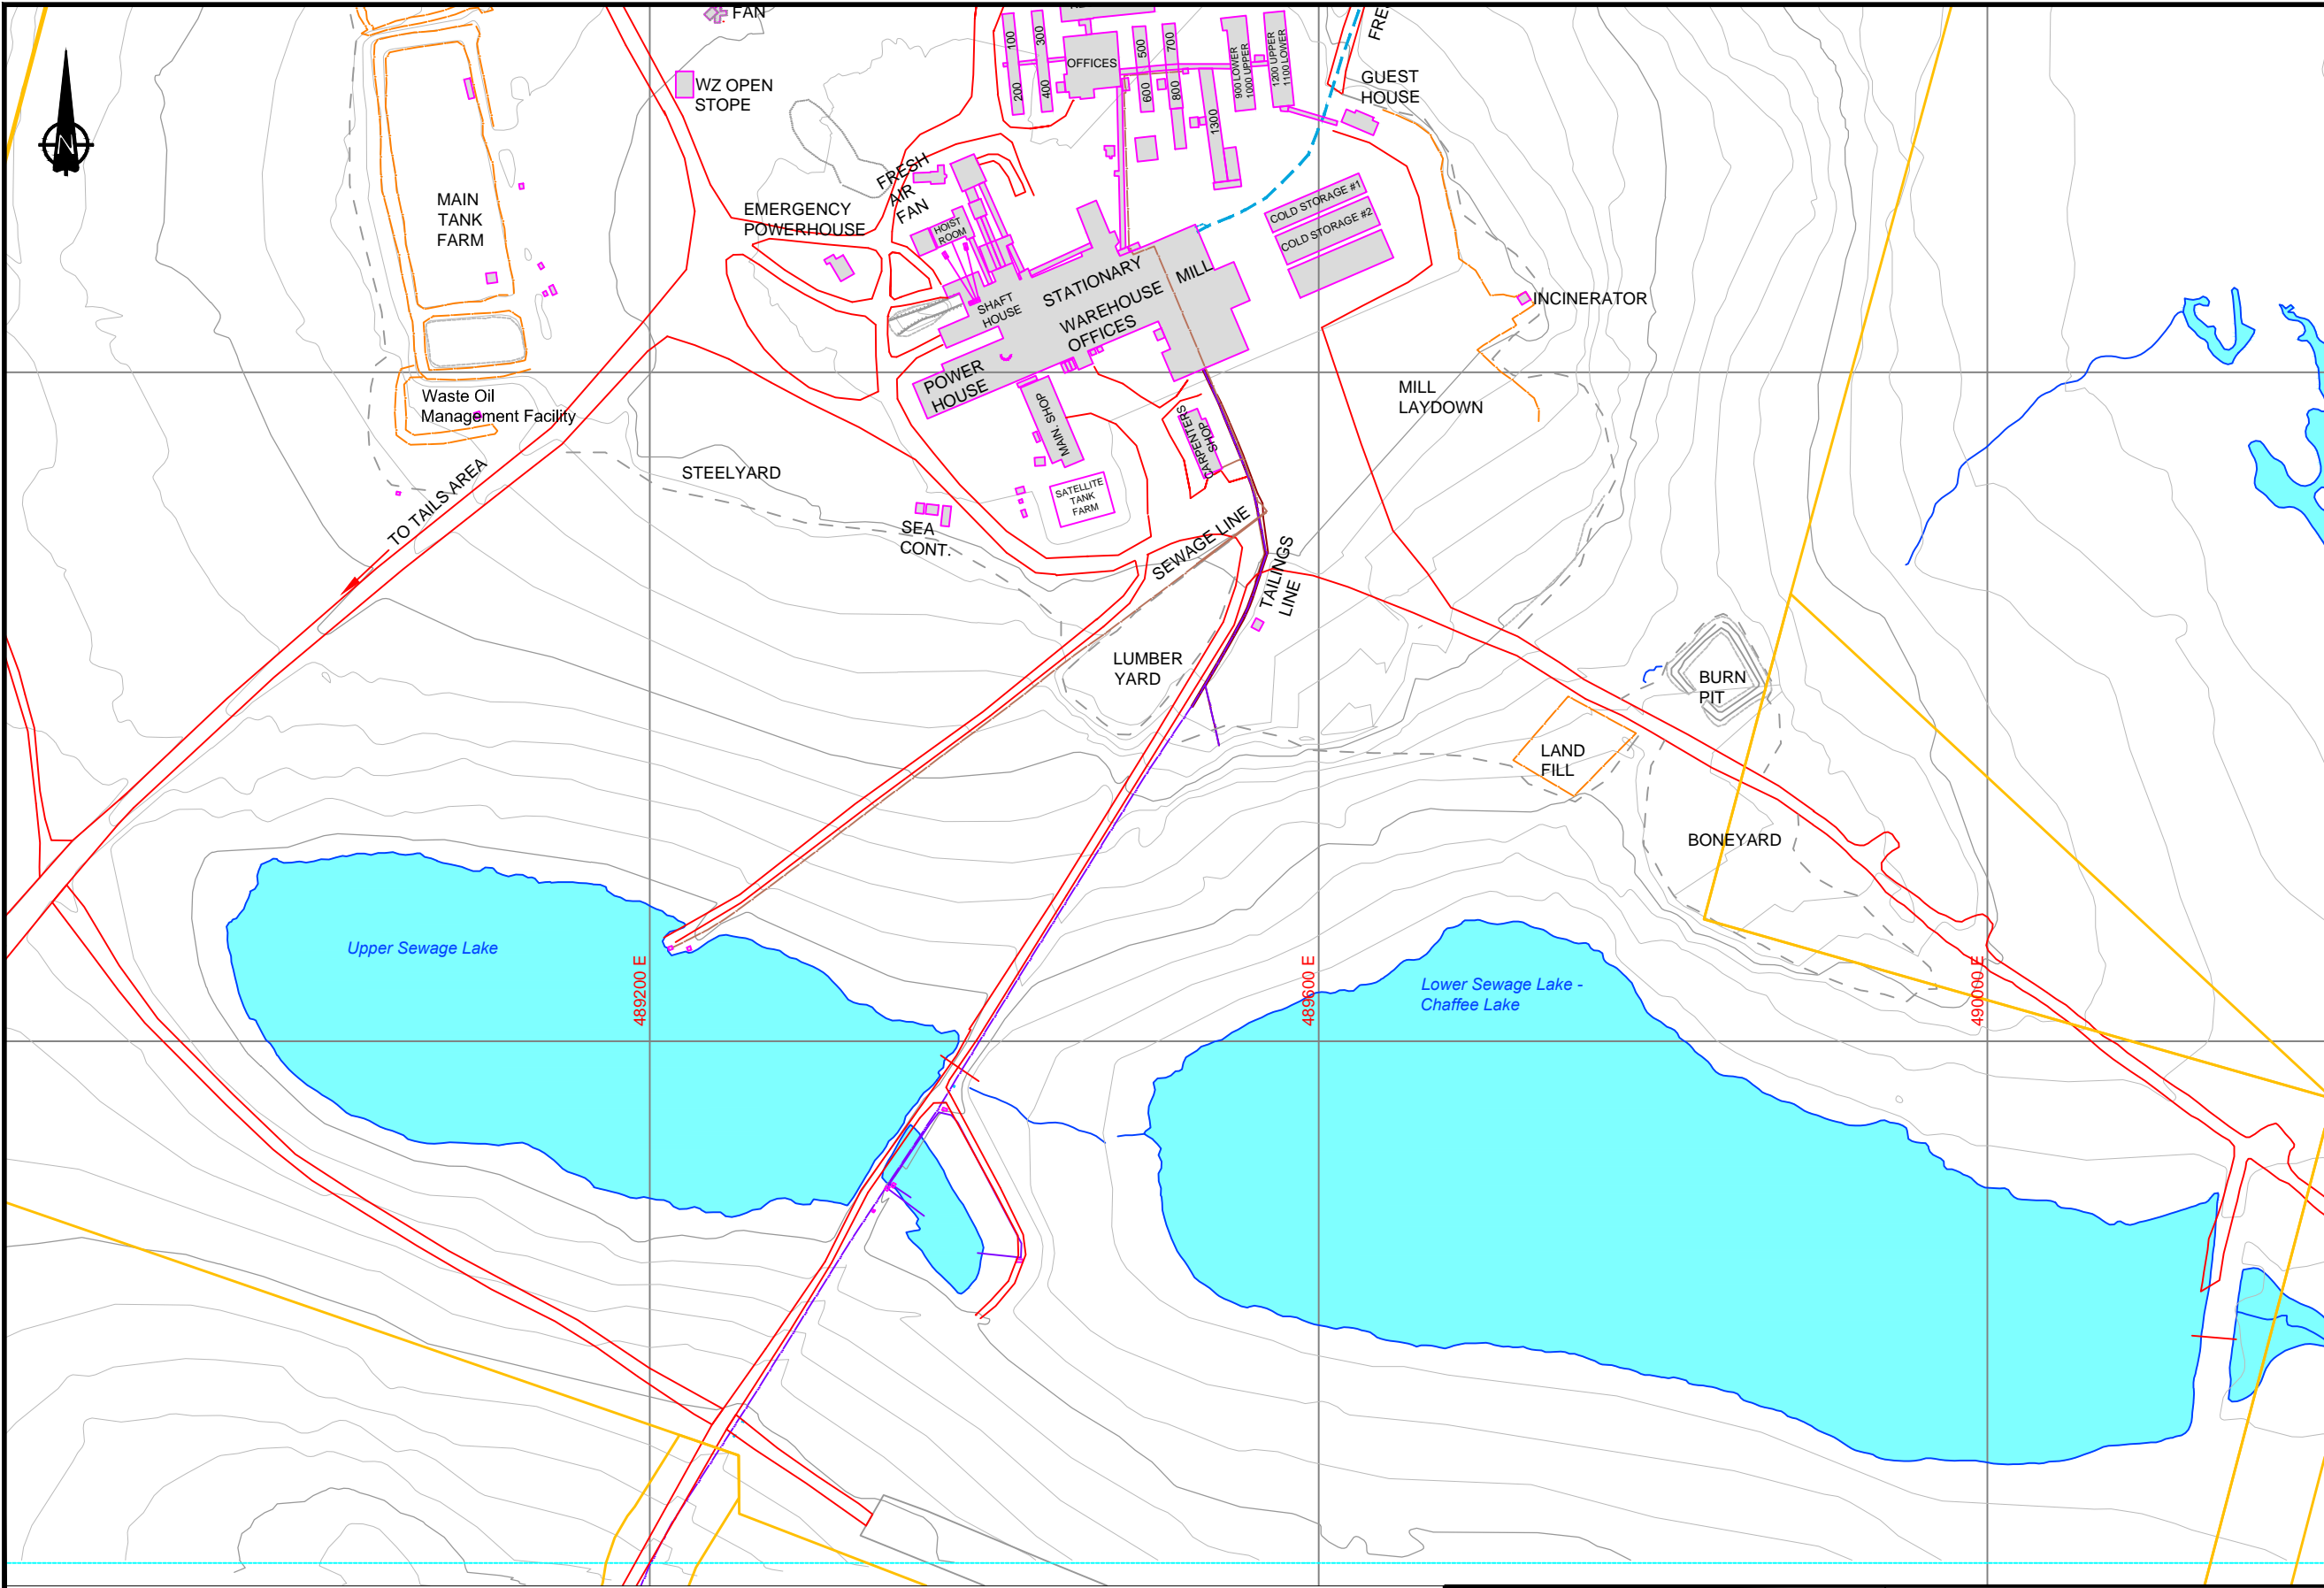
FIGURE:
2.1

The Lupin Mine consists of a mill facility, camps, airstrip and tailings containment area (Figure 2.1). The sewage management facility consists of two lagoon lakes located south of the mill facility (Figure 2.2). The sewage lagoon lakes system was constructed in a natural valley which generally drains from a northwest to southeast direction. The system consists of two lakes, created by Upper and Lower Sewage Dams. The dams are generally aligned in a north to south direction, and observed to be constructed from compacted esker sand and gravel estimated to be 3-4 m high. The Upper Sewage Dam is around 60 m in length and the crest supports the now decommissioned tailings pipeline which discharged tailings to the tailings containment area (TCA) from the mill. A small containment (tailings dump pond #1) is built downstream in the southern section of the upper sewage dam, using it as a buttress. The height of this small containment varies between 3-4 m. The Lower Sewage Dam is around 80 m in length.
