2021 Lupin Mine Tailings Area Inspection Report

Annual Geotechnical Inspection of the
Tailings Containment Area

November 5, 2021

Lupin Mines Incorporated

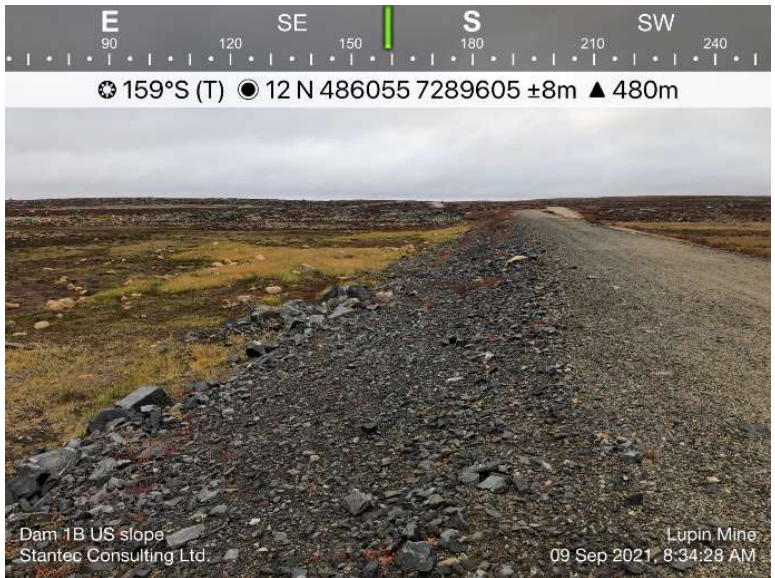
Pond 2 water level has lowered significantly from last year's discharge. The observed freeboard at the perimeter dams was around 4.5m or greater. This well exceeds the minimum requirement of 1m freeboard as stated in the water license. Dam 1B, 1C, Dam 5 and Dam 6 do not have water on the upstream face of the dams.

Photo 5: Looking south at the upstream slope of Dam 1B.

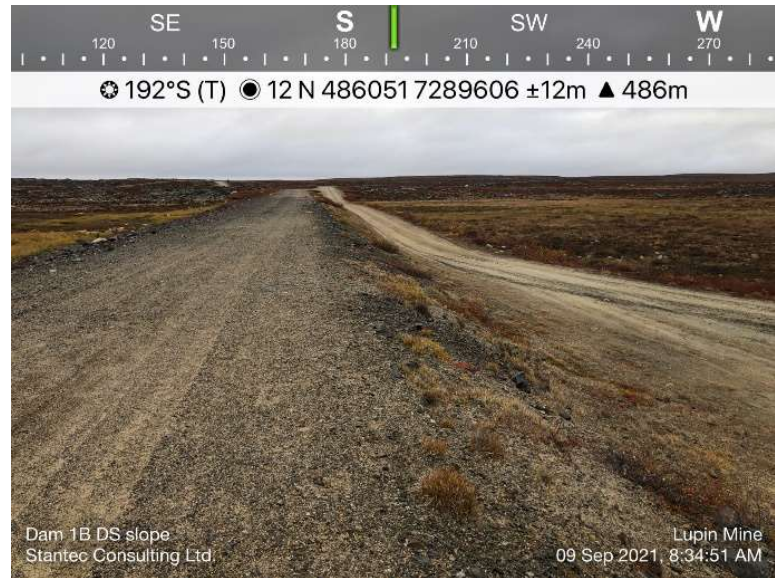
Photo 6: Looking south at the downstream slope of Dam 1B.

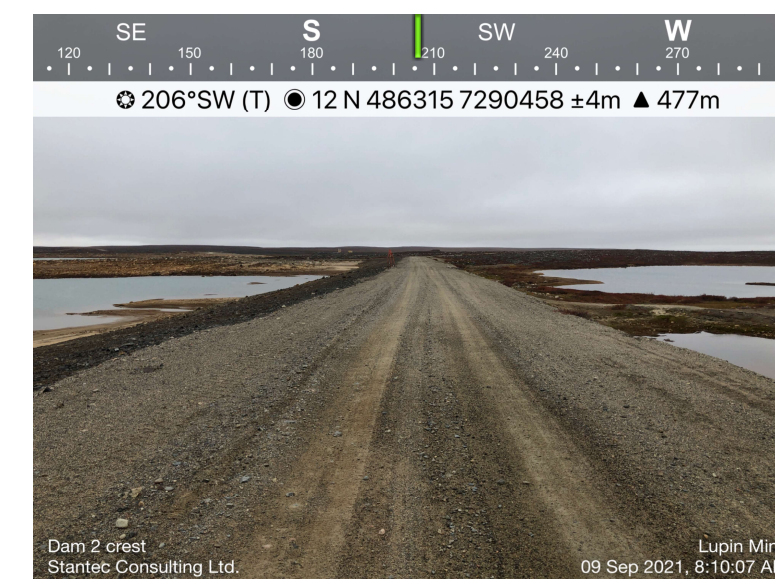
Photo 12: Looking south at the crest of Dam 2.

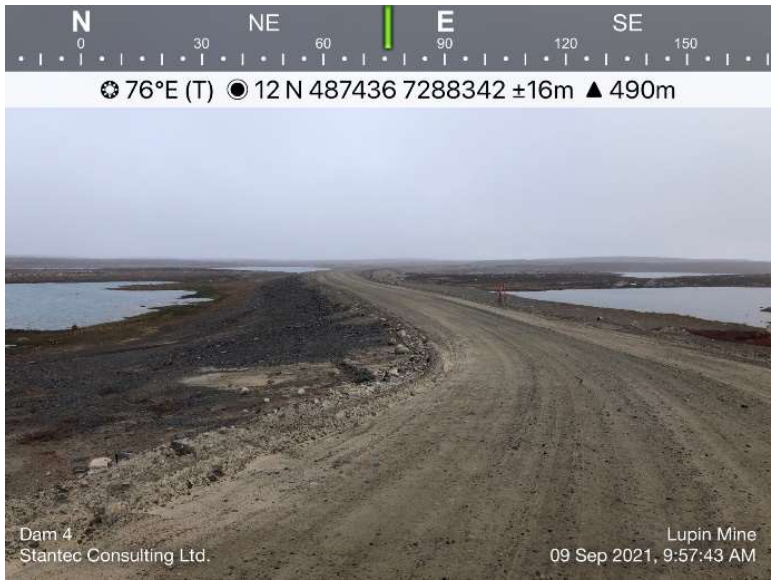
Photo 16: Looking east from the west abutment at the crest slope of Dam 4

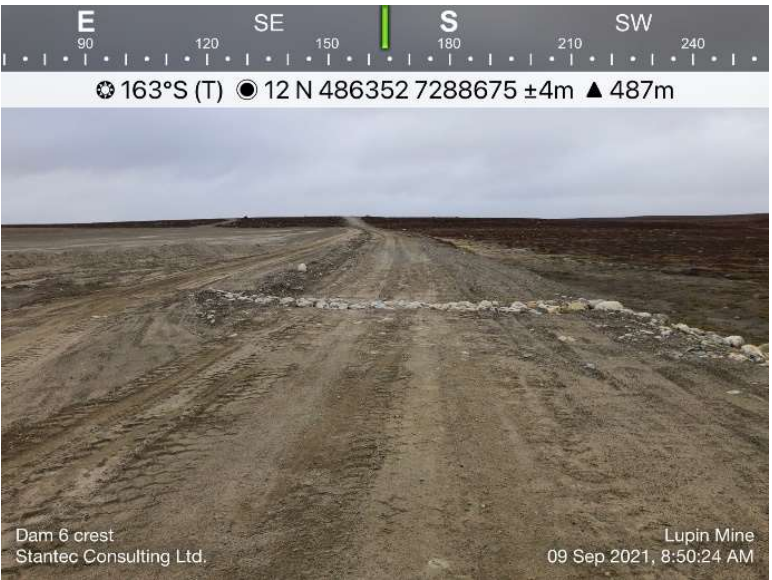
It was noted by the site engineer that a minor surface erosion occurred on Dam 6 during early freshet around the first week of June. The erosion is a shallow surface erosion, approximately 2m wide and 0.5m deep on the crest of Dam near the north abutment. Immediate active water management (pumping) was done to reroute the freshet water and the erosion was repaired with compacted coarse sand and gravel with cobble, under the supervision of the site engineer with direction from the EOR.

Photo 23: Looking south at the crest of Dam 6

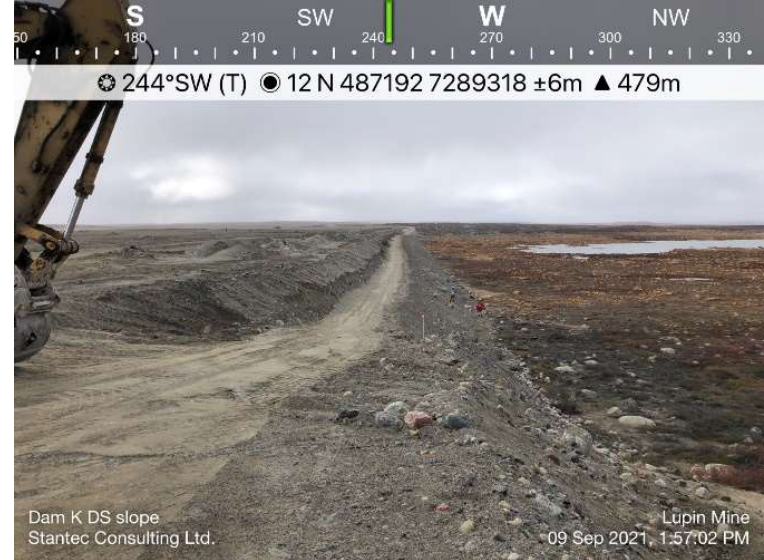
Photo 37: Looking southwest from the north abutment of the reinforcement buttress.

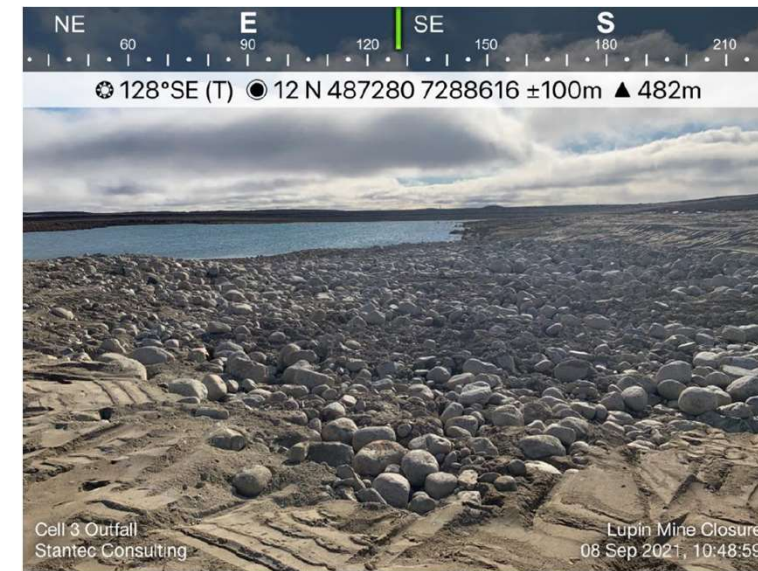
Photo 40: Cell 3 outlet armoring.

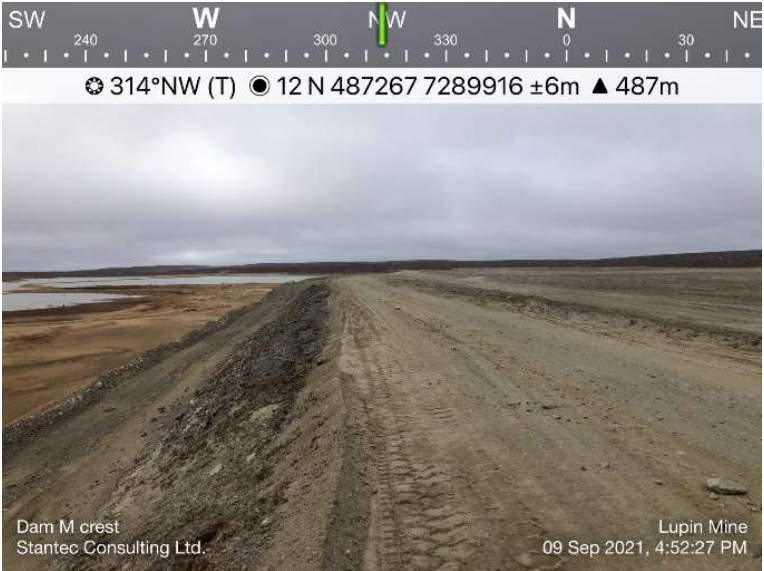
The buttress at Dam M experienced localized minor sloughing in 2020. During 2020 closure activities, a minor localized failure caused by a construction incident was observed by the EOR representative. This area was monitored

by the EOR representative throughout 2021 and further deformation was observed. Upon the 2021 inspection, it was determined that this localized failure does not impact the overall stability of Dam M and further repair was suspended to be completed during the final reslope to minimize risks.

Photo 44: Looking northwest at the crest of Dam M with Cell 5 to the right.

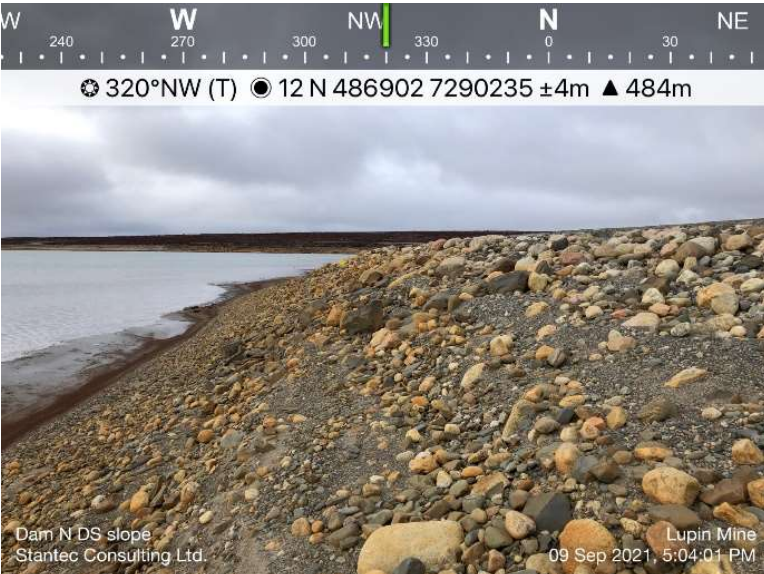
There was visual evidence of a couple of small sand boils noted along the toe of Dam N, although they were not actively showing seepage or flow at the time of inspection. Based on communication with the site engineer, it is surmised the sand boils were caused by excess pore pressure from construction traffic on the Cell N cover. This area has been monitored since and no active flow was observed. The area will be monitored in 2022 during the Cell N construction.

Photo 48: Looking northwest at the downstream slope of Dam N with Pond 2.

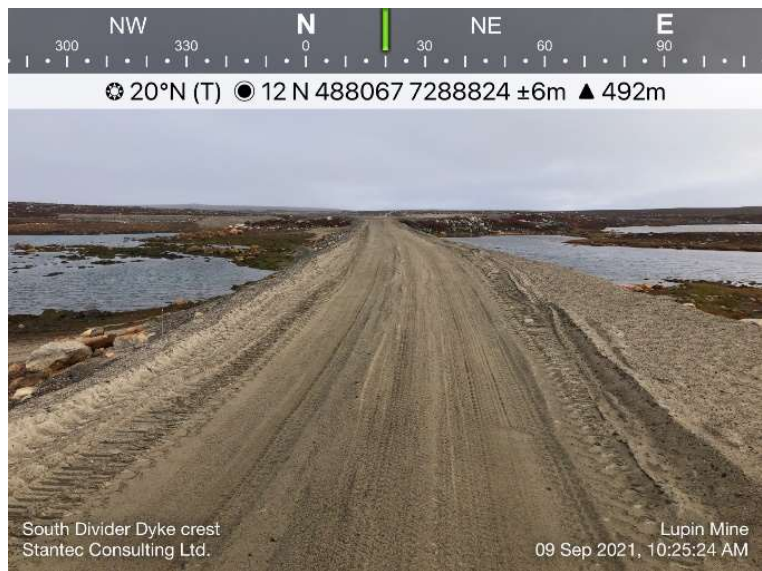
An engineered spillway was constructed through the Divider Dyke along the old culvert alignment. The spillway is passively controlling the Cell 4 water level at El. 484m. The lowered water effectively rendered the Divider Dyke to be an overland feature as it will no longer retain Cell 4 water. As the water was lowered to below the dam, the seepages noted last year were not observed in 2021. The closure work was overseen by the EOR representative to ensure quality assurance. A summary construction report (Stantec 2021d) was submitted to document the work done in the Divider Dyke.

Photo 50: Looking north at the repaired upstream slope and crest of the southern divider dyke.
